# HAZARD RISK ASSESSMENT REPORT AND COSTED ACTION PLAN

## PIERRE CHARLES SECONDARY SCHOOL

DOMINICA

Revision Date: June 22, 2020

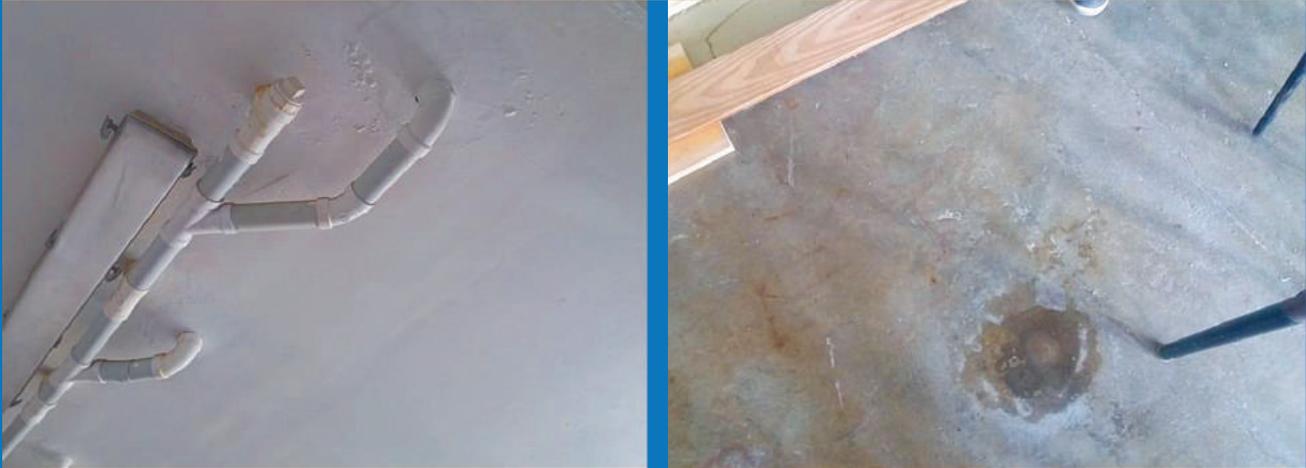
**FIGURE 7.2: IMAGE SHOWING LEAK IN LOWER FLOOR CLASSROOM FROM BATHROOM/PLUMBING ABOVE (MAY 2019)**

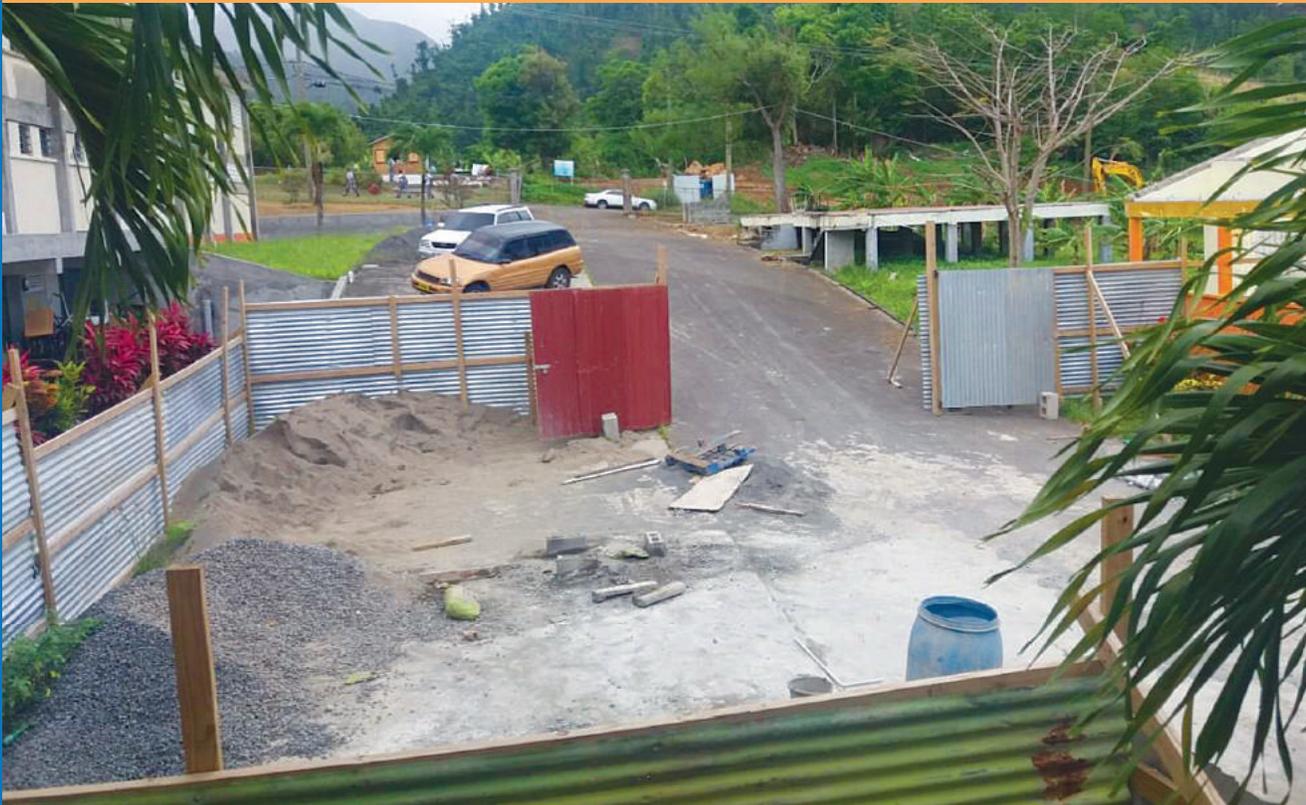
**FIGURE 7.3: CONSTRUCTION UNDERWAY AT PIERRE CHARLES SECONDARY (FENCED OFF, NO SIGNAGE) (MAY 2019)**

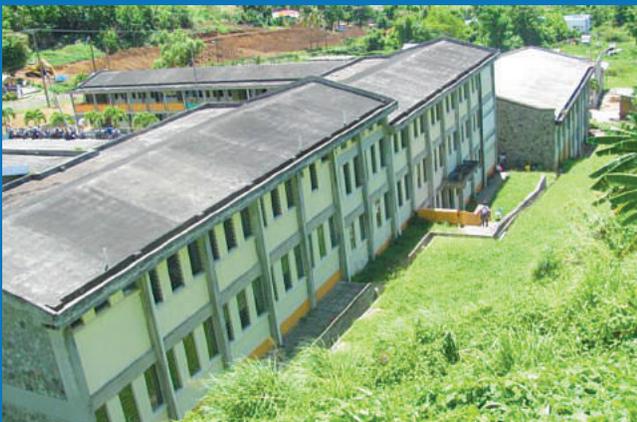
AREA WHERE SLOPE FAILURE RESULTED IN LANDSLIDE ONTO SCHOOL COMPOUND DURING HURRICANE

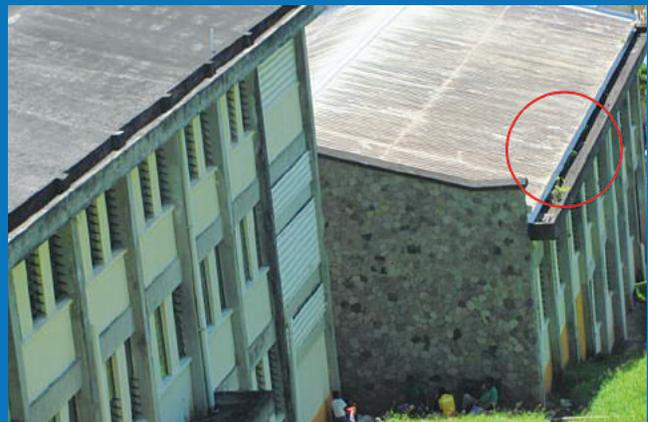
SHRUBBERY GROWING IN ROOF DRAIN

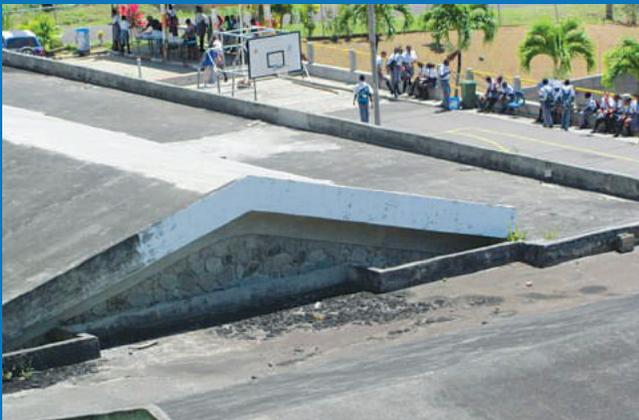
■ SIGNS OF PONDING ON ROOF SLAB

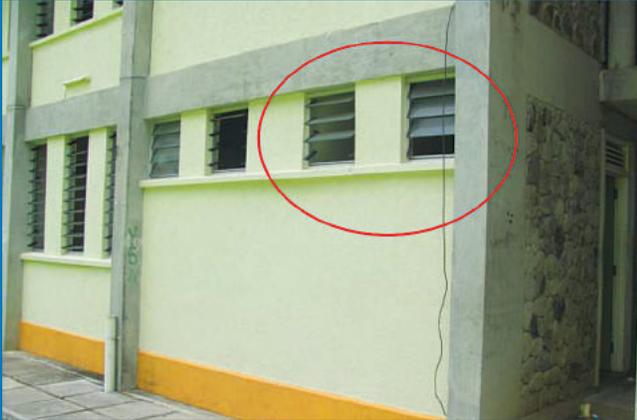
■ WINDOWS WITH MISSING PANES OF GLASS

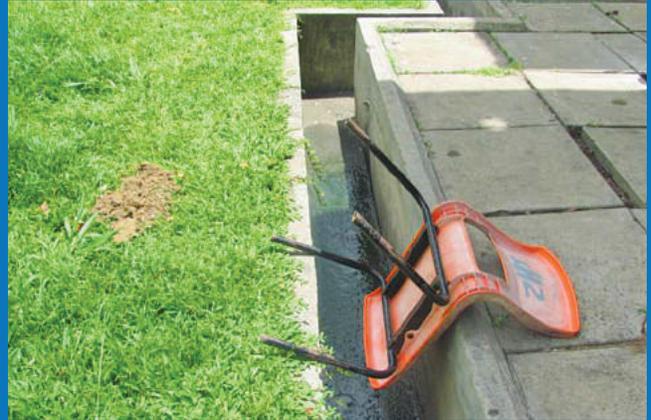
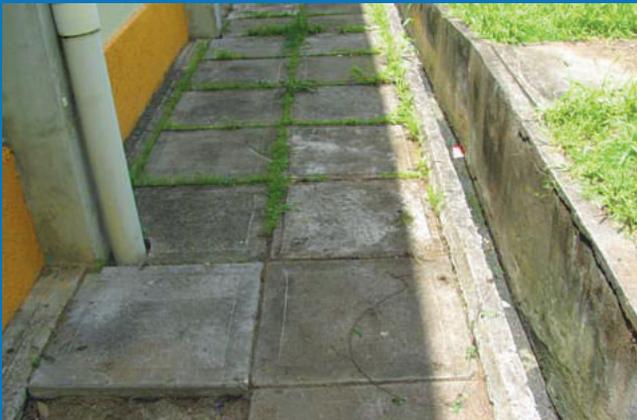
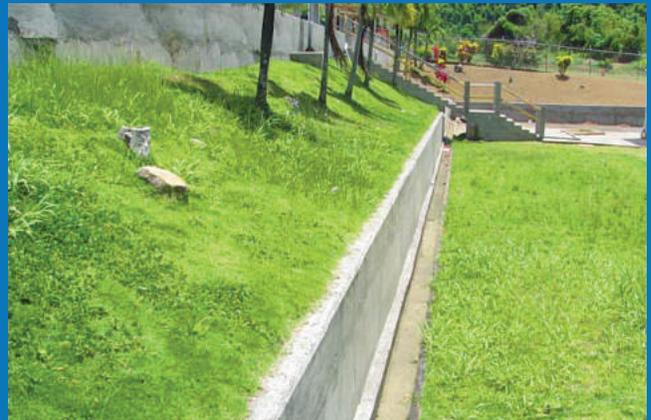
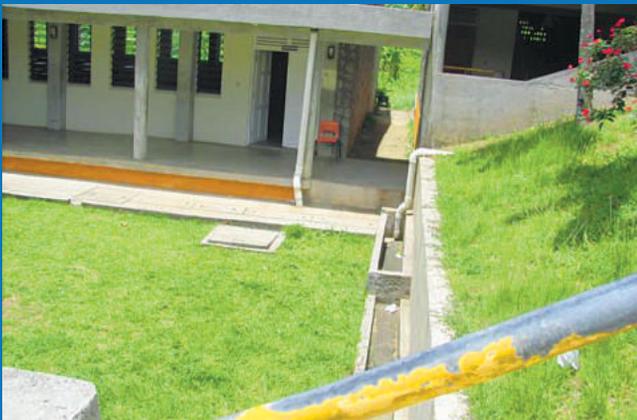
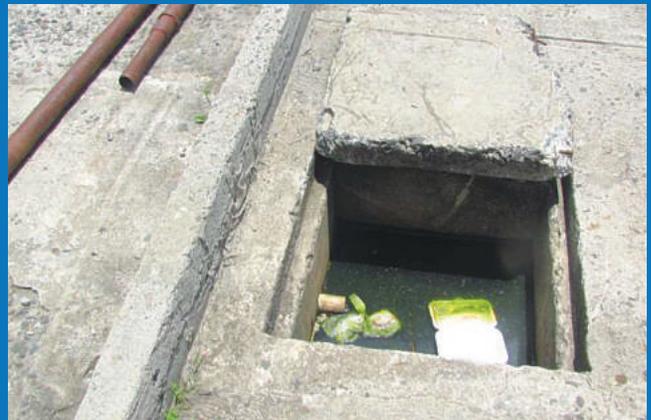
■ STORM DRAINAGE NETWORK TRAVERSES UNDER BUILDING

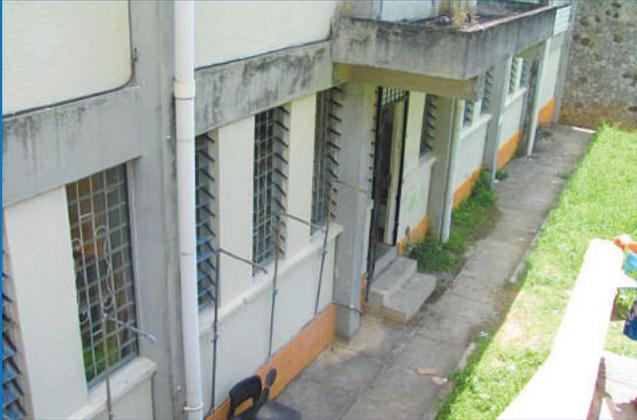
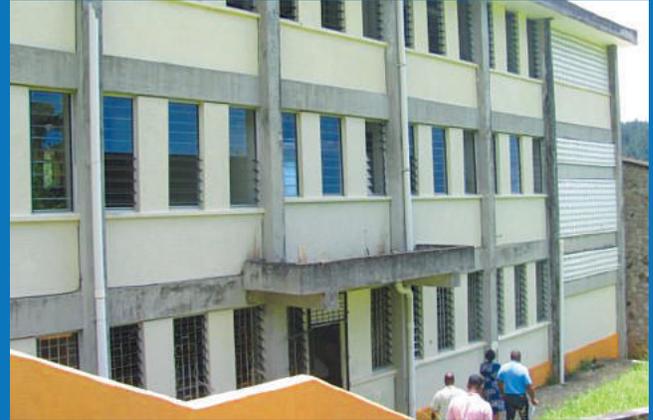
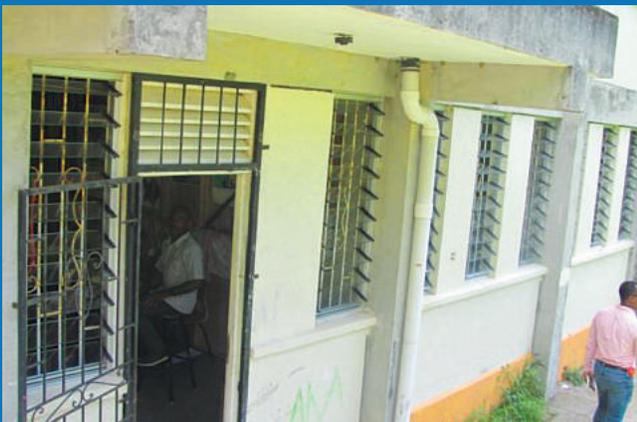
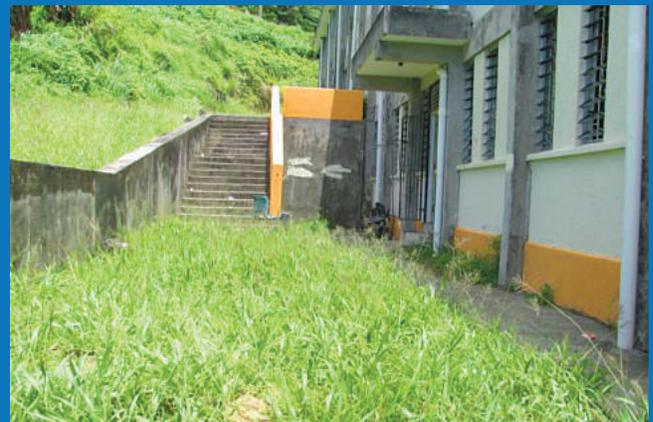
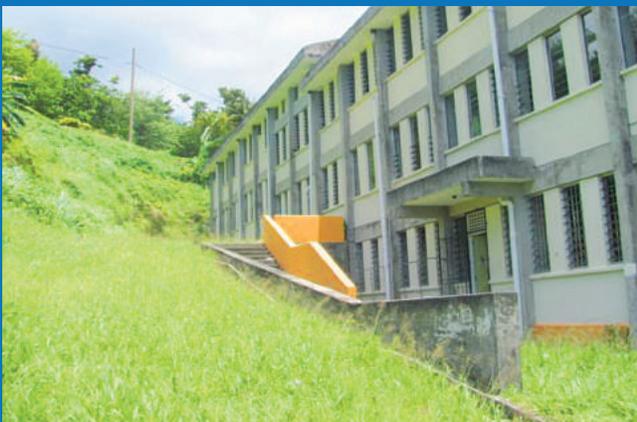
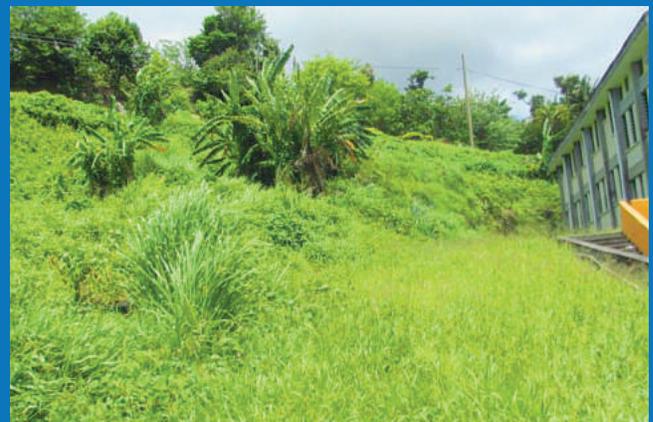
■ BASEMENT LEVEL AFFECTED BY FLOOD AND LANDSLIDE

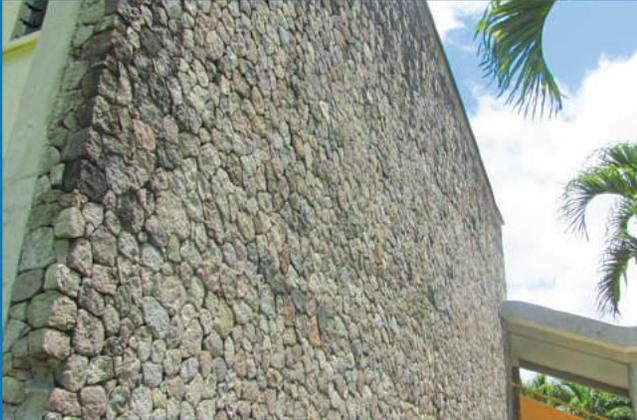
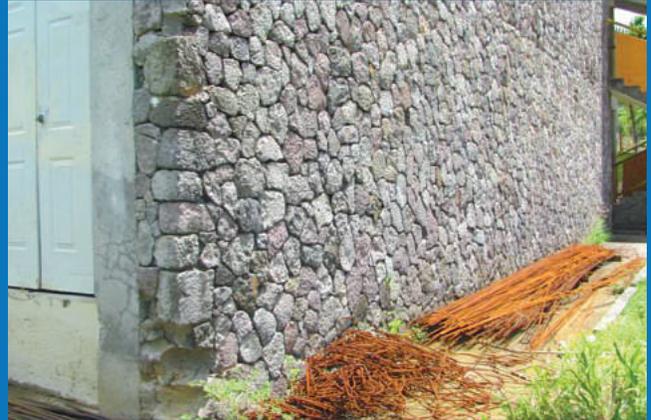
■ STONE MASONRY IN NEED OF ATTENTION

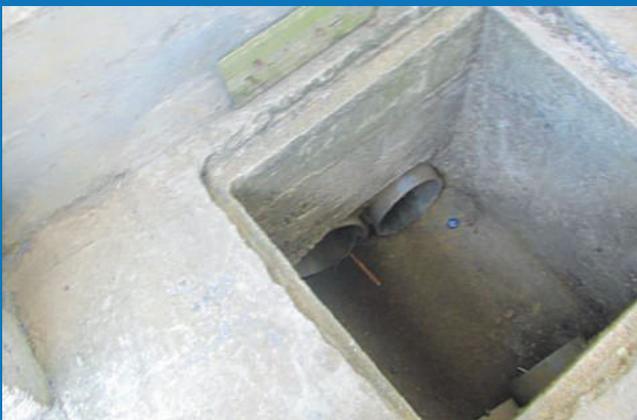
■ NETWORK OF STORM DRAIN UNDER BUILDING – PROBLEMATIC

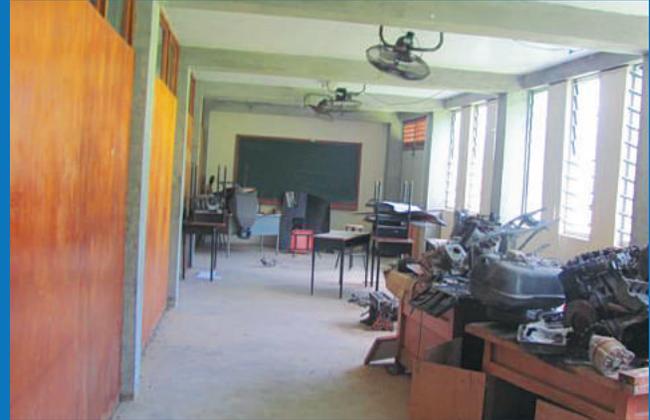
■ ROOM ABANDONED DUE TO FLOODING PROBLEMS

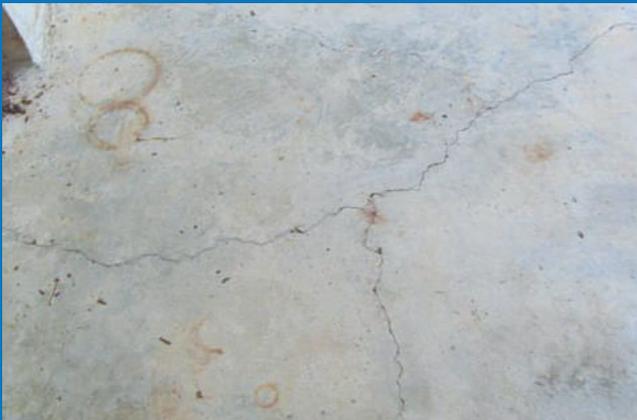
■ HAIRLINE CRACKS IN FLOOR SLAB

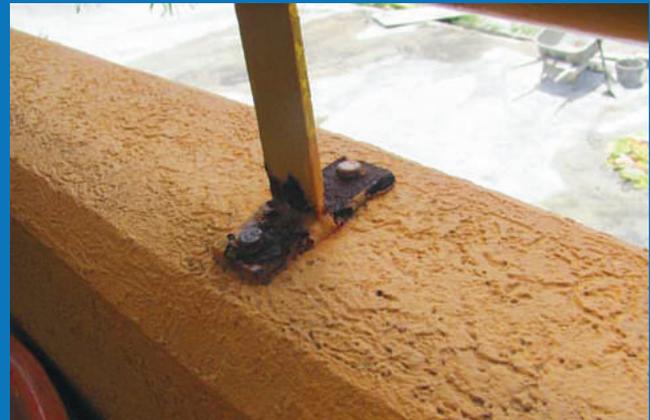
■ CORRODED RAIL BRACKET SUPPORTS

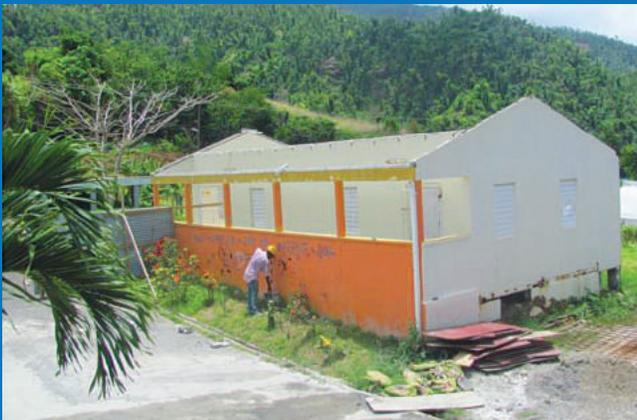
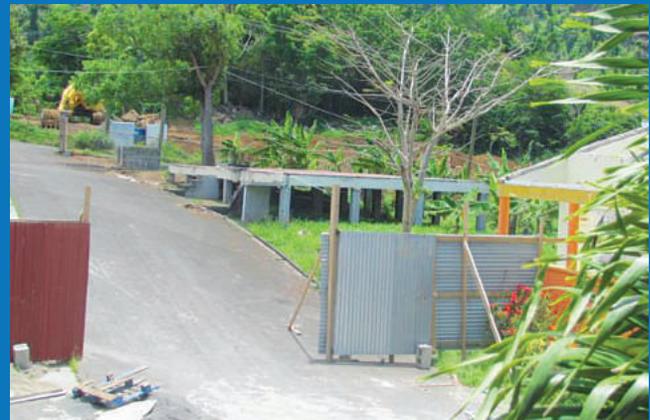
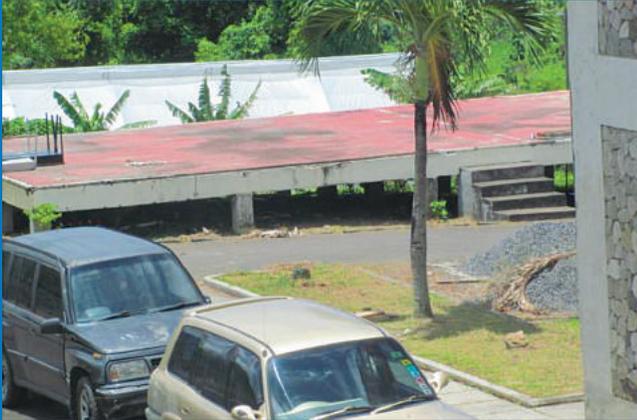
■ CLASSROOM BUILDING DAMAGED DURING HURRICANE

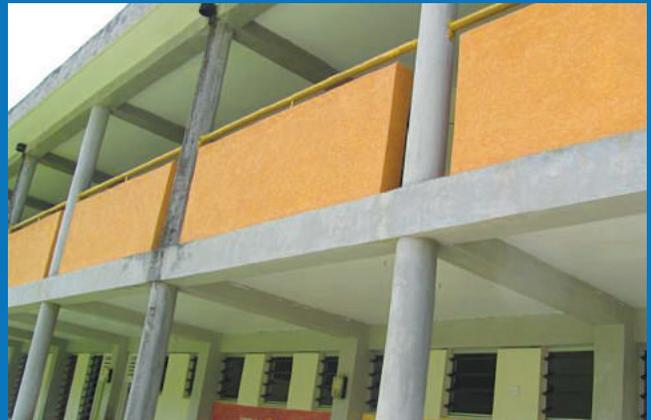
■ UNSTABLE RAILS AND BROKEN ROOF DRAINS

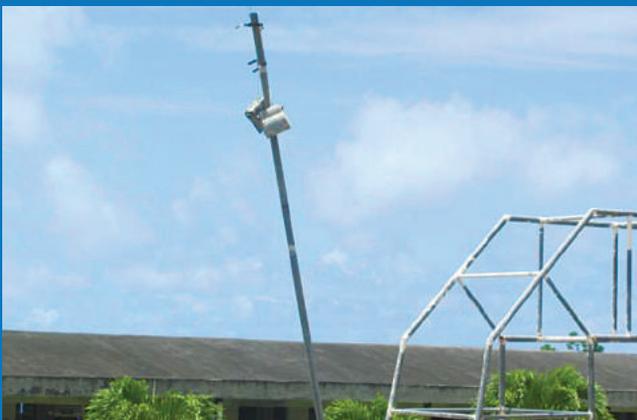
■ BROKEN EXTERIOR LIGHTS
