IMPLEMENTATION OF THE MODEL SAFE SCHOOL PROGRAMME IN THE CARIBBEAN

HAZARD RISK ASSESSMENT REPORT AND COSTED ACTION PLAN

COLIHAUT PRIMARY SCHOOL

DOMINICA

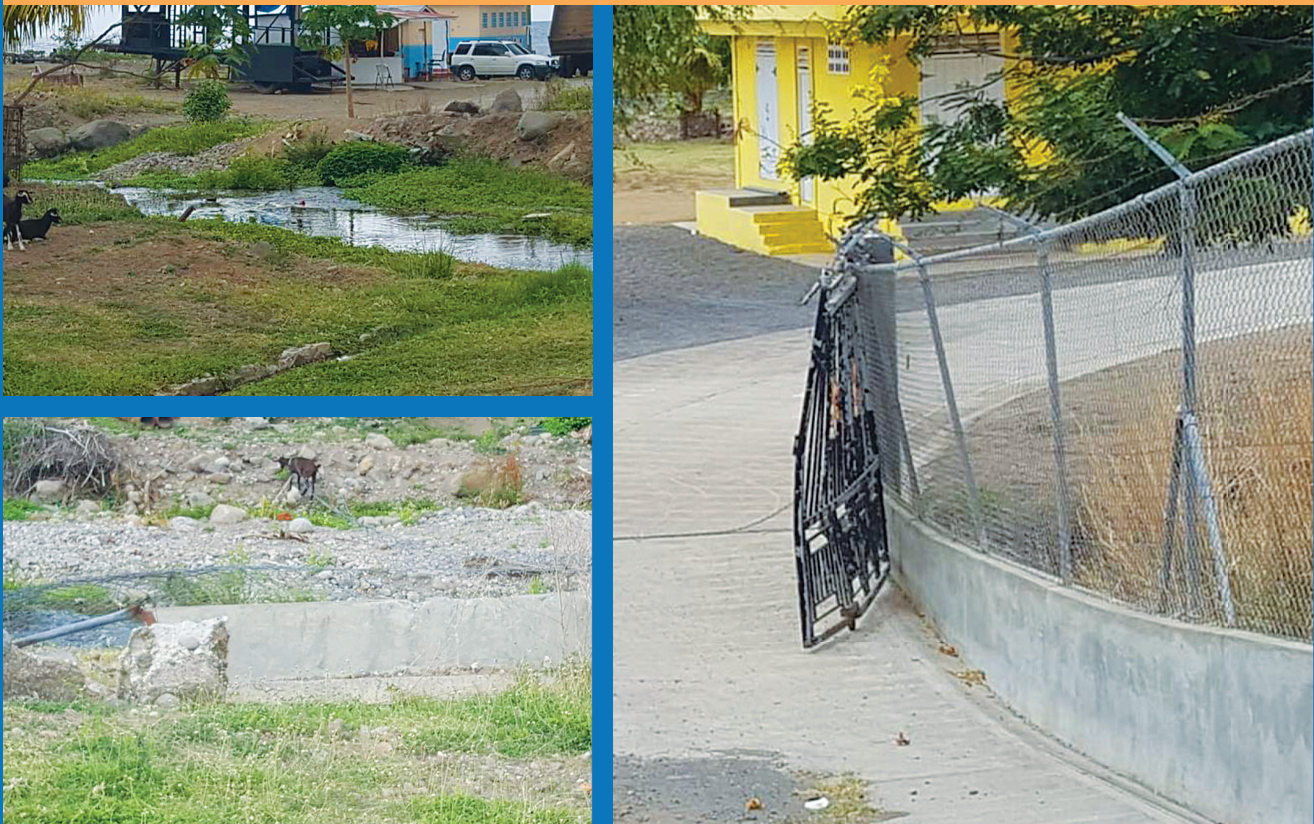
- Some repairs required to the physical plant to ensure safety before or during a hazard event.

FIGURE 7.1: IMAGES HIGHLIGHTING AREAS WHERE PERIMETER FENCE AND GATE REQUIRE REPAIRS (MAY 2019)
