IMPLEMENTATION OF THE MODEL SAFE SCHOOL PROGRAMME IN THE CARIBBEAN

# HAZARD RISK ASSESSMENT REPORT AND COSTED ACTION PLAN

## MASSACRE PRIMARY SCHOOL

DOMINICA

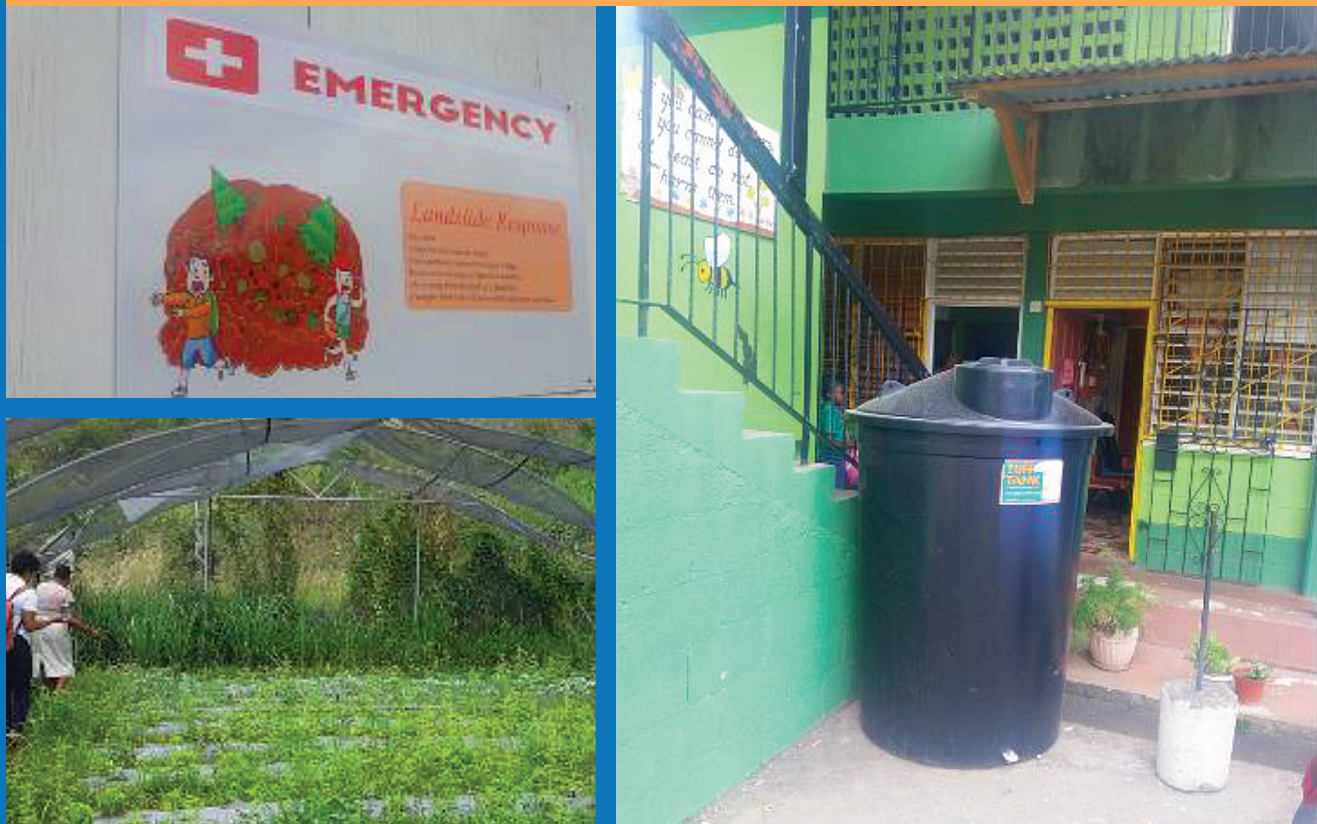
FIGURE 7.1: HIGHLIGHTS FROM MASSACRE/CANEFIELD PRIMARY SCHOOL (MAY 2019)

- The school is exposed to landslides and slippage from the hill behind, however land tenure issues are an obstacle to mitigating the current level of exposure.

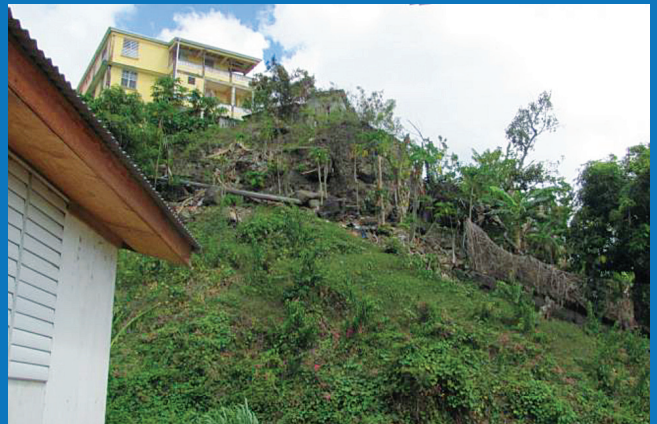
■ ROCKFALL/LANDSLIDE RISK
