IMPLEMENTATION OF THE MODEL SAFE SCHOOL PROGRAMME IN THE CARIBBEAN

# HAZARD RISK ASSESSMENT REPORT AND COSTED ACTION PLAN

## MORNE PROSPER PRIMARY SCHOOL

DOMINICA

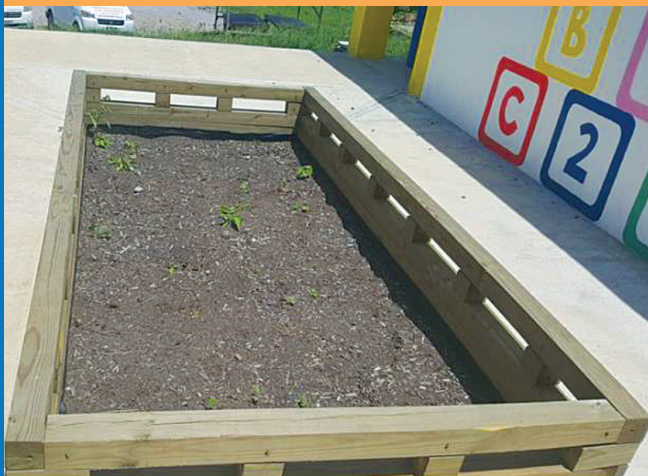
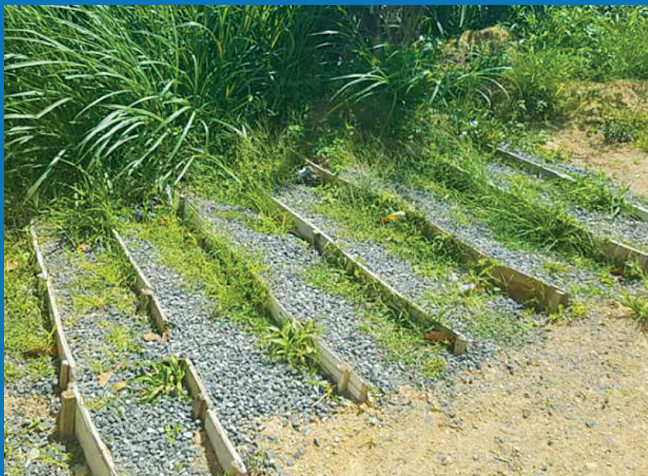
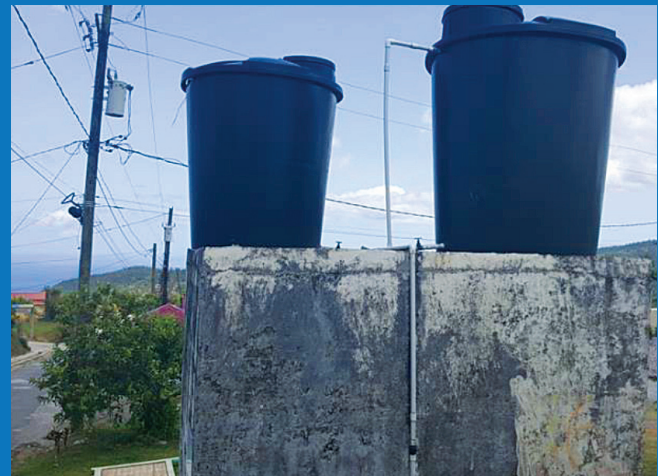
**FIGURE 7.1: IMAGES SHOWING SAFETY HIGHLIGHT AT MORNE PROSPER PRIMARY SCHOOL (MAY 2019)**

- Some repairs required to the physical plant to ensure safety before or during a hazard event.

Section 8 – Improvement Plan and Costed Action Plan provided specific actions and timelines for recommendations on improving the overall safety of the school. Additional selected photographs can be found in the Appendix.
