IMPLEMENTATION OF THE MODEL SAFE SCHOOL PROGRAMME IN THE CARIBBEAN

# HAZARD RISK ASSESSMENT REPORT AND COSTED ACTION PLAN

## GOLDEN GROVE PRIMARY SCHOOL

### ANTIGUA AND BARBUDA

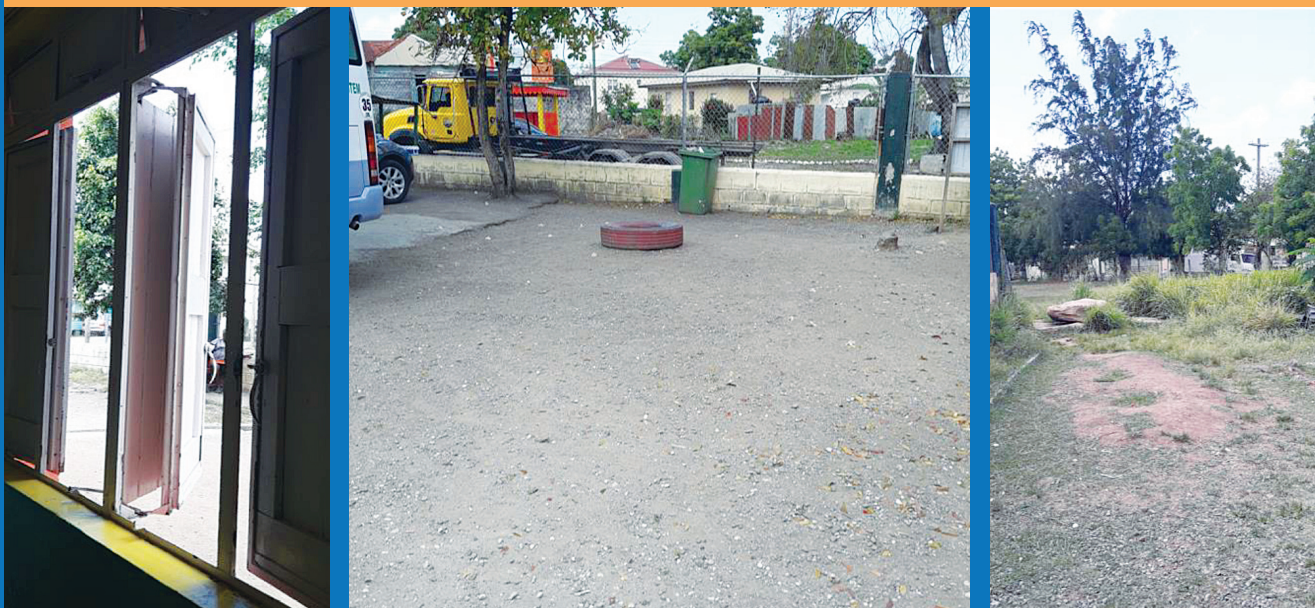
- Lack of adequate ventilation, particularly in Principal's office. The school purchased fans to alleviate this issue. Two were reportedly stolen.
- There is a sports field to the back of the school property however there is no dedicated play area/equipment for students. Students were observed playing in the parking lot during after school hours while vehicles were traversing the school grounds.

**FIGURE 7.2: EXAMPLES OF AREAS FOR IMPROVEMENT (DAMAGED WINDOWS THAT PROVIDE INADEQUATE VENTILATION, MAIN ROAD AND UNPAVED SURFACES CONTRIBUTING TO DUST LEVELS, LACK OF FENCING IN SOME AREAS)**

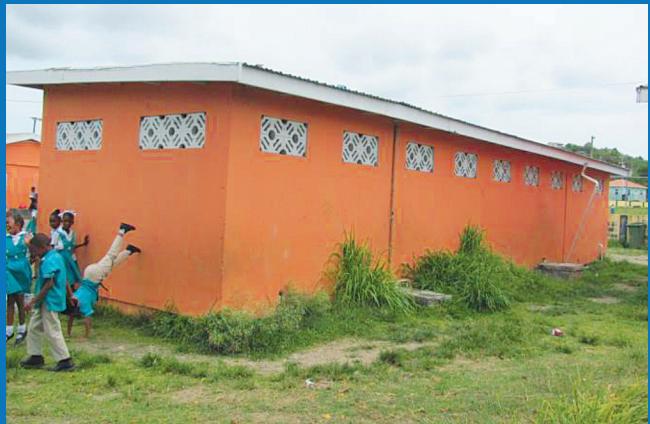
■ TOILET BLOCK  
- FUNCTIONAL, BUT IN NEED OF REPAIRS

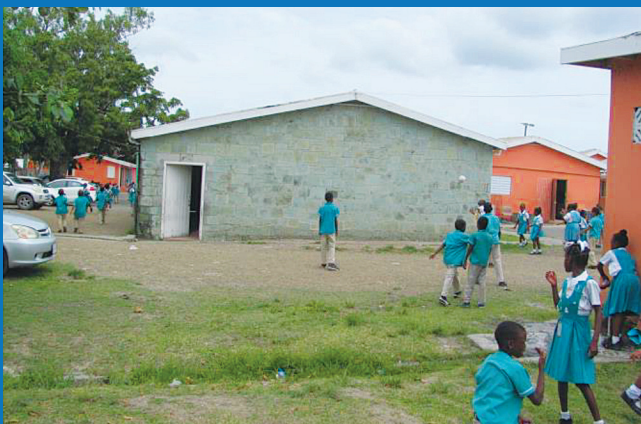
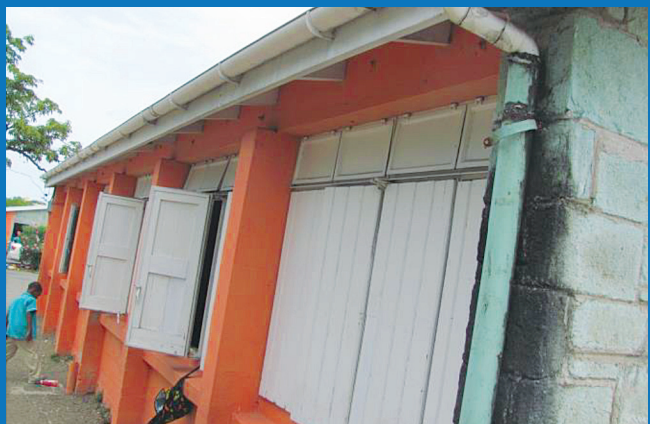
■ ONE OF THE ORIGINAL BUILDINGS IN NEED OF REFURBISHMENT

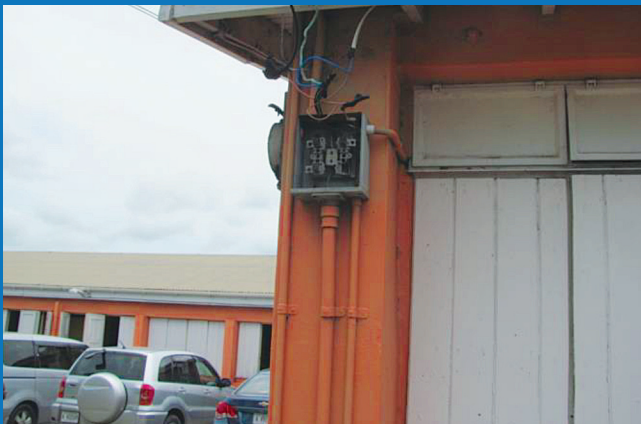
■ QUESTIONABLE ELECTRICS

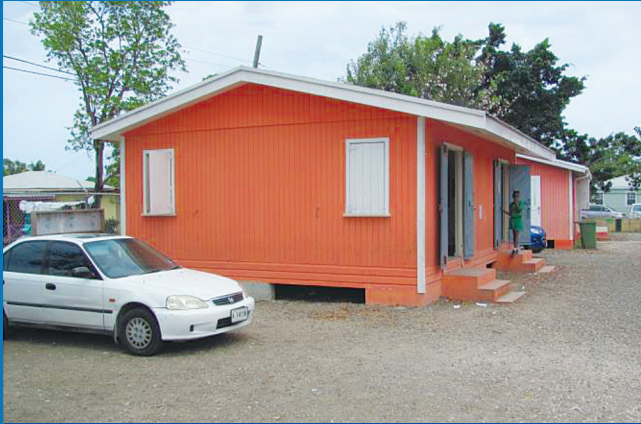
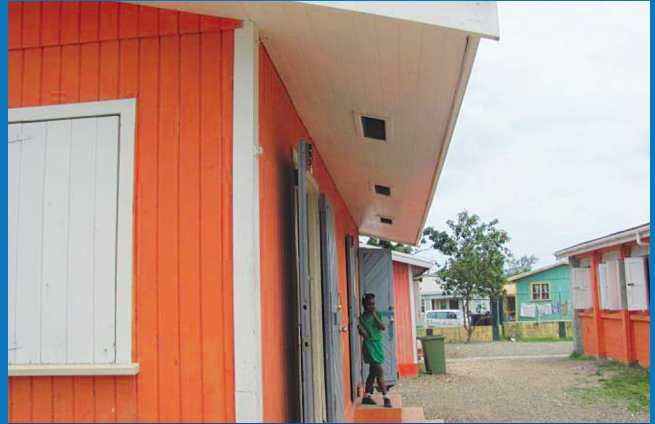
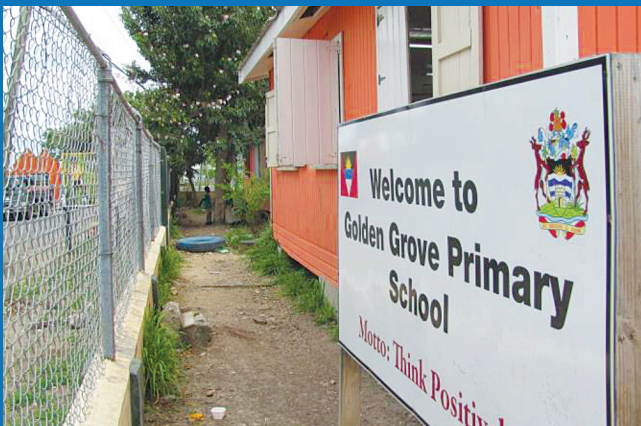
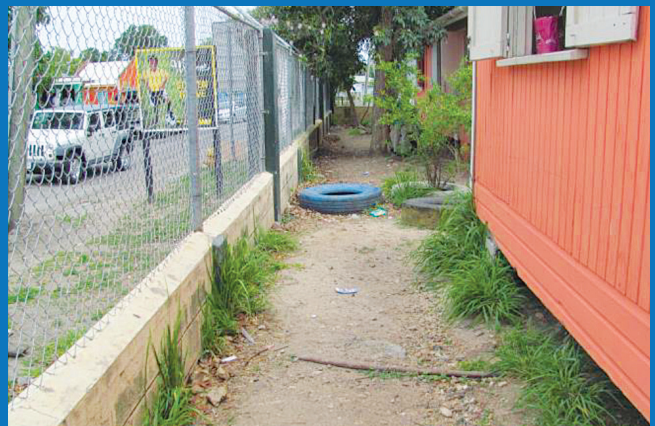
■ THE TIMBER BUILDINGS  
- (SHORT TERM SOLUTION)

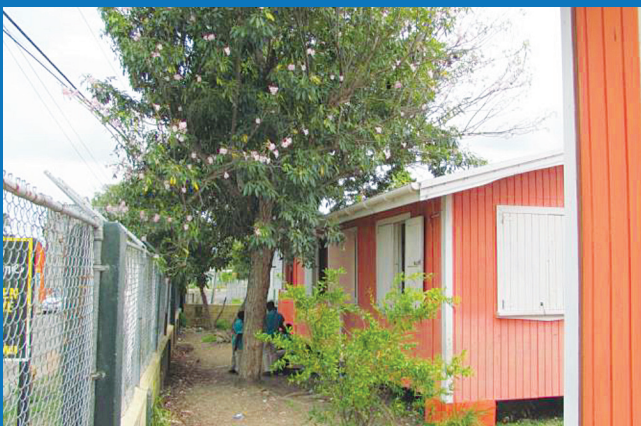
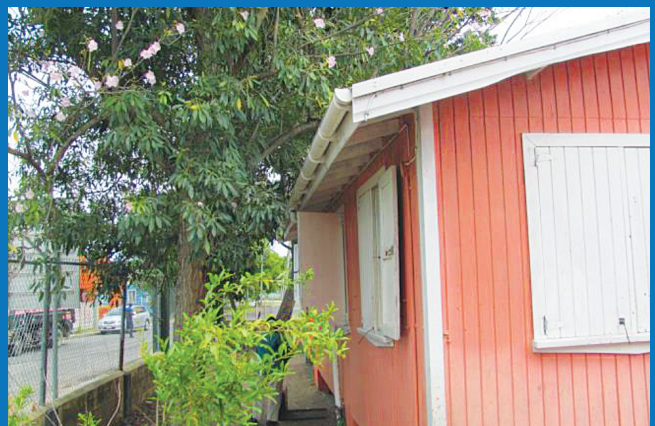
■ TREE IN CLOSE PROXIMITY  
TO TIMBER BUILDING

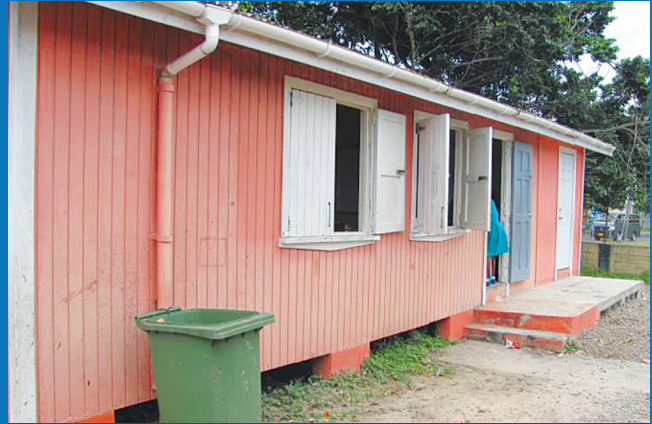
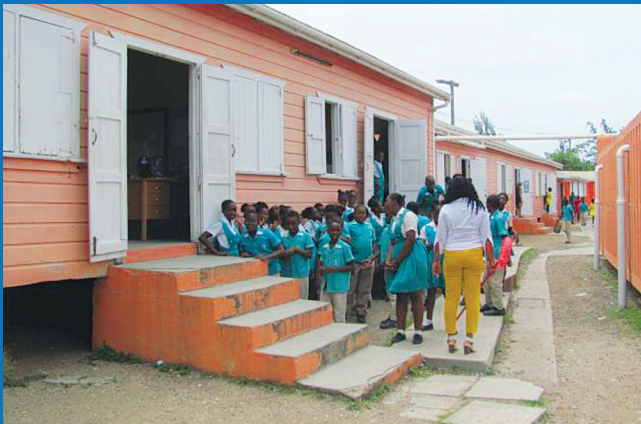
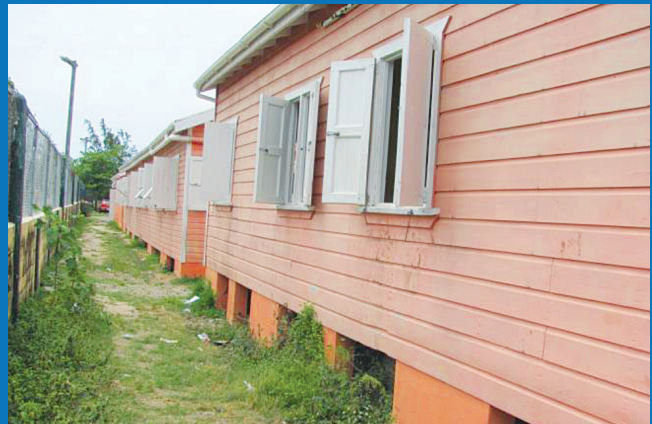
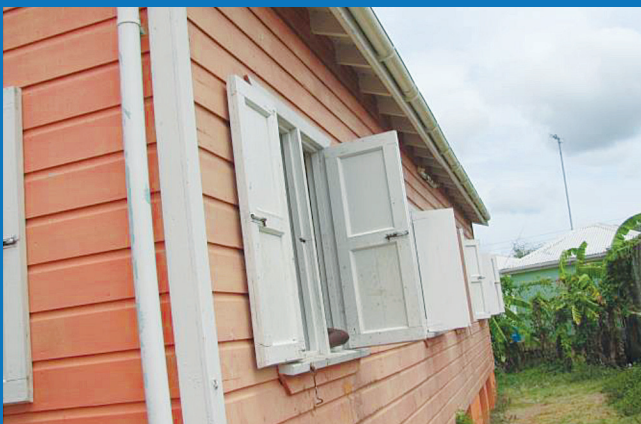
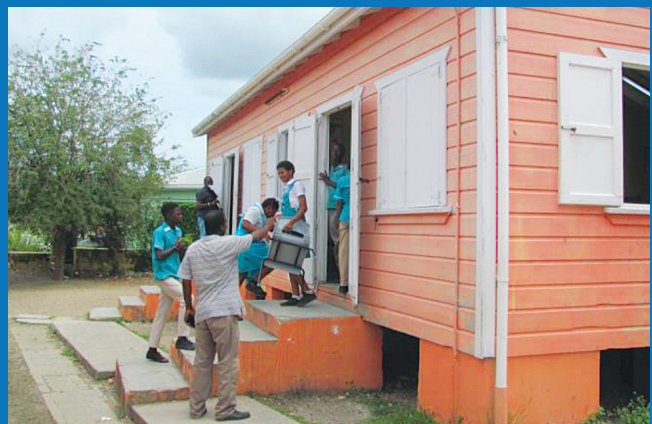
■ TIMBER BUILDING REMAINS VERY VULNERABLE TO HURRICANES

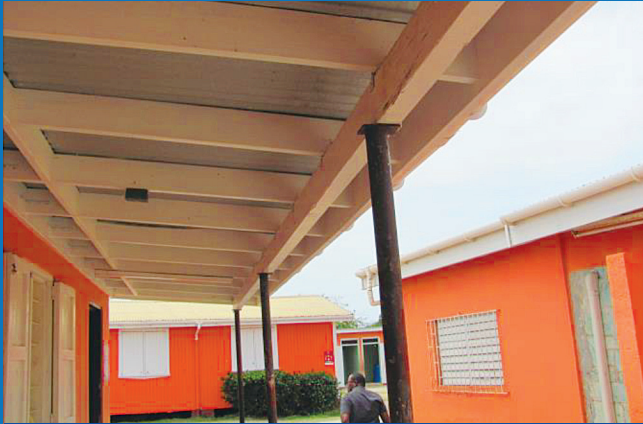
■ KITCHEN ROOF STRUCTURE ANCHORED WITH METAL STRAPS

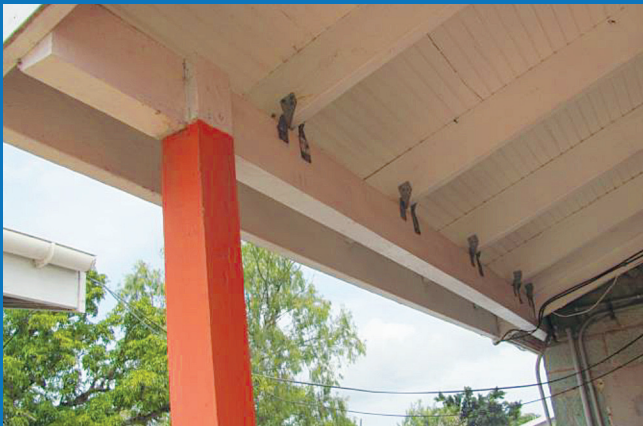
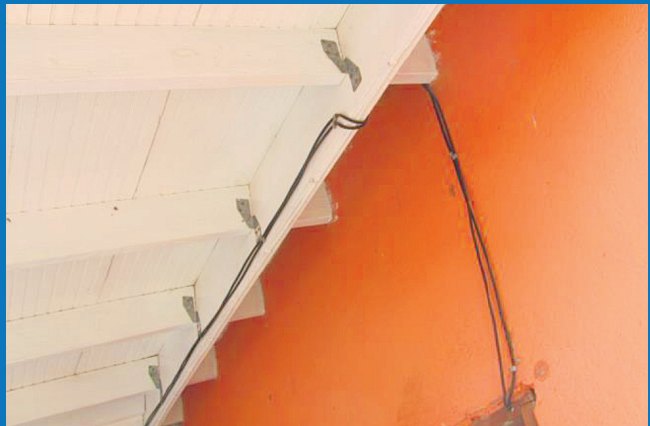
The **Golden Grove Primary School** was assessed against its National Building Code which is common for the Organisation of Eastern Caribbean States (OECS) territory. The main roof structures were found to be in generally good condition and hurricane straps were observed (See Appendix 2).

■ HURRICANE STRAPS

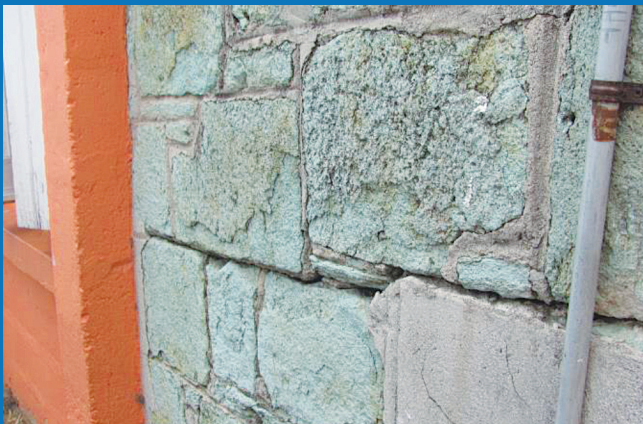
■ DETERIORATING MASONRY JOINTS

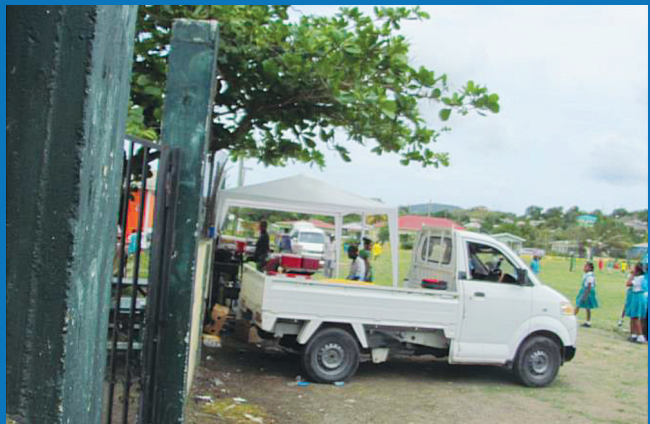
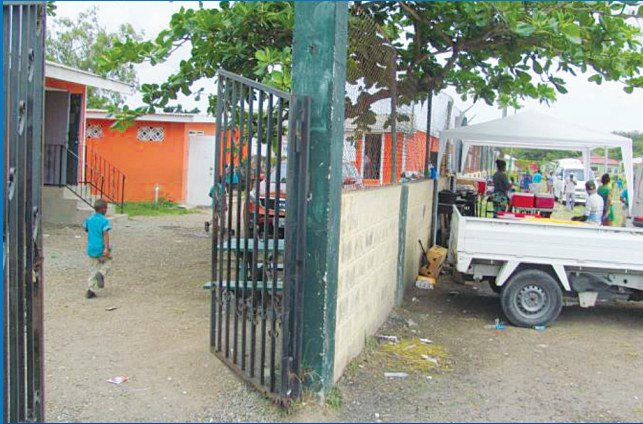
■ ADJACENT PLAYING FIELD - SOURCE OF FLOOD WATER
