IMPLEMENTATION OF THE MODEL SAFE SCHOOL PROGRAMME IN THE CARIBBEAN

HAZARD RISK ASSESSMENT REPORT AND COSTED ACTION PLAN

BEXON PRIMARY SCHOOL

SAINT LUCIA

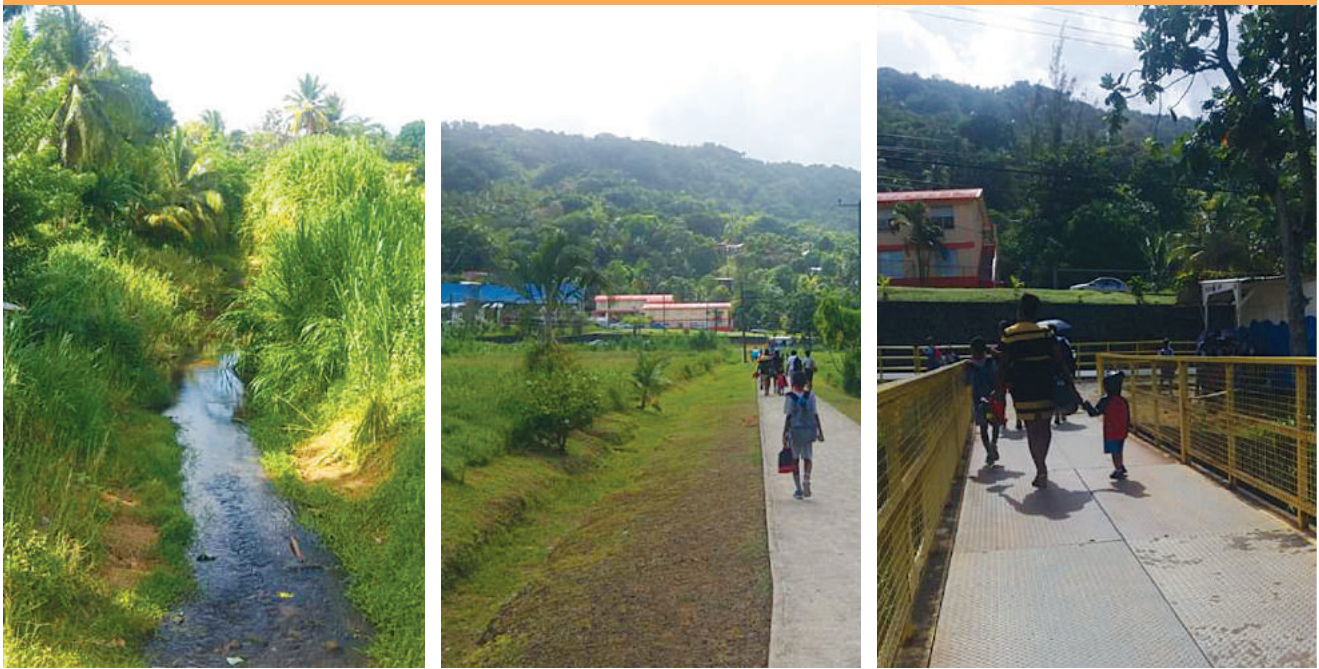
FIGURE 4.2: IMAGES OF BEXON PRIMARY – STUDENTS AND STAFF MUST CROSS FLOOD PRONE AREAS TO ACCESS MAIN ROAD

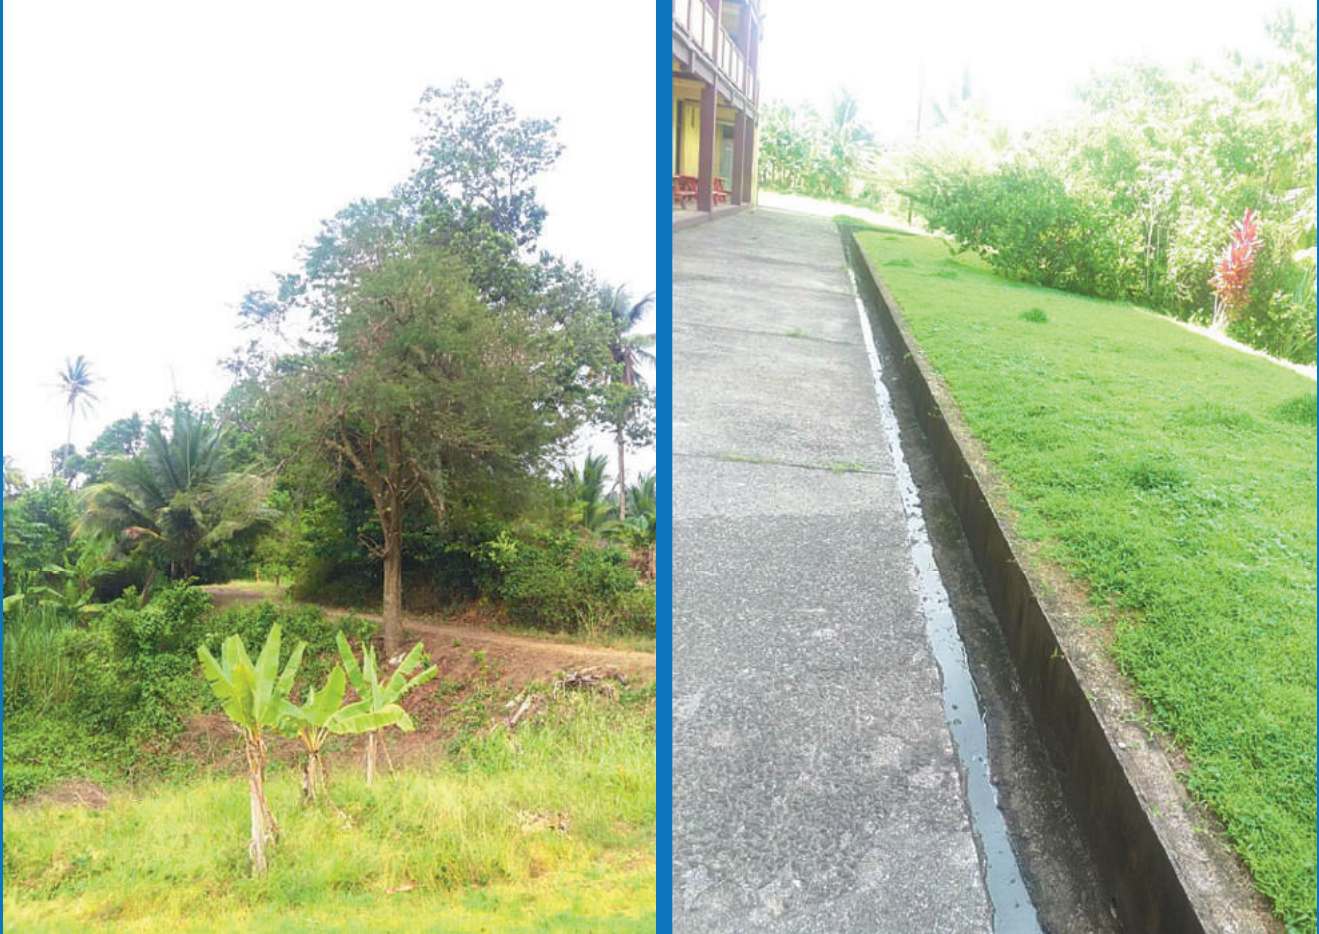
FIGURE 7.1: SELECTED PICTURES OF BEXON PRIMARY SHOWING SOME KEY AREAS FOR IMPROVEMENT (LEFT TO RIGHT: STEEP ACCESS ROAD USED AS EVACUATION ROUTE, SHALLOW DRAINS FOR HANDLING STORM WATER)

- Some repairs required to the physical plant to ensure safety before or during a hazard event. Particular focus should be given to roof repair and storm water drainage.

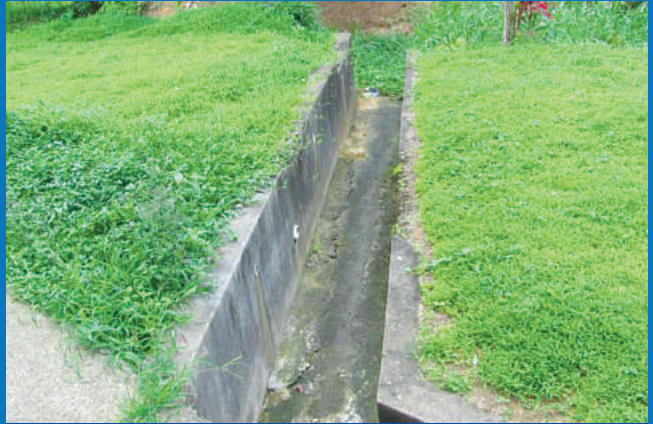
■ STORM DRAINS

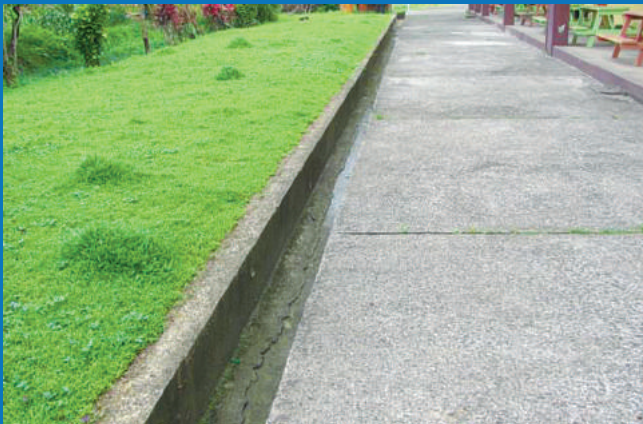
■ STORM DRAINS
