IMPLEMENTATION OF THE MODEL SAFE SCHOOL PROGRAMME IN THE CARIBBEAN

HAZARD RISK ASSESSMENT REPORT AND COSTED ACTION PLAN

CANARIES PRIMARY SCHOOL

SAINT LUCIA

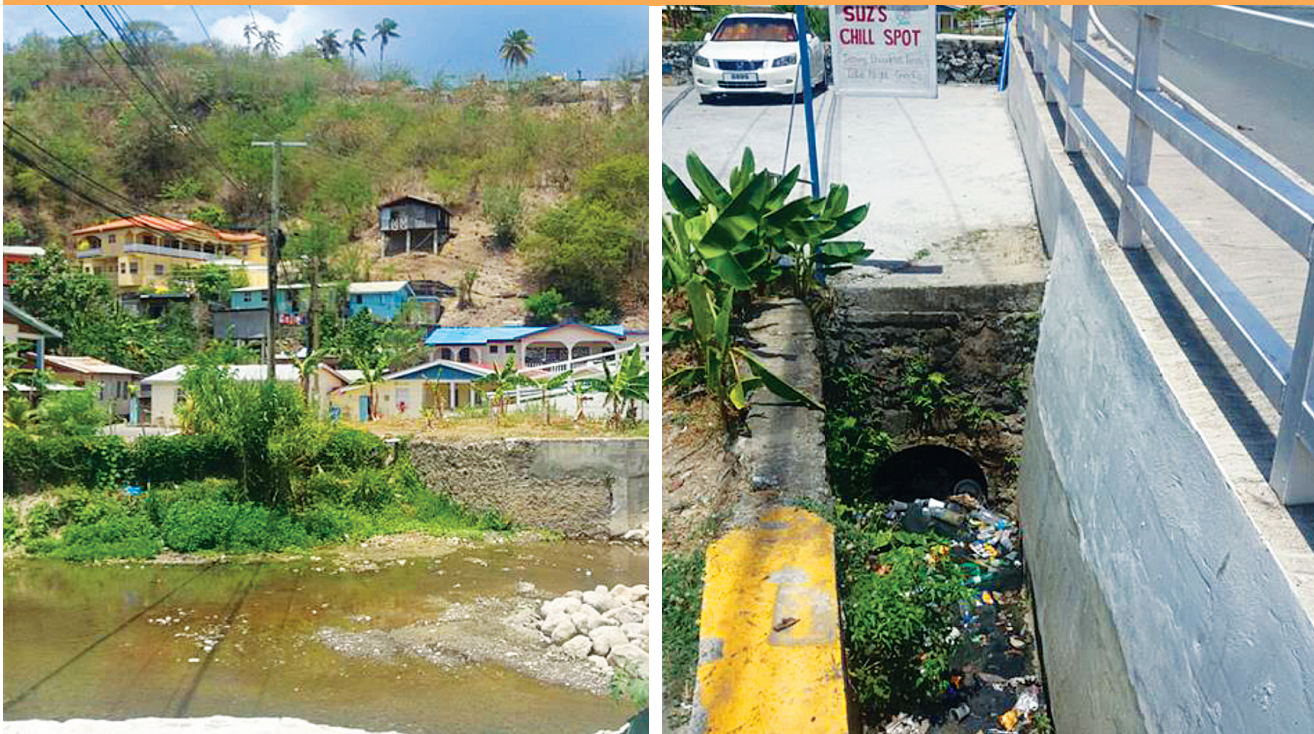
FIGURE 4.2: LEFT: CANARIES RIVER SOUTH OF SCHOOL; RIGHT: SOLID WASTE IN DRAINS THAT MAY EXACERBATE FLOODING
