IMPLEMENTATION OF THE MODEL SAFE SCHOOL PROGRAMME IN THE CARIBBEAN

HAZARD RISK ASSESSMENT REPORT AND COSTED ACTION PLAN

GORDON AND WALCOTT MEMORIAL METHODIST SCHOOL

SAINT LUCIA

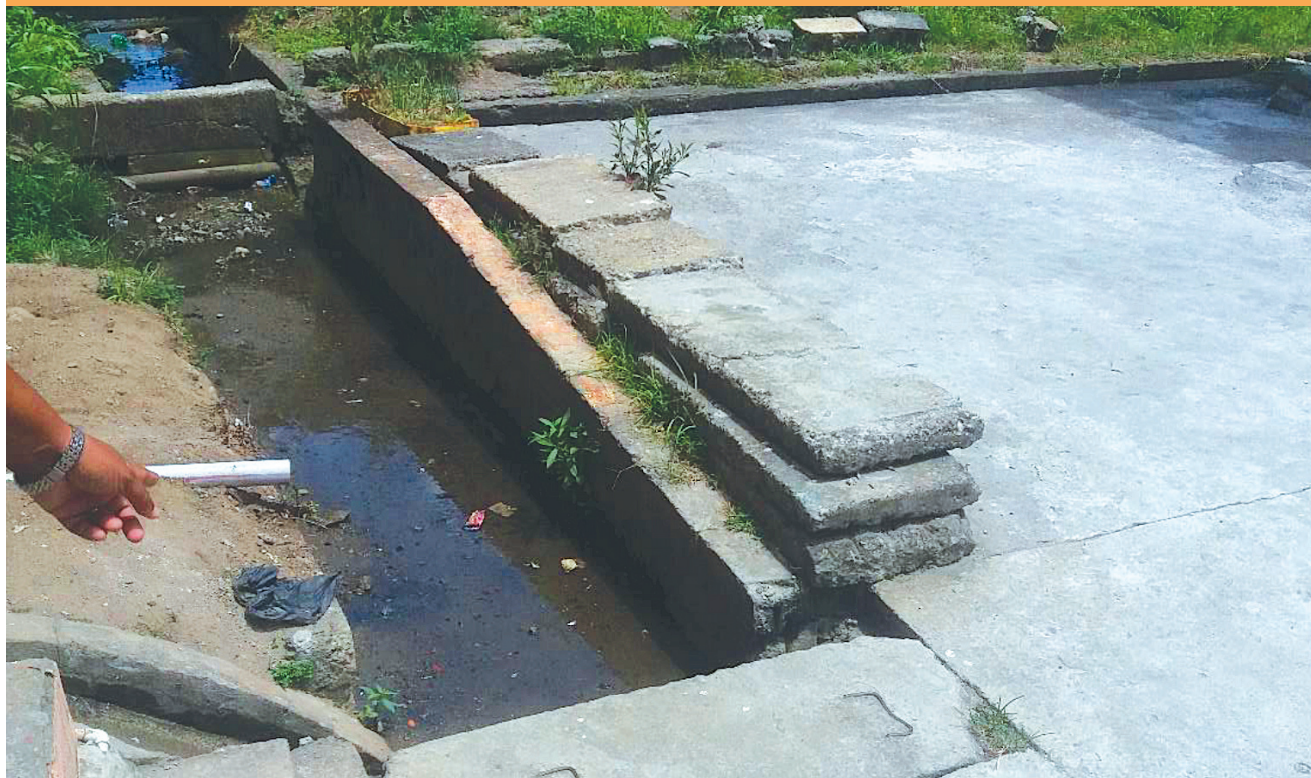
FIGURE 4.1: PORTION OF COMMUNITY DRAIN RUNNING THROUGH THE SCHOOL (SOURCE: CHARIM.NET)

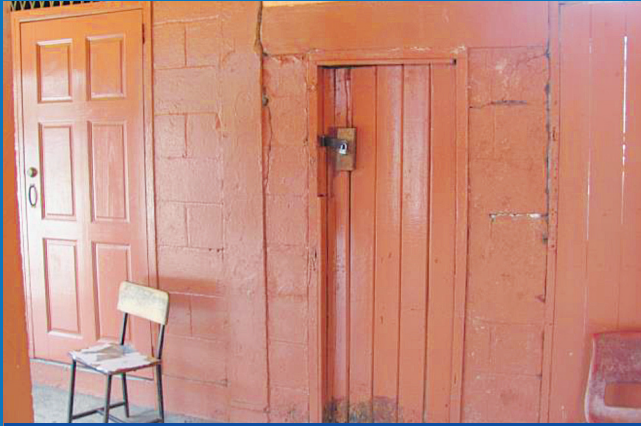
■ STOREROOM IN NEED OF REPAIRS

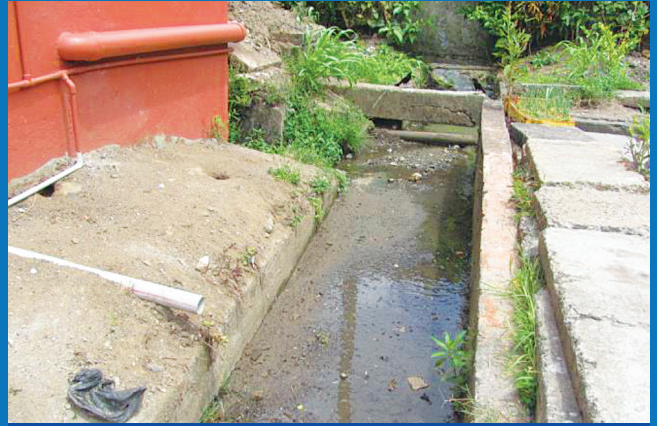
■ STOREROOM IN NEED OF REPAIRS

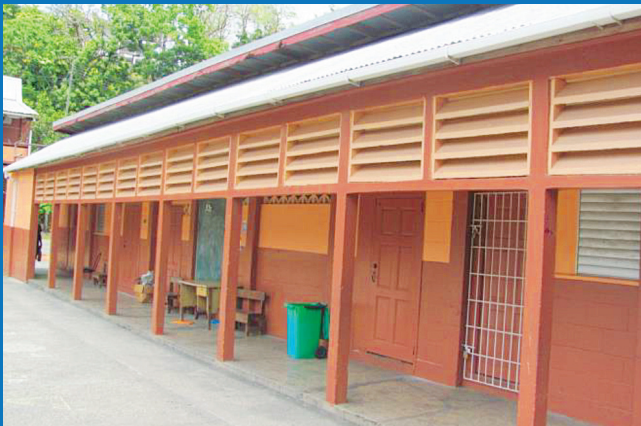
■ BUILDING ORIGINALLY 2-STOREYS TOP FLOOR DEMOLISHED- EXCESSIVE SETTLEMENT WAS OBSERVED

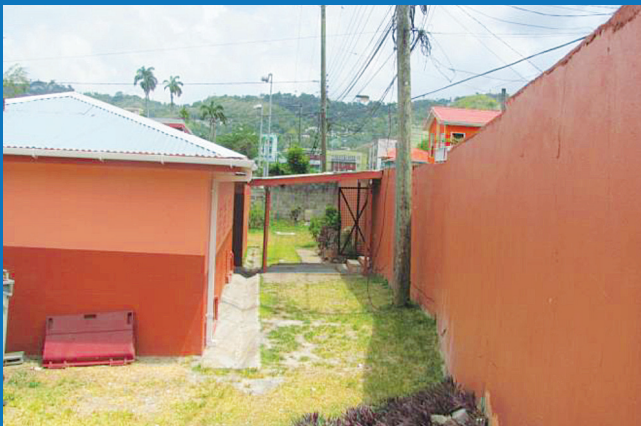
■ EMERGENCY EXIT

A primary safety concern expressed by persons interviewed at GWMMS was the need for an additional emergency exit at the school. At the time of this assessment, there were two exits in operation, both on the same side of the school and both opening onto a major thoroughfare. Given that there are alternate evacuation routes specific to different hazards, this is a critical area for school safety. The maintenance of the community drain was also expressed as a priority issue as it contributes to rapid flooding that occurs at the school. Maintenance of the drain is the responsibility of the Castries Constituency Council. Persons interviewed also reported issues with termites, despite regular maintenance provided by the government, as well as the need for an additional trained, dedicated security person.

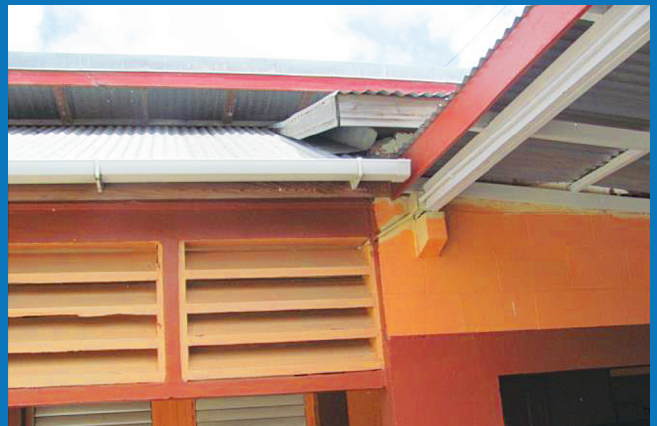
■ ROOF TO BE REDESIGNED

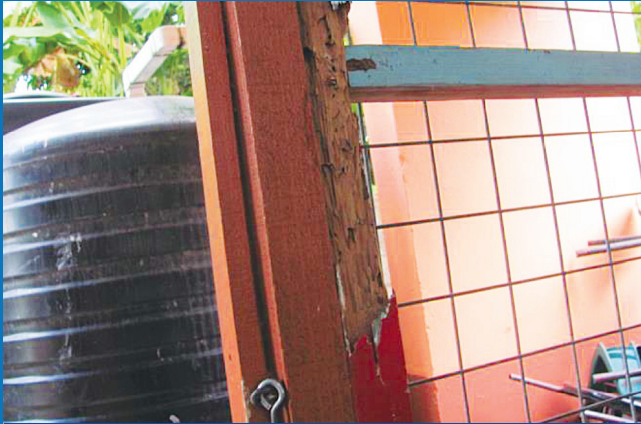
■ TERMITE INFESTATION
