# HAZARD RISK ASSESSMENT REPORT AND COSTED ACTION PLAN

## VIEUX FORT PRIMARY SCHOOL

SAINT LUCIA

Original Submission Date: January 17, 2020

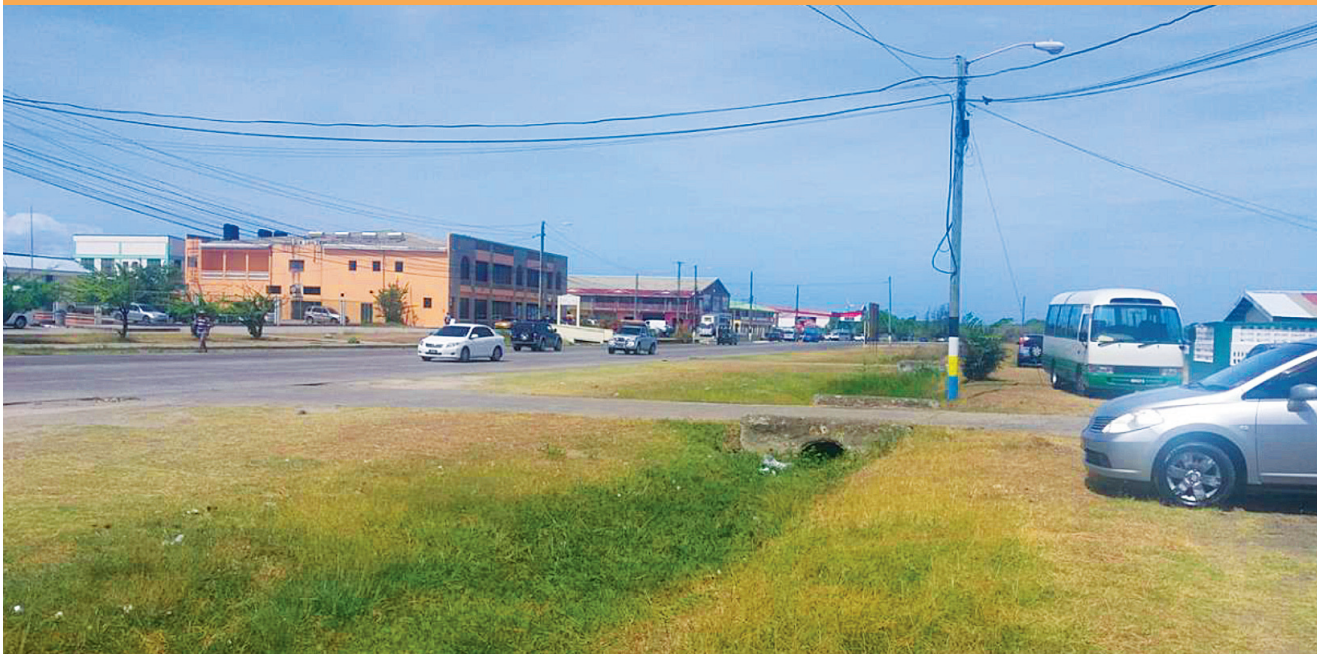
FIGURE 4.2: IMAGE OF VIEUX FORT PRIMARY – EAST-WEST DRAIN DIRECTLY IN FRONT OF THE PROPERTY

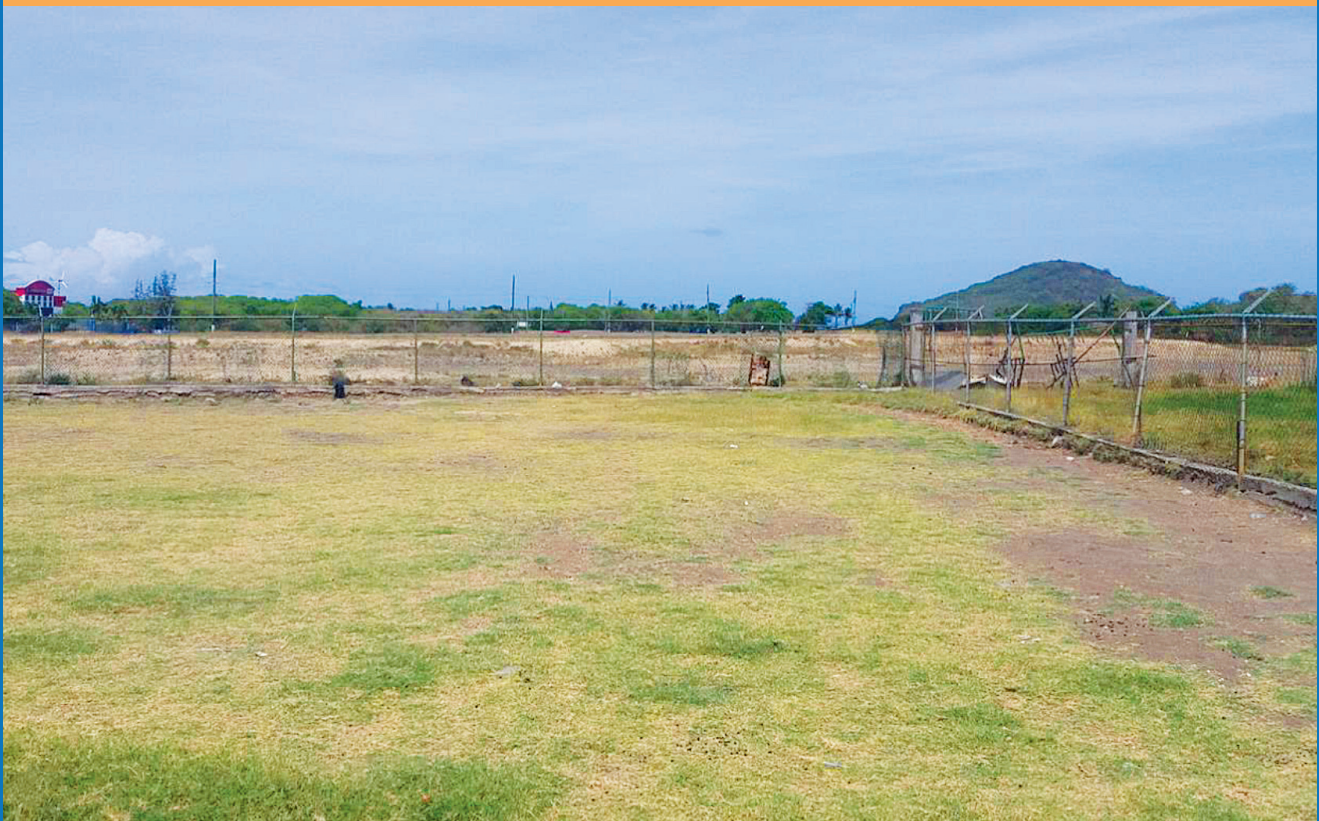
- At the time of the assessment, the school had not recently been assessed to determine hazards for the school population, visitors or vulnerable groups.
- The perimeter of the school is not secured; persons are able to access the school from multiple points and the caretaker is not equipped to manage all points. Persons interviewed report that there have been security incidents including interlopers that have stolen furniture from the school (Figure 7-2).
- At the time of the assessment, no drills or simulations had been conducted.
- Audits for energy, water and waste have not been conducted however these actions fall under the purview of the Ministry of Education.
- Repairs required to the physical plant to ensure safety before or during a hazard event. Focus should be given to roof repair and storm water drainage.

**FIGURE 7.2: PERIMETER FENCE IN NEED OF REPAIR AT VIEUX FORT PRIMARY (MAY 2019)**

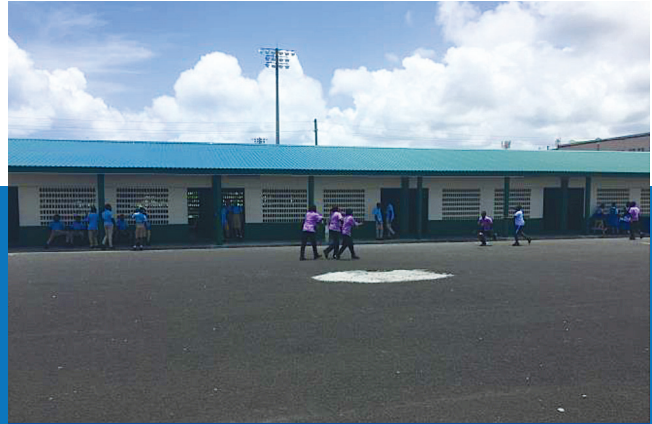
■ BUILDING WITH VENT BLOCKS  
- NEW ROOF

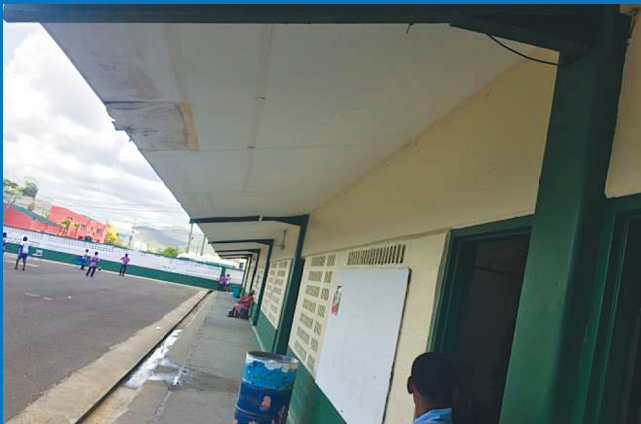
■ WATER DAMAGED CEILING

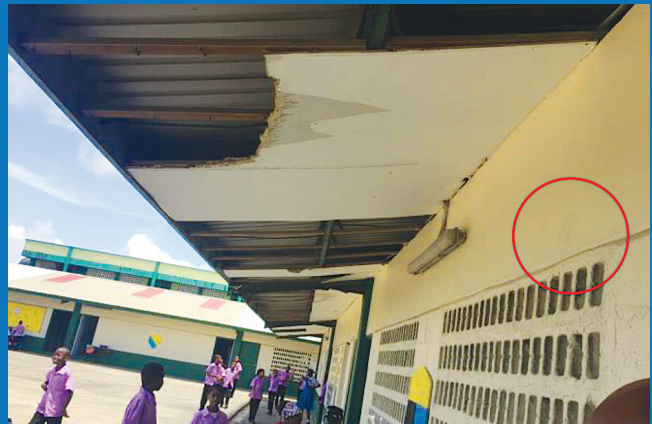
■ WATER DAMAGED CEILING

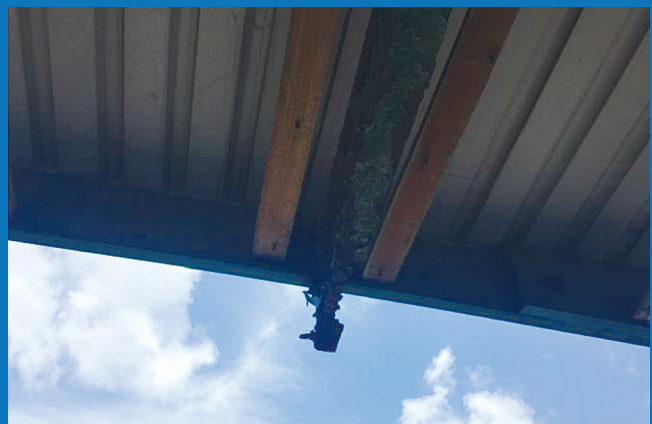
■ CORRODED STRUCTURAL STEEL

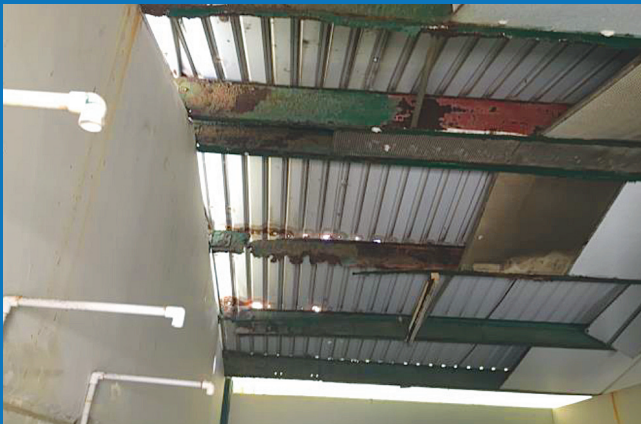
■ CORRODED ROOF STRUCTURE OF TOILETS

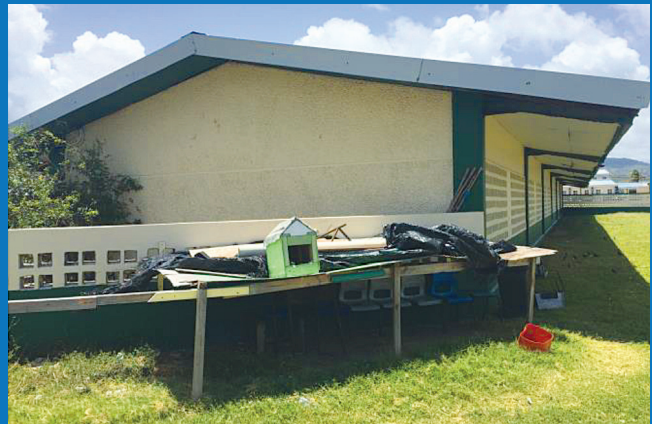
■ TYPICAL END VIEW WITH EXCESSIVE EAVES

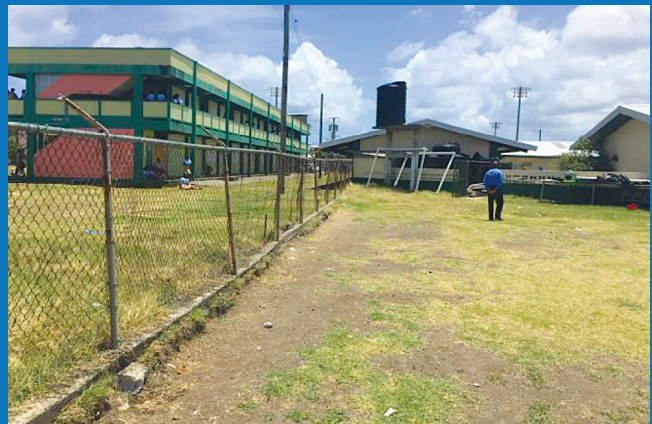
■ ADJACENT SECONDARY SCHOOL SHARES PART OF THE PRIMARY SCHOOL BUILDING
