IMPLEMENTATION OF THE MODEL SAFE SCHOOL PROGRAMME IN THE CARIBBEAN

HAZARD RISK ASSESSMENT REPORT AND COSTED ACTION PLAN

CAYON HIGH SCHOOL ST. KITTS AND NEVIS

Environmental Solutions Limited

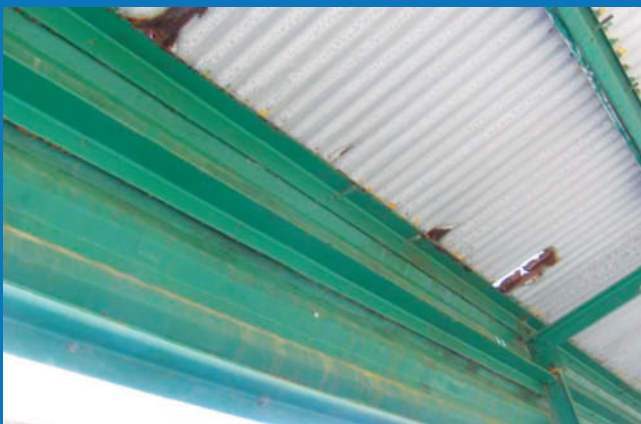
■ CORRODED ROOF SHEETING

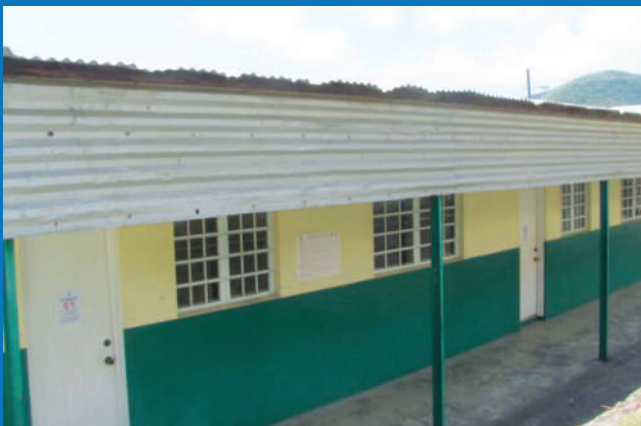
■ MAKESHIFT SUN AND RAIN BARRIER – VERTICAL ALUZINC SHEETS

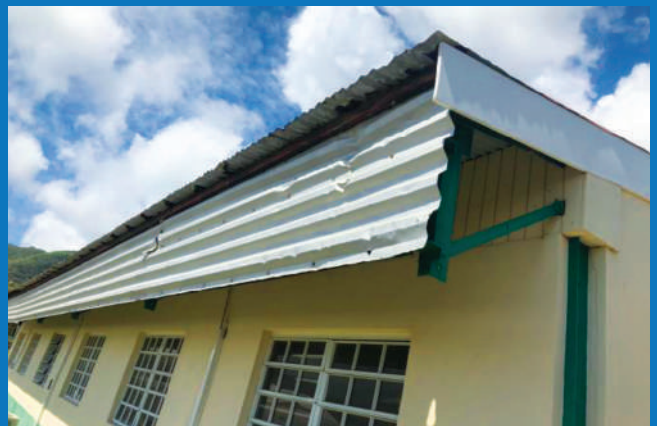
■ MAKESHIFT SUN AND RAIN BARRIER – VERTICAL ALUZINC SHEETS

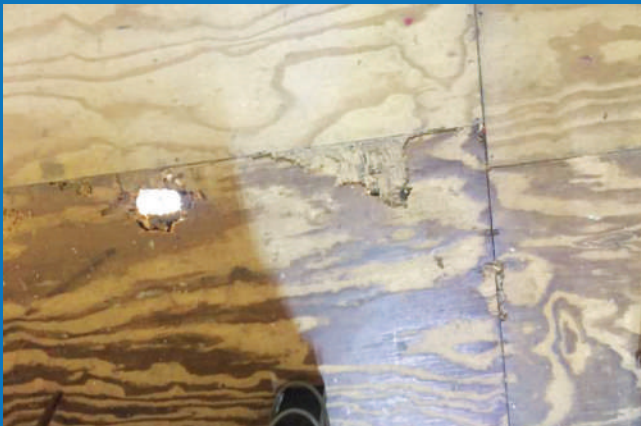
■ **TIMBER BUILDING**
- TERMITE DAMAGE

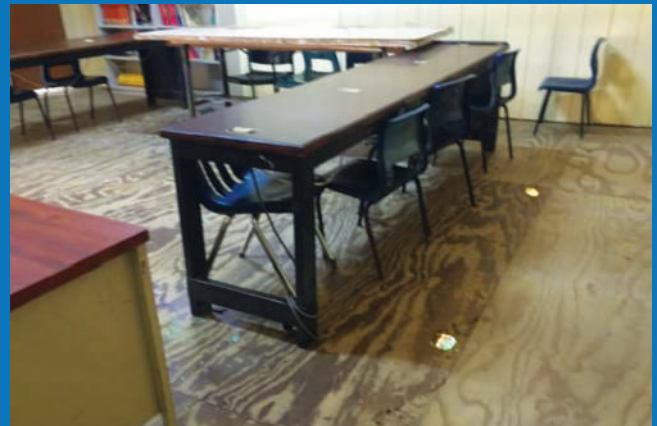
■ **TIMBER BUILDING**
- TERMITE DAMAGE

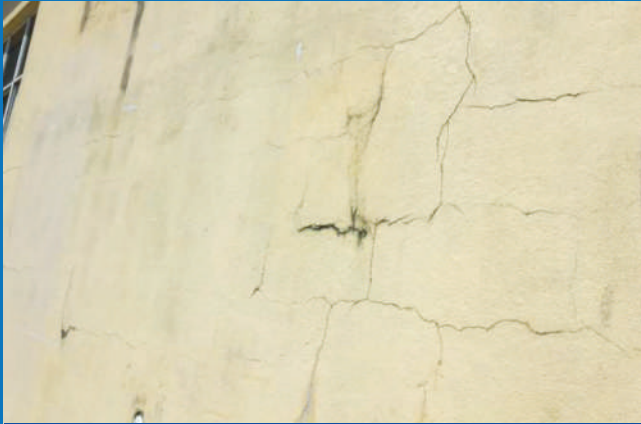
■ SIGNS OF MOISTURE PENETRATION
- CRACKS

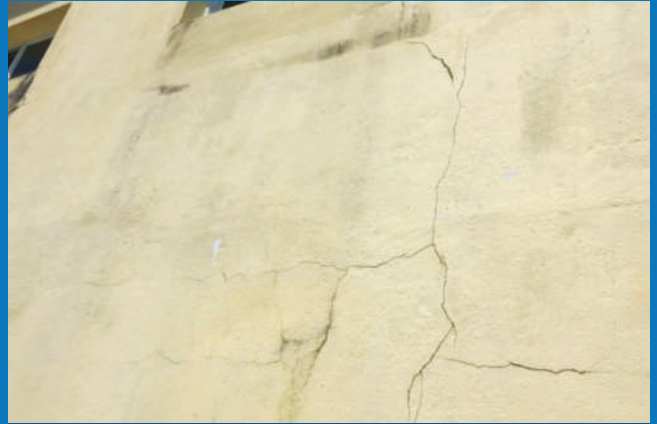
■ SIGNS OF MOISTURE PENETRATION
- CRACKS

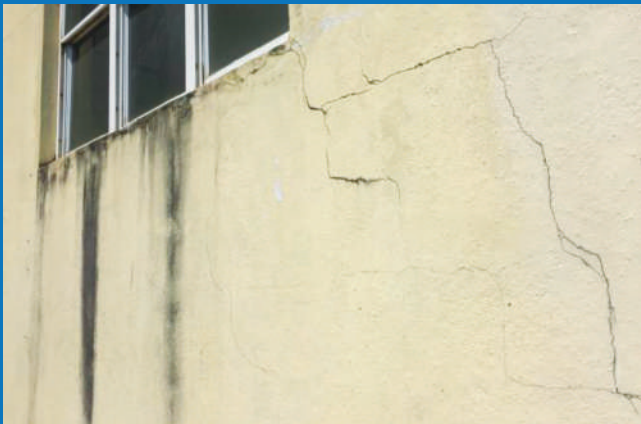
■ SIGNS OF MOISTURE PENETRATION
- CRACKS

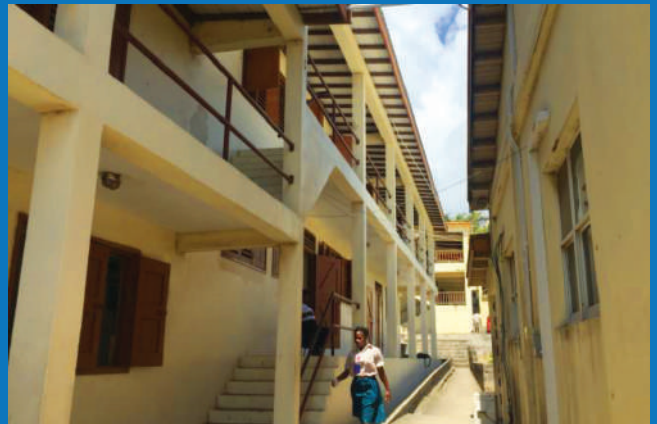
■ NARROW PASSAGES - CONSEQUENCE OF
UNPLANNED INCREMENTAL CONSTRUCTION

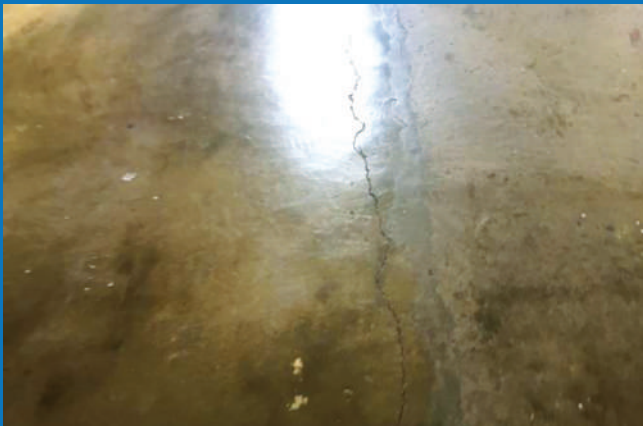
■ CRACKS TO FLOOR SLAB

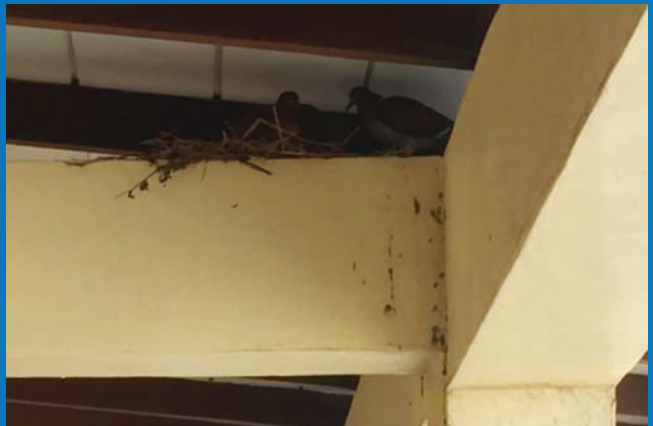
■ SIGNS OF BIRD INFESTATION

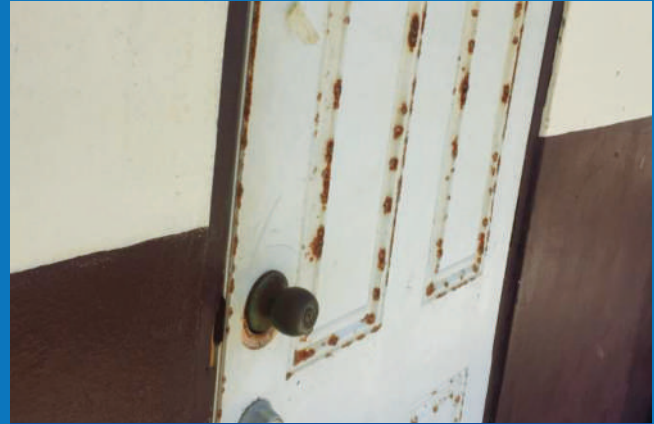
■ CORRODING METAL DOOR

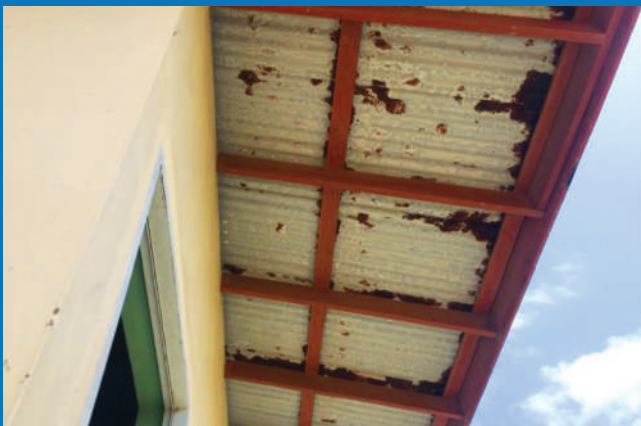
■ CORRODED ROOF SHEETING

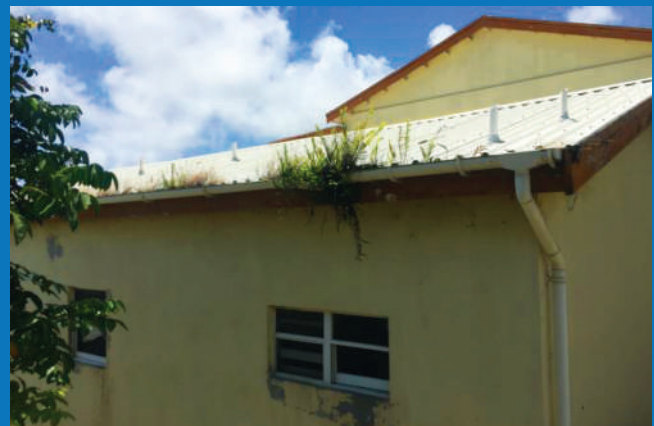
■ ROOF DAMAGE - NEEDS ATTENTION

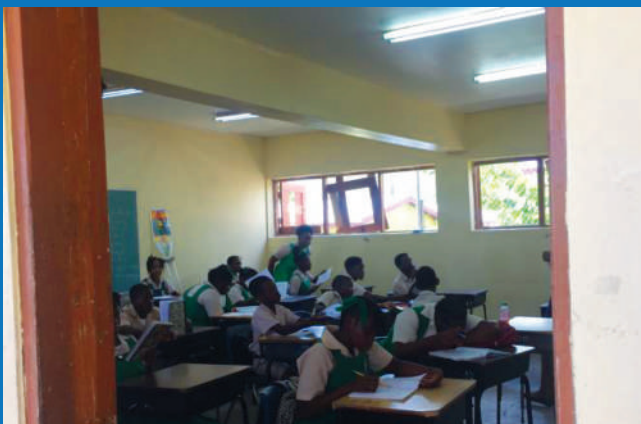
■ BROKEN WINDOWS

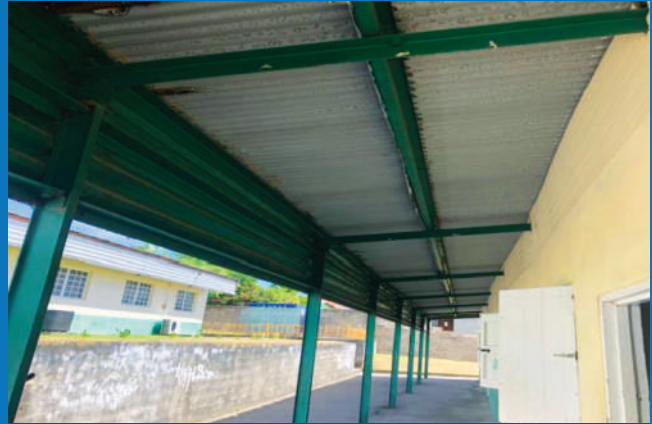
■ STEEL FRAME BUILDING WITH CORRODED ROOF SHEETS

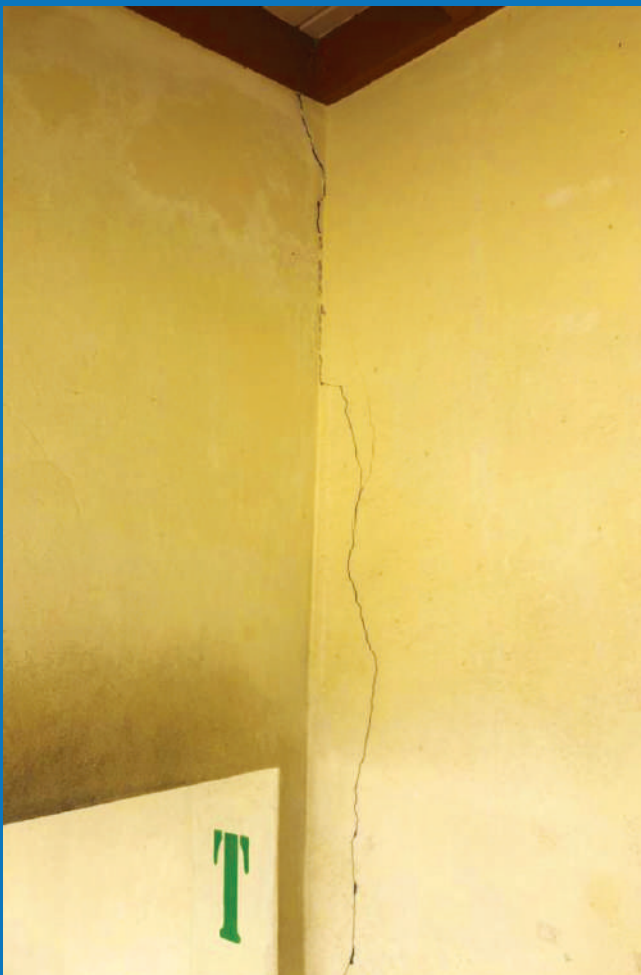
■ VERTICAL HAIRLINE CRACKS TO WALL

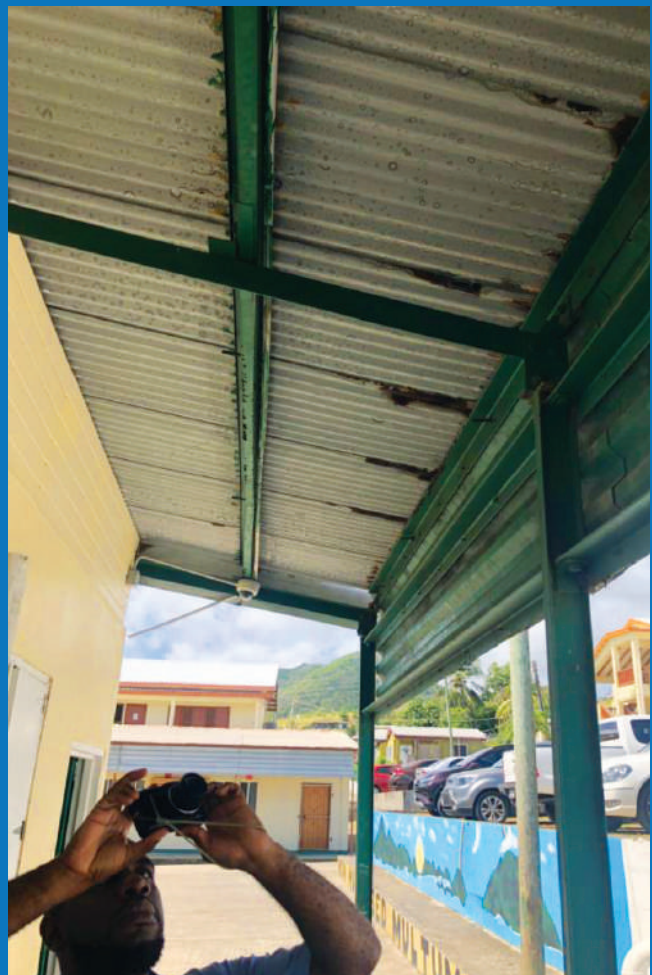
■ STEEL FRAME BUILDING WITH CORRODED ROOF SHEETS

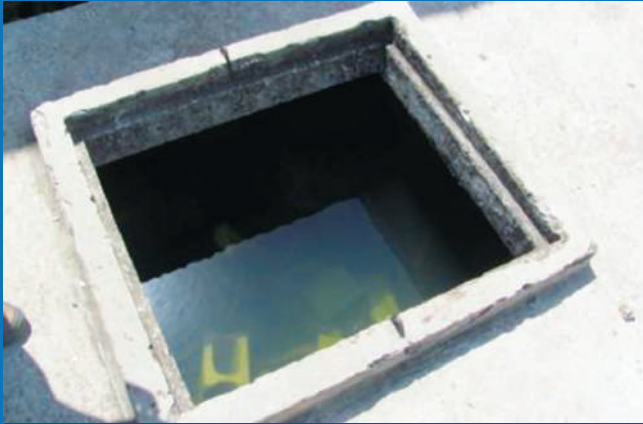
■ CISTERN
- IN NEED OF REPAIRS

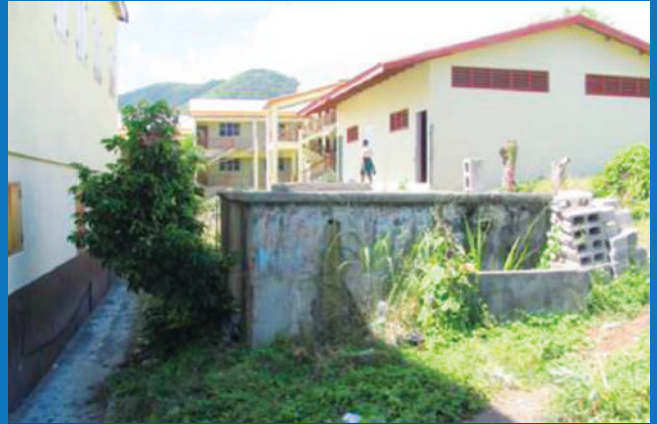
■ CISTERN
- IN NEED OF REPAIRS
