IMPLEMENTATION OF THE MODEL SAFE SCHOOL PROGRAMME IN THE CARIBBEAN

HAZARD RISK ASSESSMENT REPORT AND COSTED ACTION PLAN

CHARLESTOWN SECONDARY SCHOOL ST. KITTS AND NEVIS

Environmental Solutions Limited

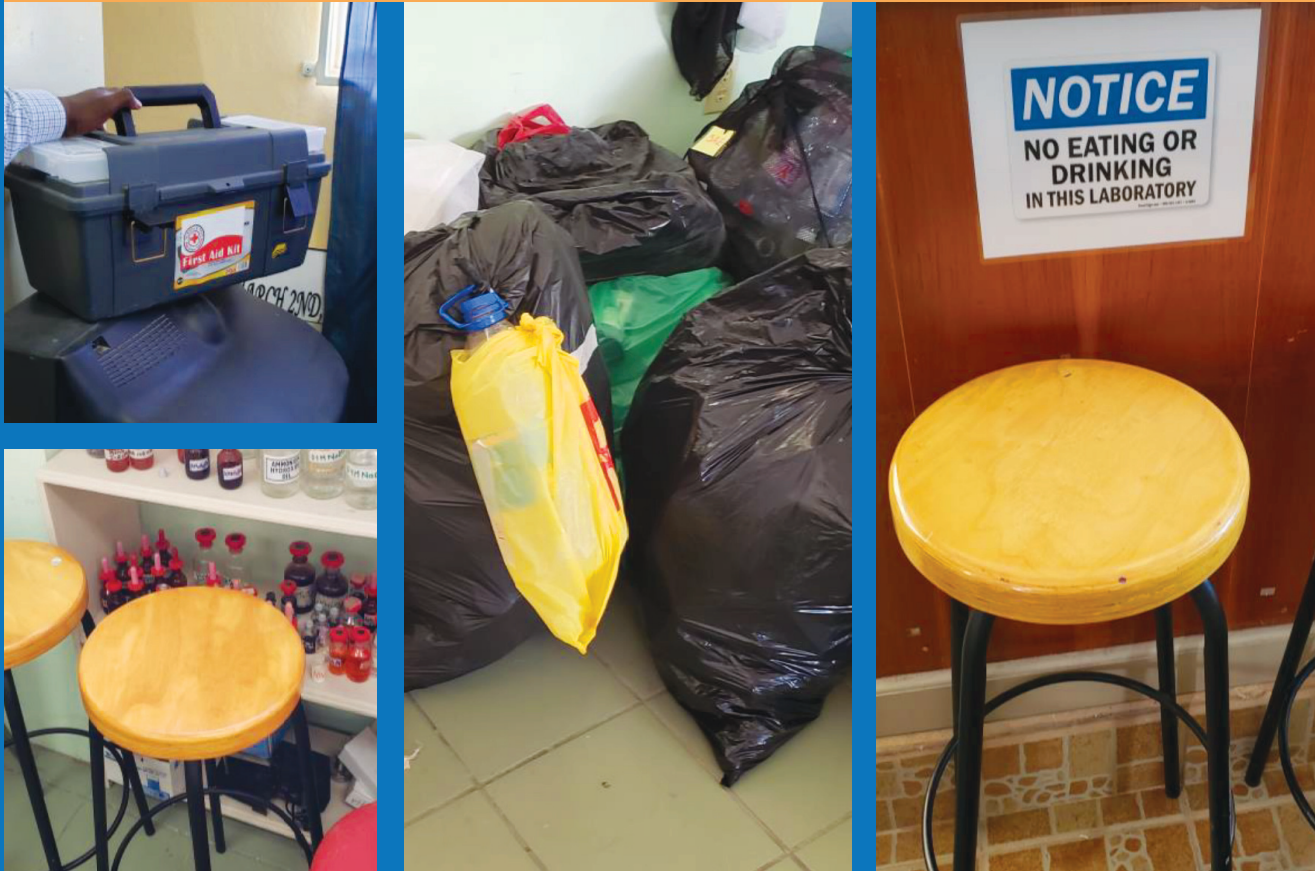
FIGURE 7.1: EXAMPLES OF KEY STRENGTHS

- The school has also participated in national simulation exercises.
- Evacuation plans are reportedly posted on classroom notice boards.
- The school has a designated safe zone/assembly point.
- Two First Aid Kits are present and accessible.
- There is a visitor sign in policy.
- Windows reportedly provide adequate ventilation and are equipped with hurricane shutters.
- An energy audit has been conducted.
- Energy efficient light bulbs and appliances are used.
- Perimeter fencing is intact.
- Plastic bottles are recycled (see image below).
- Appropriate signage in chemistry lab. Bottles are properly labelled as well (see images below).

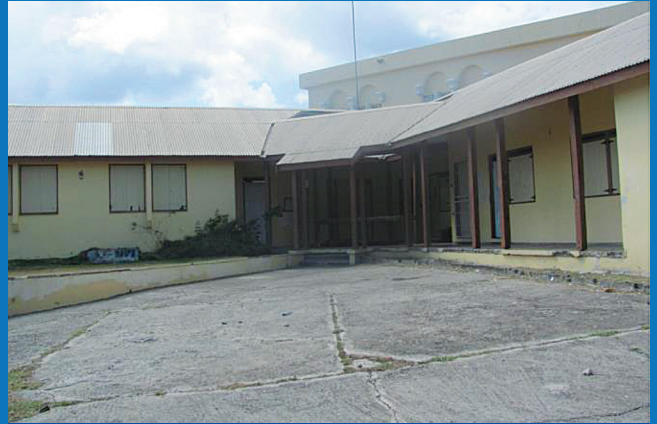
■ BLOCK IN STATE OF DISREPAIR
