# HAZARD RISK ASSESSMENT REPORT AND COSTED ACTION PLAN

## GRANDBAY PRIMARY SCHOOL

DOMINICA

Original Submission Date: January 17, 2020

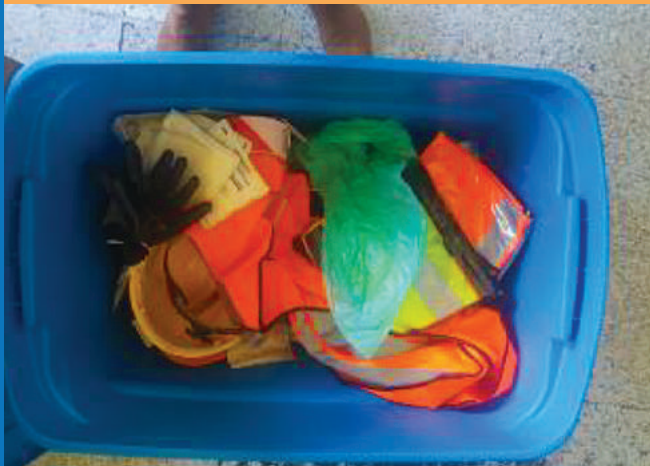
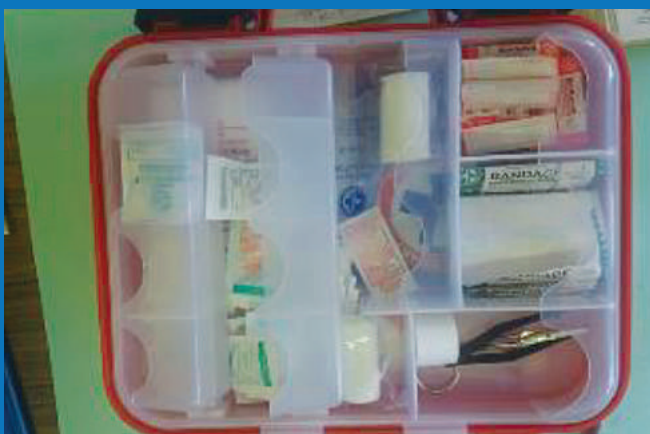
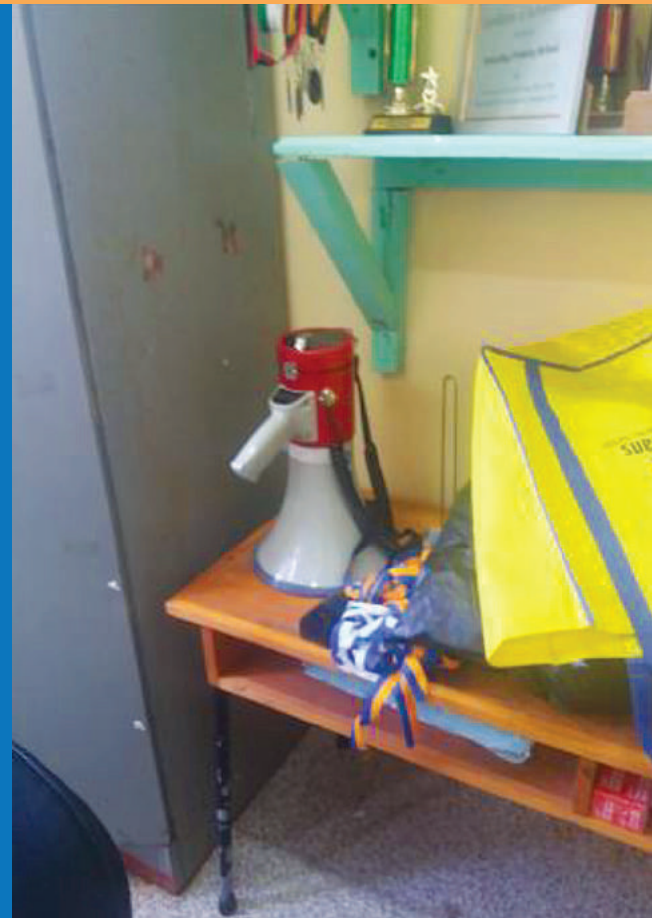
**FIGURE 7.1: IMAGES SHOWING SAFETY HIGHLIGHTS AT GRANDBAY PRIMARY SCHOOL (MAY 2019)**

- Some repairs required to the physical plant to ensure safety before or during a hazard event. For example, in the food preparation area, there were shards of broken glass hanging from the ceiling. One third of the school was closed off to students at the time of this assessment, and portions of the roof were covered in tarpaulin.

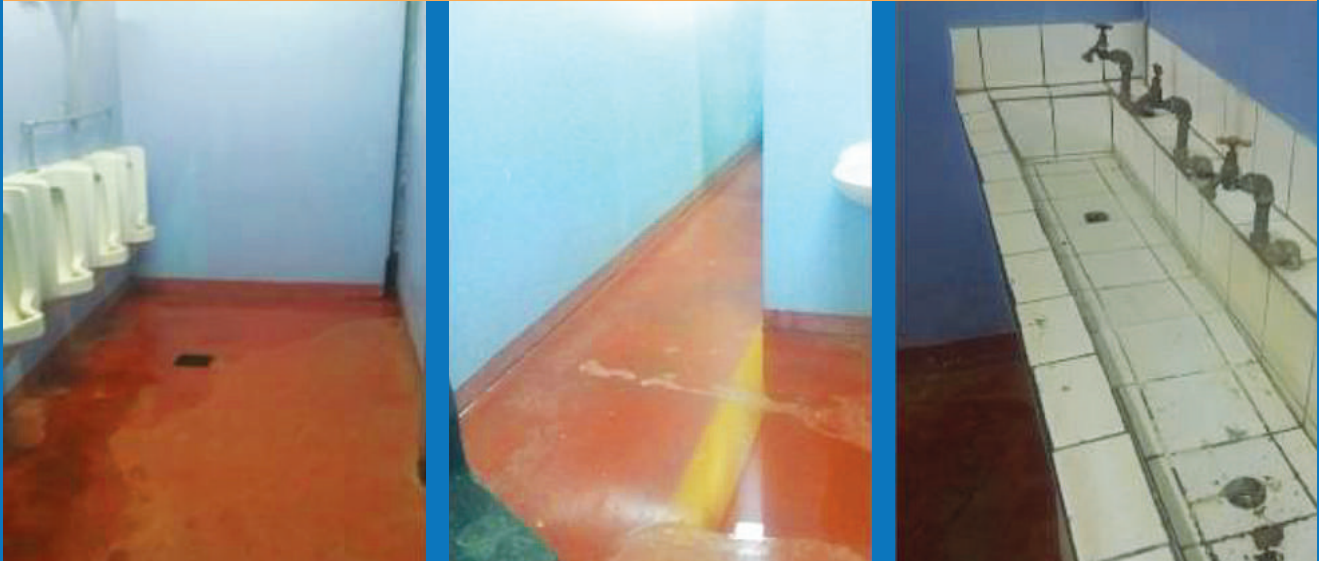
**FIGURE 7.2: IMAGES HIGHLIGHTING POOLING WATER IN RESTROOMS AT GRANDBAY PRIMARY (MAY 2019)**

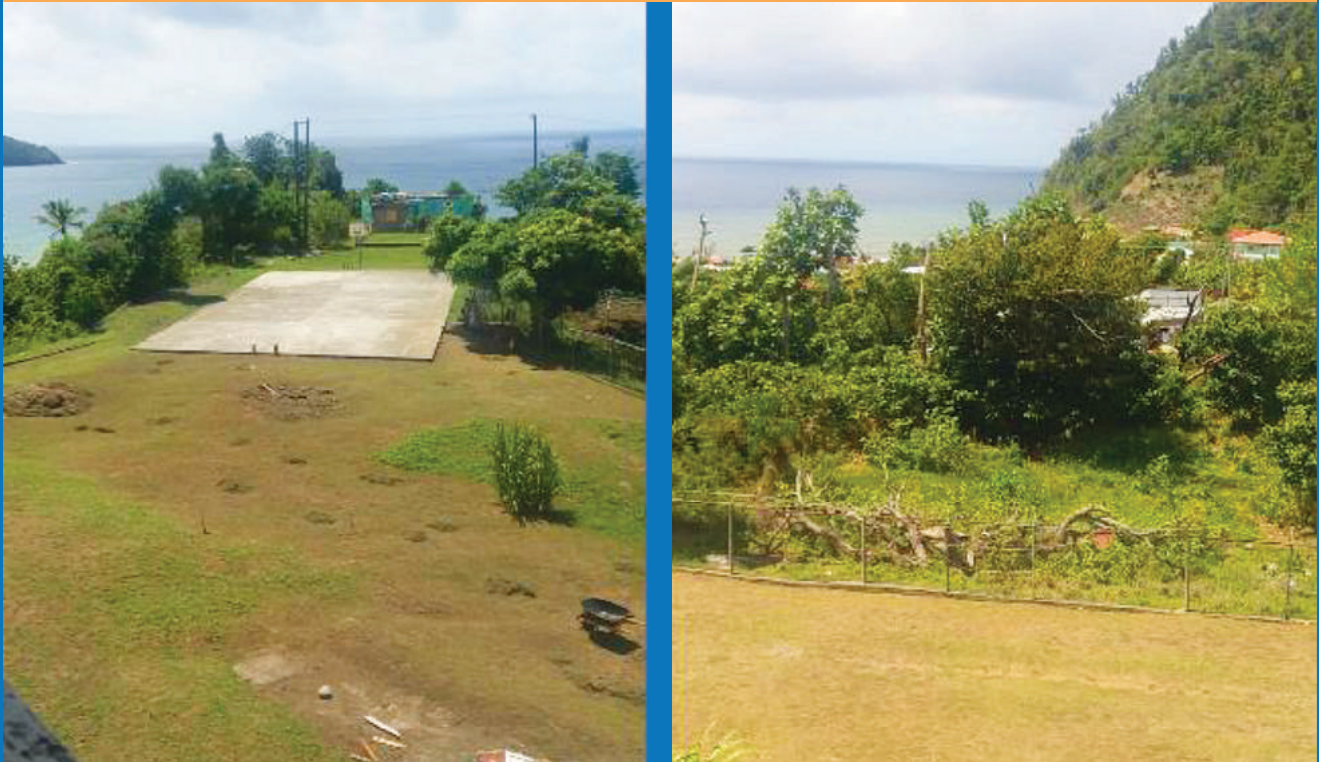
**FIGURE 7.3: IMAGES HIGHLIGHTING SECTIONS WHERE PERIMETER FENCE IS NEEDED AT GRANDBAY PRIMARY (MAY 2019)**

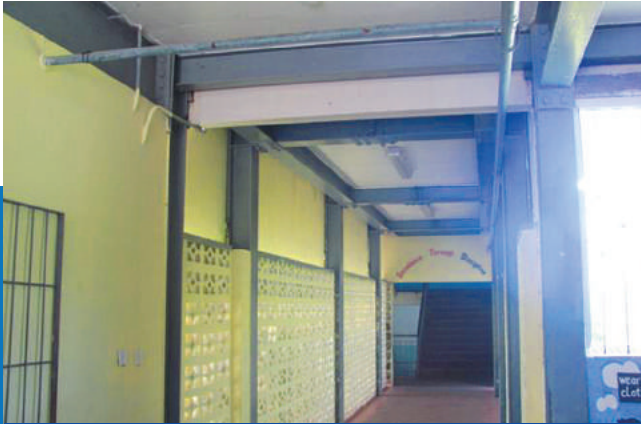
■ STRUCTURAL STEEL FRAME BUILDING IN REASONABLY GOOD CONDITION

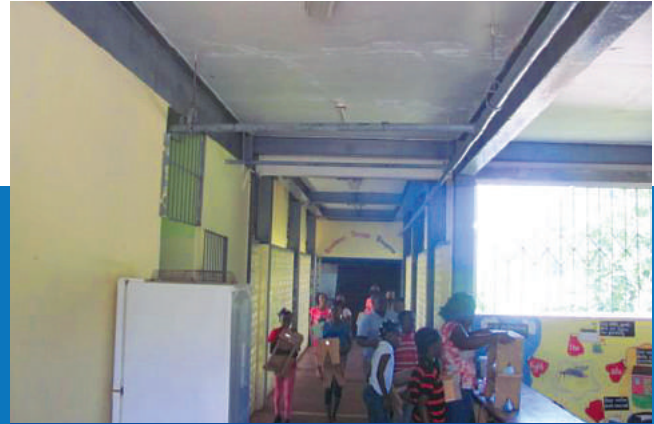
■ STRUCTURAL STEEL FRAME BUILDING IN REASONABLY GOOD CONDITION

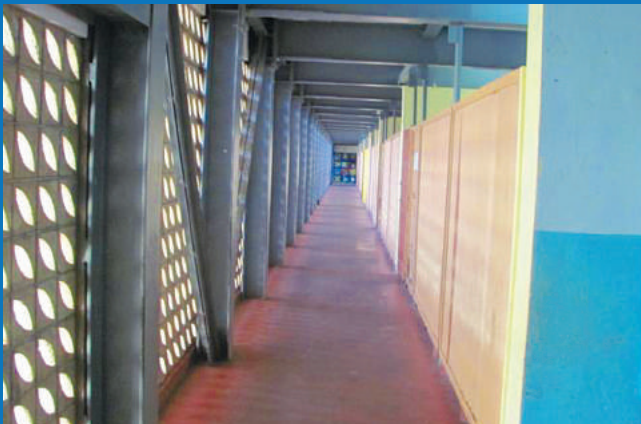
■ STRUCTURAL STEEL FRAME BUILDING IN REASONABLY GOOD CONDITION

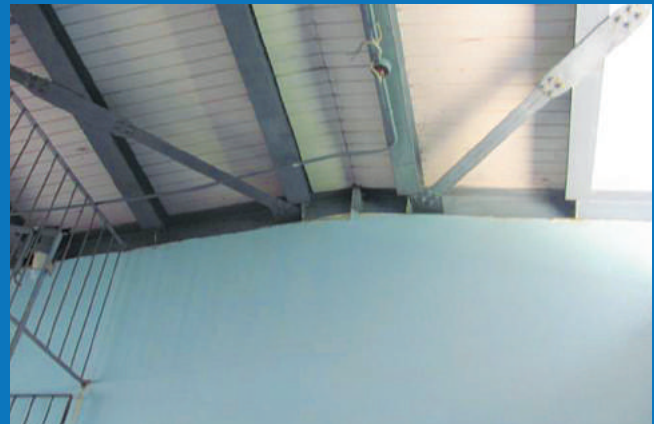
■ STRUCTURAL STEEL FRAME BUILDING IN REASONABLY GOOD CONDITION

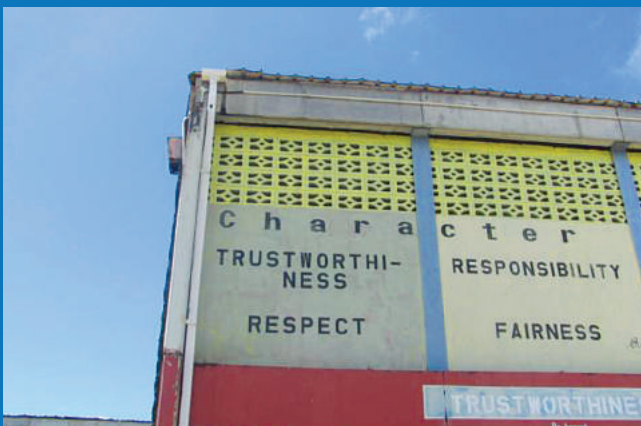
■ ROOF DRAINS DESTROYED BY HURRICANE, MARIA IN 2017

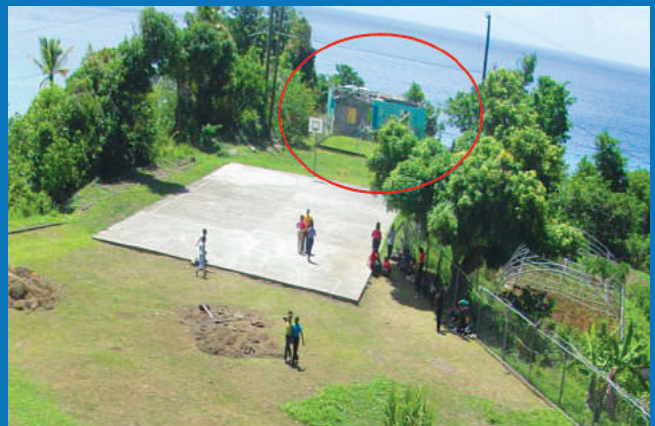
■ BUILDING WHOSE EXTERNAL WALL FAILED UNDER HURRICANE FORCE WINDS

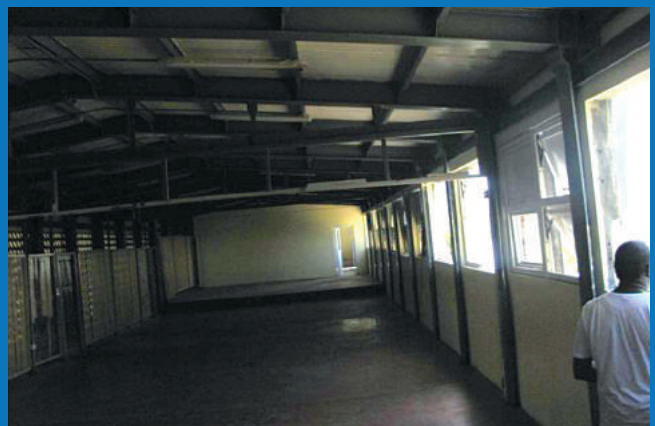
■ SECTION OF SCHOOL NOT IN USE DUE TO HURRICANE DAMAGE TO ROOF AND WINDOWS

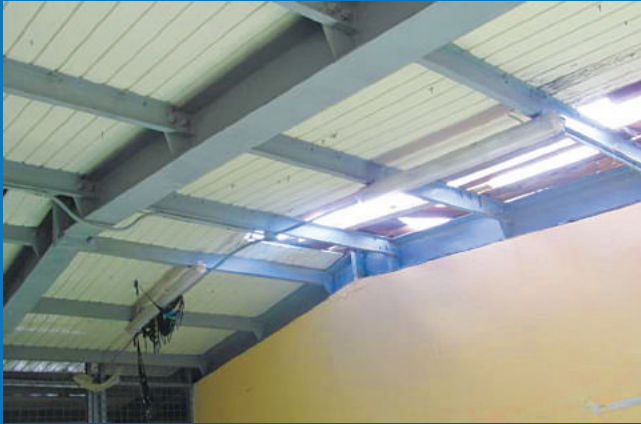
■ SECTION OF SCHOOL NOT IN USE DUE TO HURRICANE DAMAGE

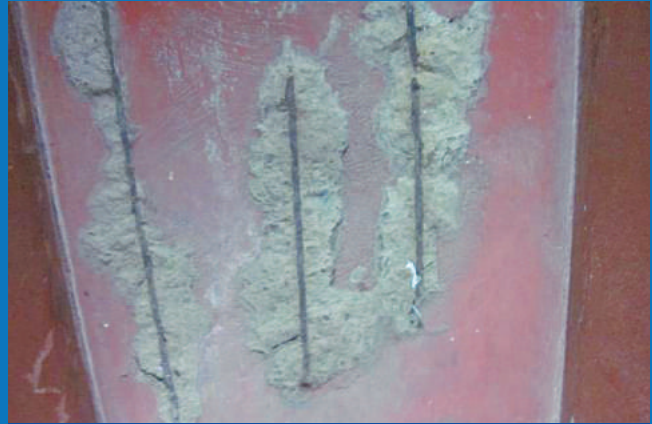
■ EXPOSED CORRODED STEEL REINFORCEMENT IN FLOOR SLAB

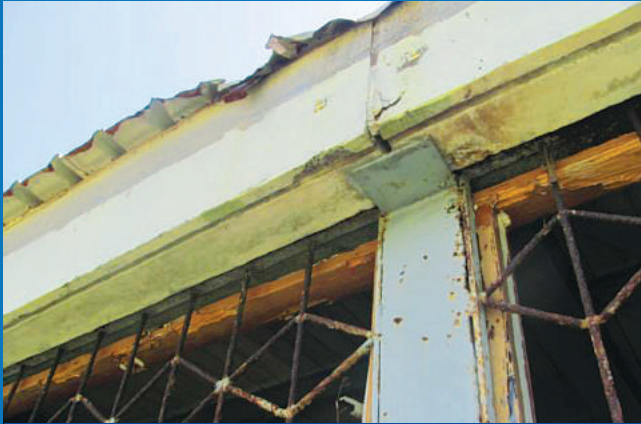
■ CORRODED STRUCTURAL STEEL MEMBERS

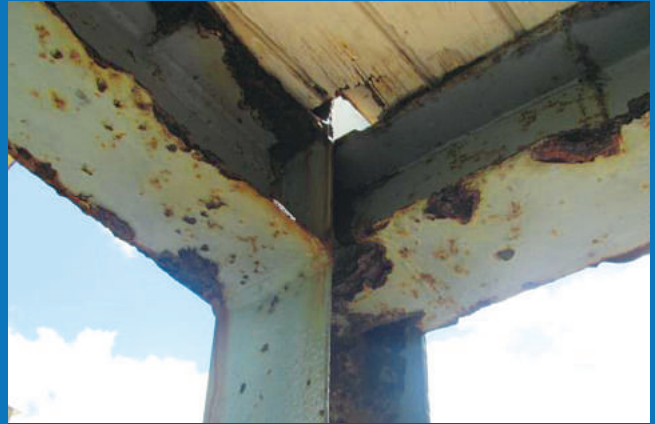
■ CORRODED STRUCTURAL STEEL MEMBERS

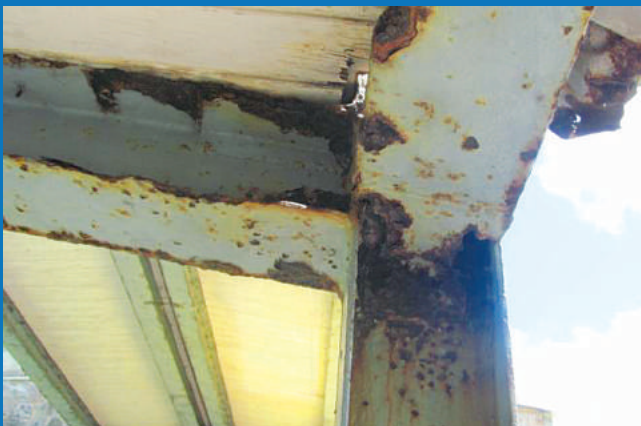
■ CORRODED STRUCTURAL STEEL MEMBERS

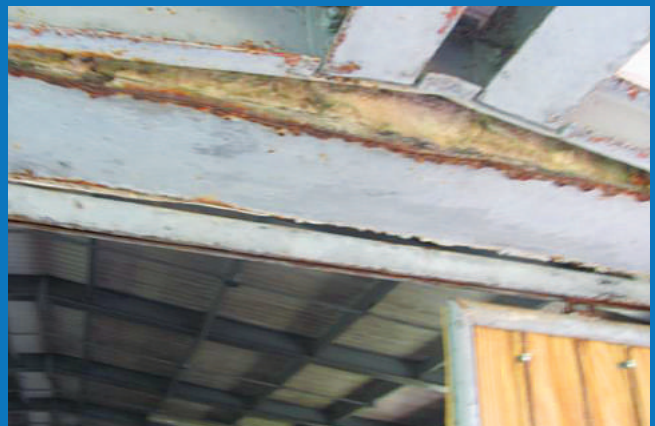
■ CORRODED STRUCTURAL STEEL MEMBERS

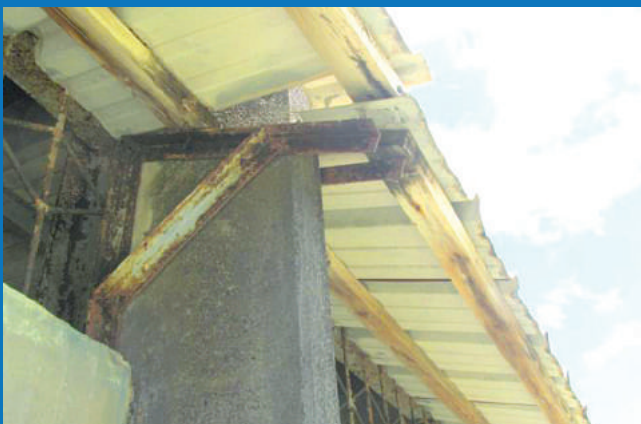
■ CORRODED STRUCTURAL STEEL MEMBERS

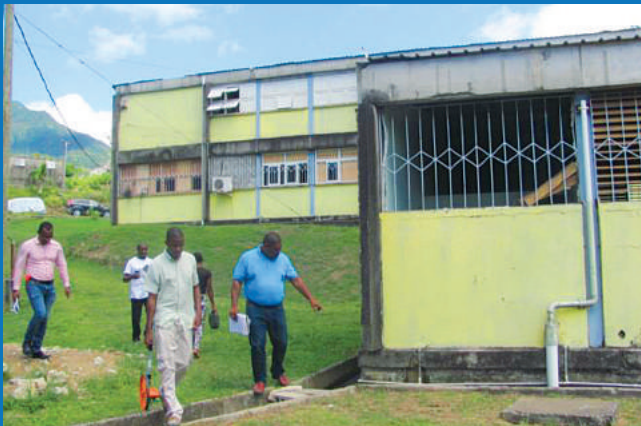
■ DAMAGED WINDOWS

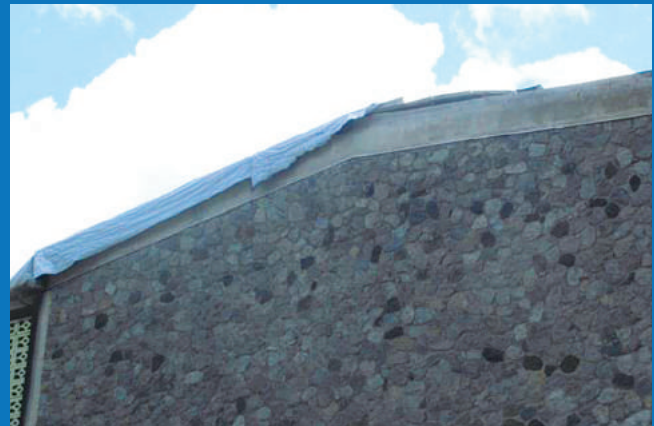
■ DAMAGED ROOF

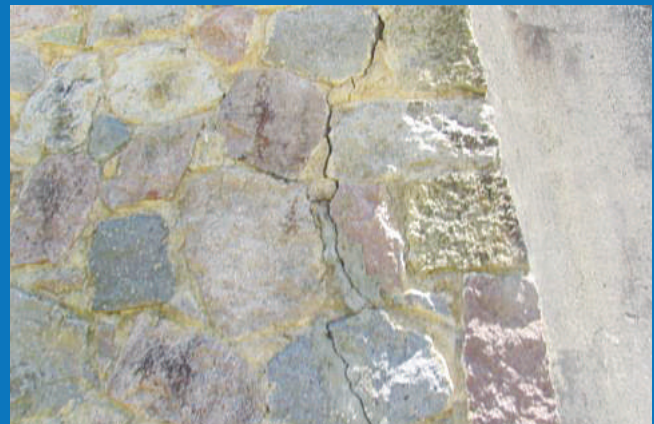
■ CRACKS IN STONE MASONRY WALL

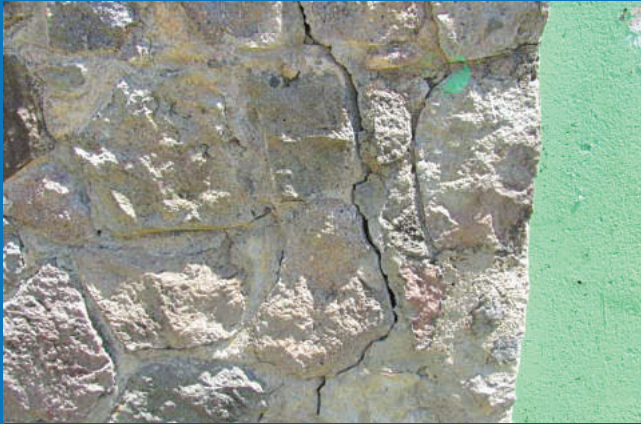
■ CRACKS IN  
STONE MASONRY WALL
