IMPLEMENTATION OF THE MODEL SAFE SCHOOL PROGRAMME IN THE CARIBBEAN

HAZARD RISK ASSESSMENT REPORT AND COSTED ACTION PLAN

BEXON PRIMARY SCHOOL

SAINT LUCIA

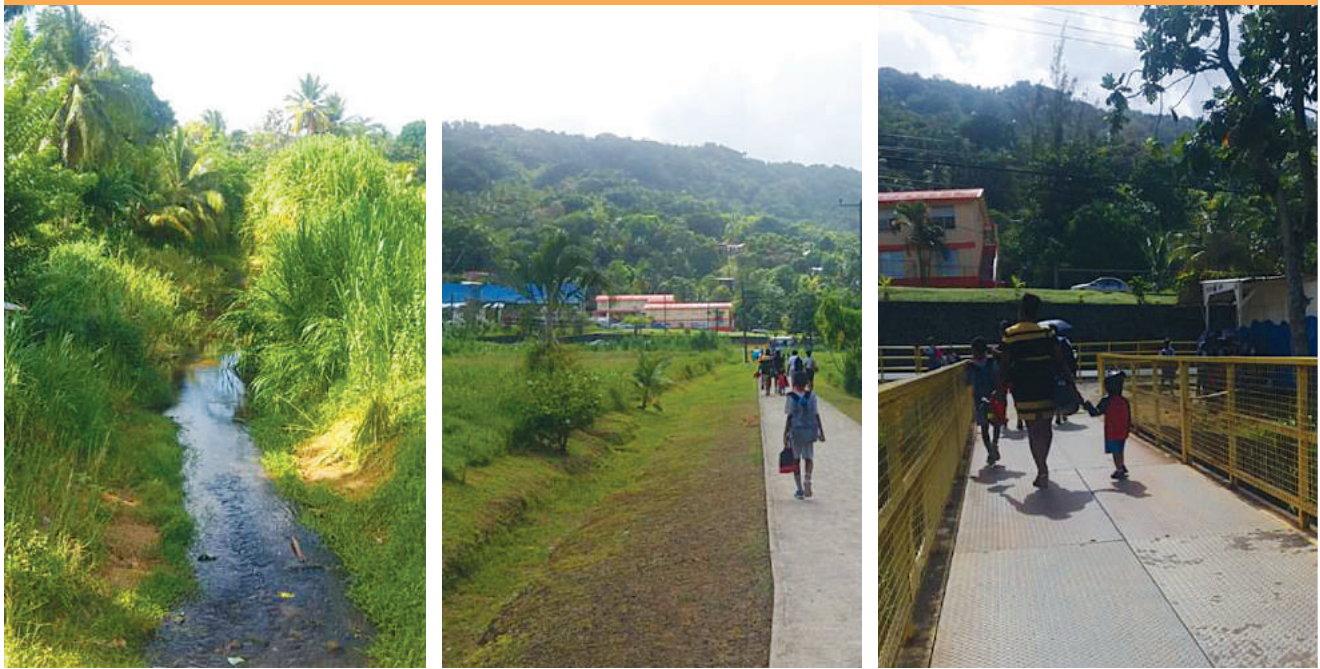
FIGURE 4.2: IMAGES OF BEXON PRIMARY – STUDENTS AND STAFF MUST CROSS FLOOD PRONE AREAS TO ACCESS MAIN ROAD

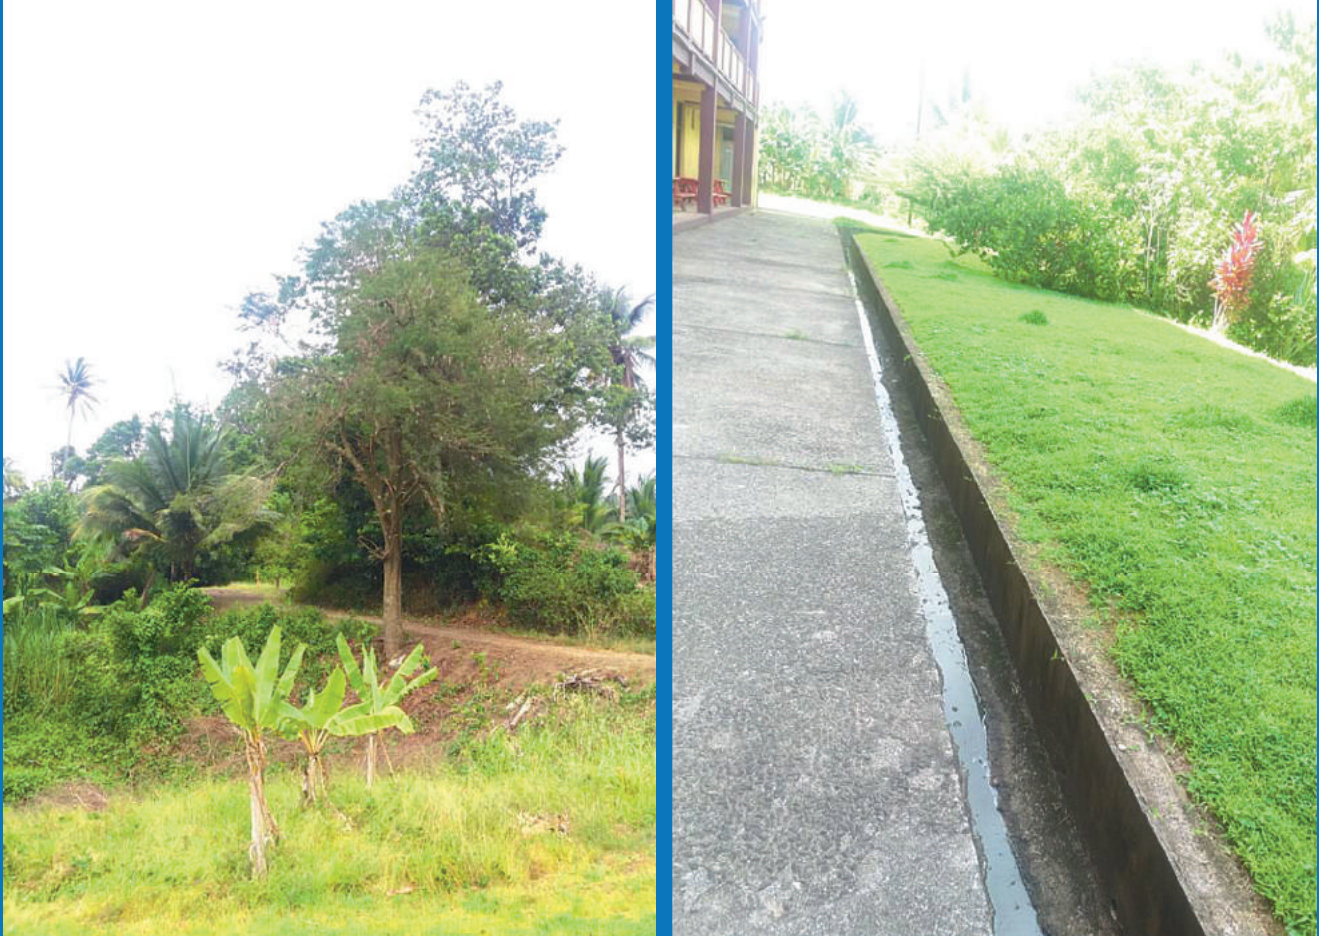
FIGURE 7.1: SELECTED PICTURES OF BEXON PRIMARY SHOWING SOME KEY AREAS FOR IMPROVEMENT (LEFT TO RIGHT: STEEP ACCESS ROAD USED AS EVACUATION ROUTE, SHALLOW DRAINS FOR HANDLING STORM WATER)

- Some repairs required to the physical plant to ensure safety before or during a hazard event. Particular focus should be given to roof repair and storm water drainage.

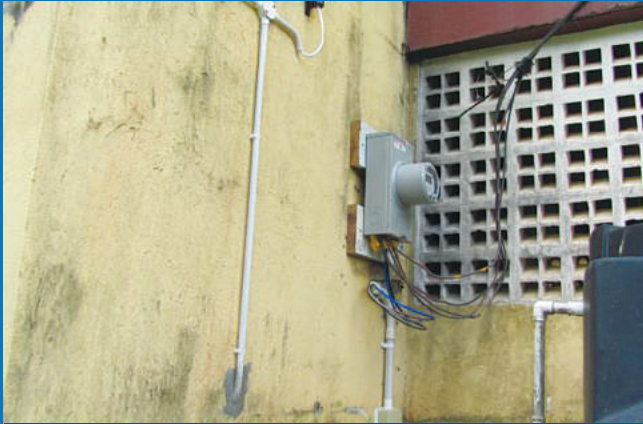
■ MAKESHIFT ELECTRICALS

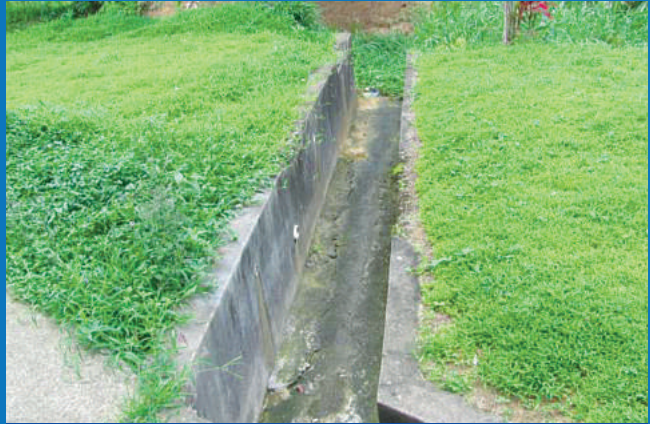
■ STORM DRAINS

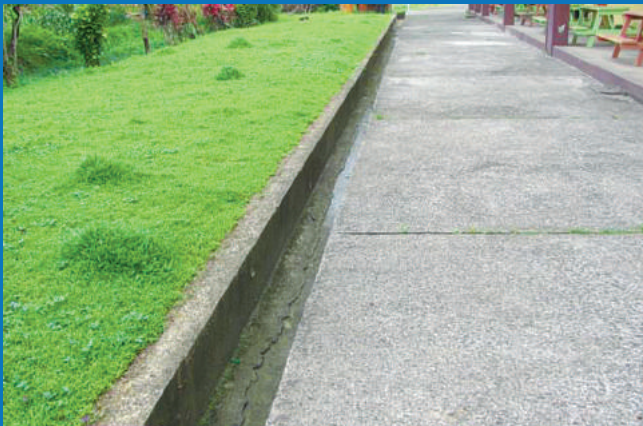
■ STORM DRAINS

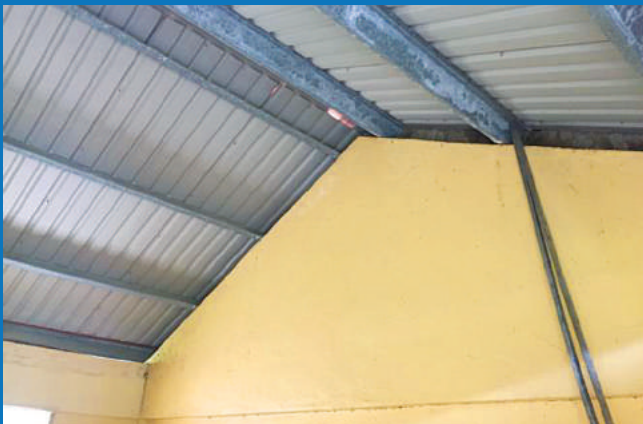
■ ROOF OVER STAIRWELL

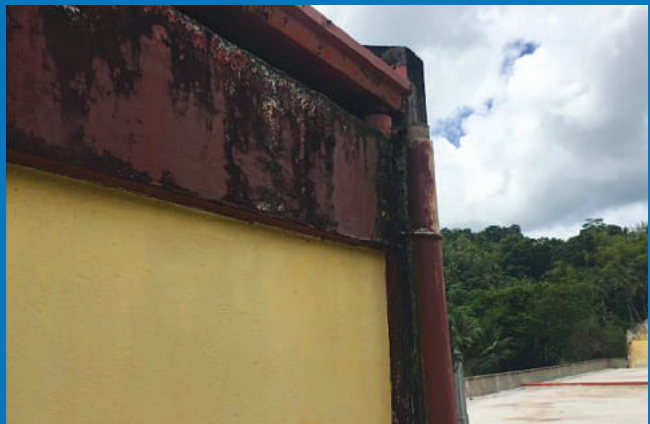
■ ROOF DRAINS

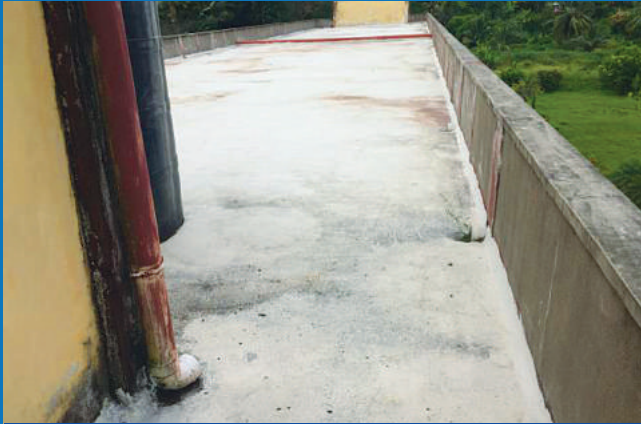
■ ROOF RECENTLY REPAIRED

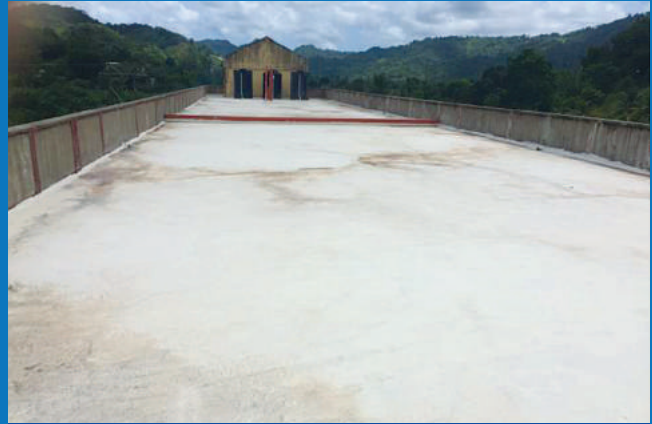
■ ROOF RECENTLY REPAIRED

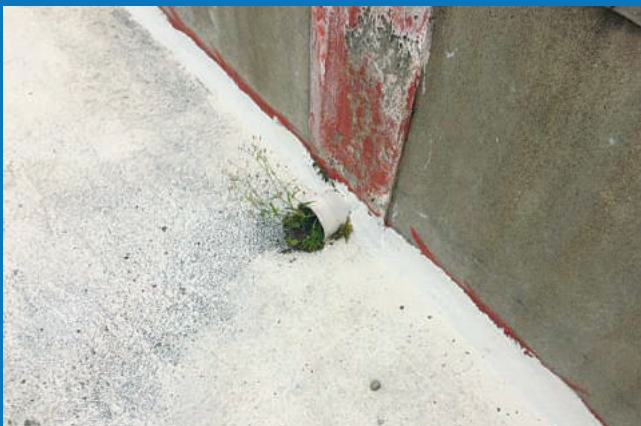
■ ROOF DRAIN OUTLET
