IMPLEMENTATION OF THE MODEL SAFE SCHOOL PROGRAMME IN THE CARIBBEAN

HAZARD RISK ASSESSMENT REPORT AND COSTED ACTION PLAN

SOUFRIERE PRIMARY SCHOOL

SAINT LUCIA

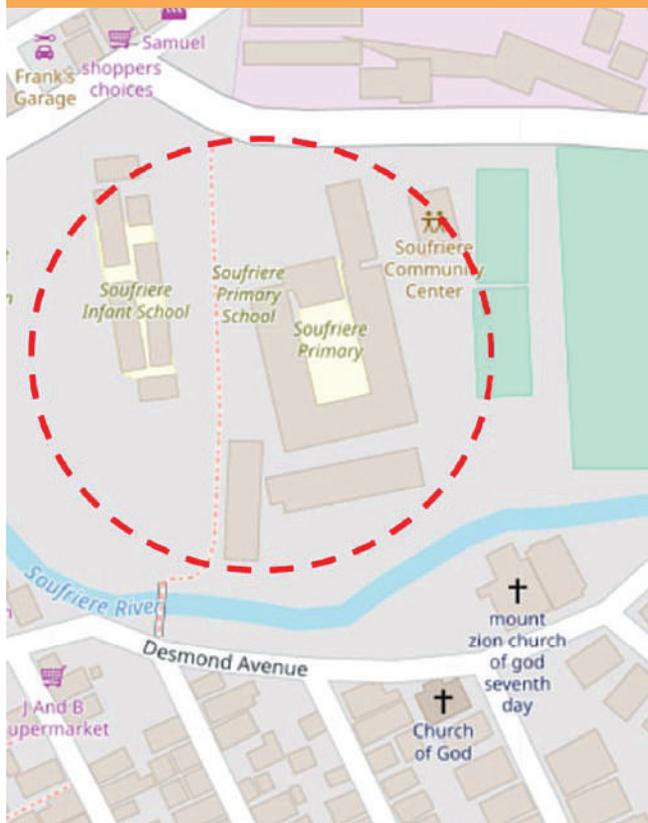
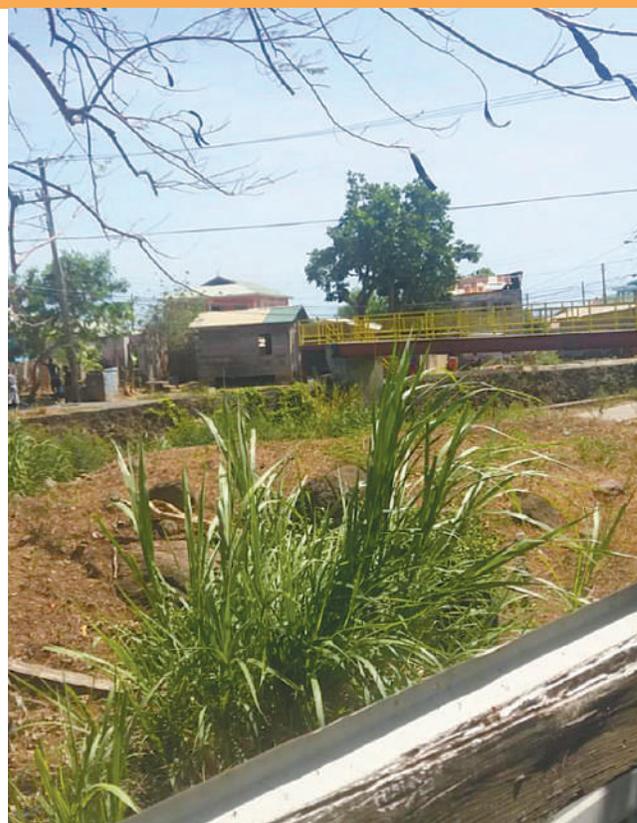
FIGURE 4.1: IMAGES SHOWING PROXIMITY OF SOUFRIERE SCHOOL TO RIVER

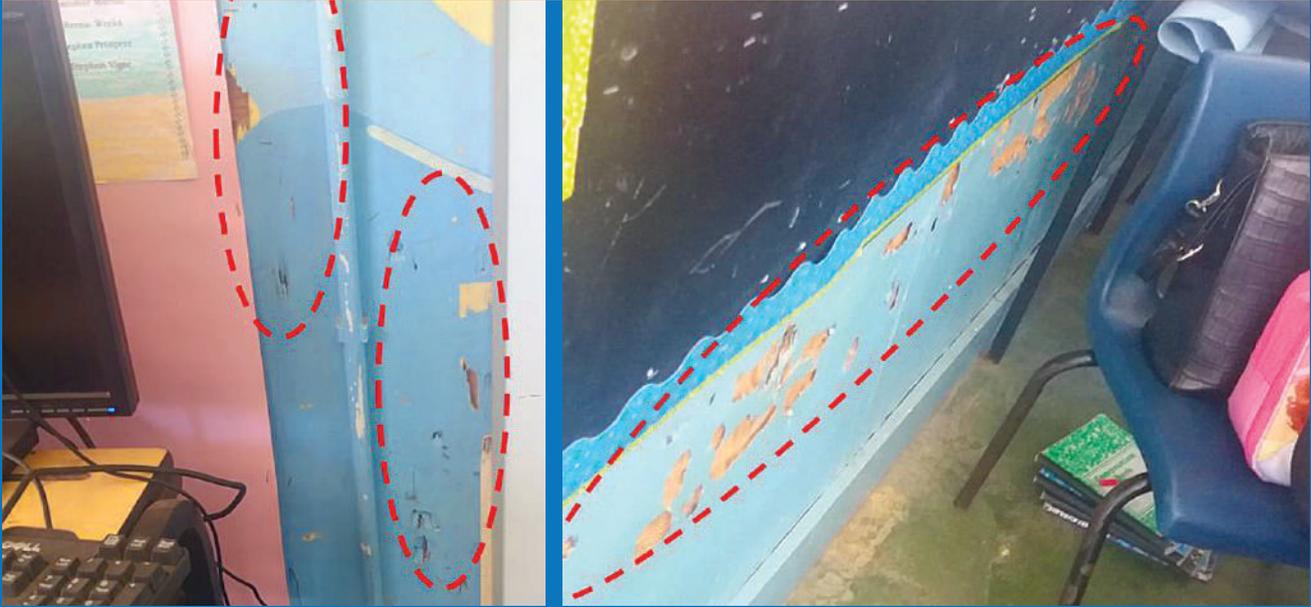
The school is also susceptible to pests and associated hazards. One major safety issue is rats – it was reported that rats frequently enter the walls between the classrooms and die. It is difficult for the caretaker to access these slots between classrooms, as such staff and students are experience the smell of decay. The school is also infested by termites in several places which can compromise the safety of the physical plant.

**FIGURE 7.2: EVIDENCE OF TERMITE INFESTATION (CIRCLED IN RED)
(MAY 2019)**

- Repairs required to the physical plant to ensure safety before or during a hazard event. Focus should be given to roof repairs, flood mitigation strategies and repairs to areas that have been infested by pests (rats and/or termites).

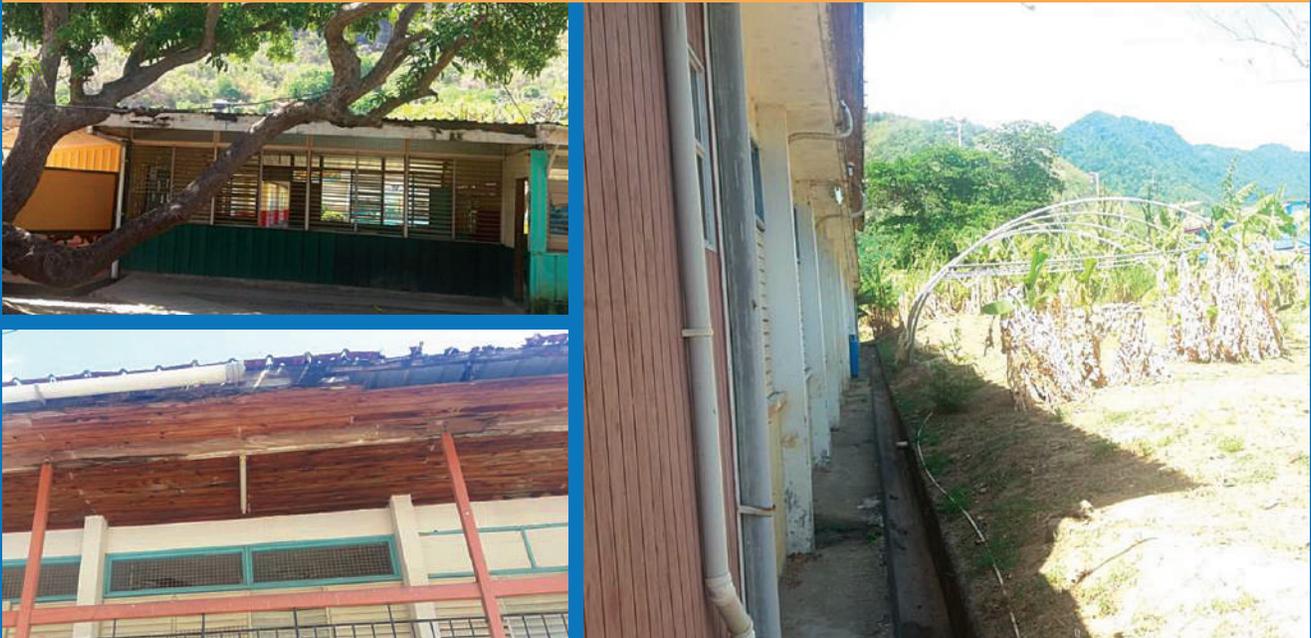
A primary safety concern expressed by persons interviewed was the need to secure the physical plant. The perimeter fence was damaged during Hurricane Tomas (2010) and has not been repaired; as such persons from the surrounding community are able to traverse the school. The school has experienced break-ins and praedial larceny as a result. Furthermore, the school is guarded by one watchman at a time; given the size of the school area to be secured, additional personnel is required.

**FIGURE 7.3: SOME SAFETY CONCERNS AT SOUFRIERE PRIMARY
(LEFT) BUILDINGS IN NEED OF MAJOR ROOF REPAIR
(RIGHT) ABANDONED GARDEN/GREENHOUSE DUE TO
PRAEDIAL LARCENY AS A RESULT OF DAMAGED PERIMETER FENCE**

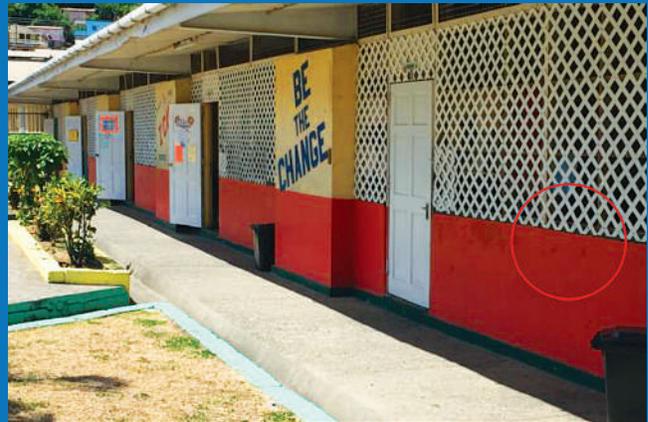
■ LATTICE IN PLACE OF WINDOWS

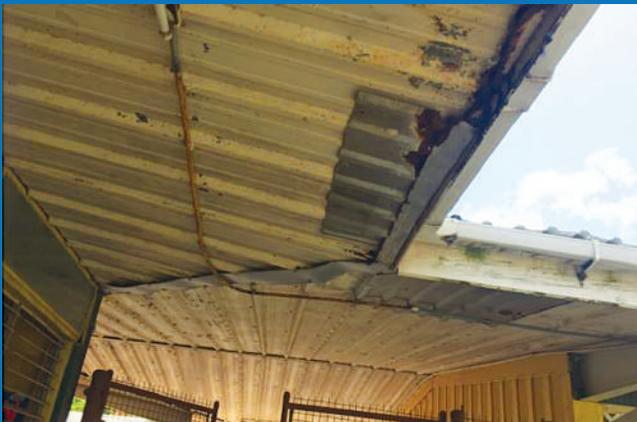
■ ROOF COVERING AND CEILING
IN STATE OF DISREPAIR

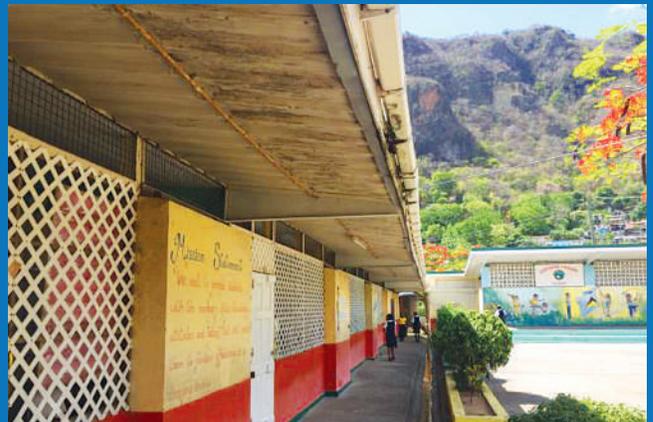
■ ROOF COVERING AND CEILING
IN STATE OF DISREPAIR

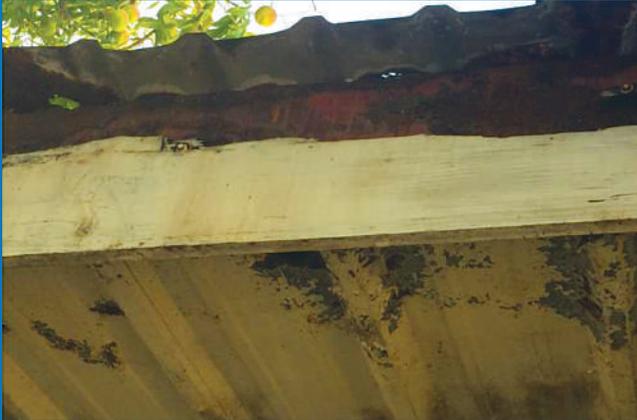
■ ROOF IN STATE OF DISREPAIR

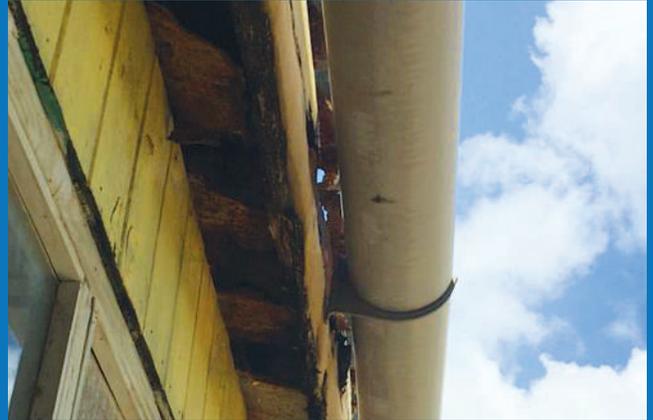
■ ROOF IN STATE OF DISREPAIR

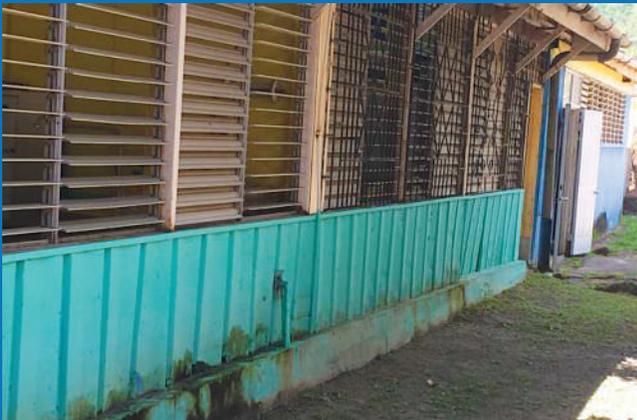
■ EXTERNAL WALL IN STATE OF DISREPAIR

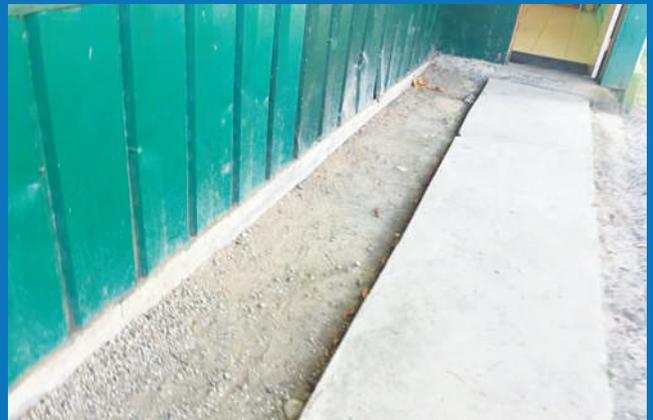
■ AREA FLOODS-ACCESS TO STAFF ROOM

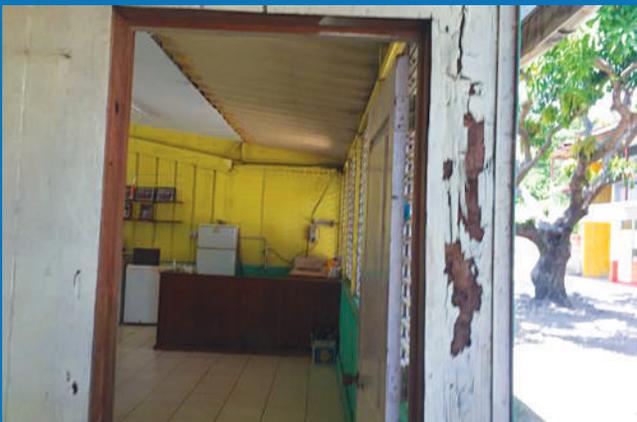
■ TERMITE INFESTATION

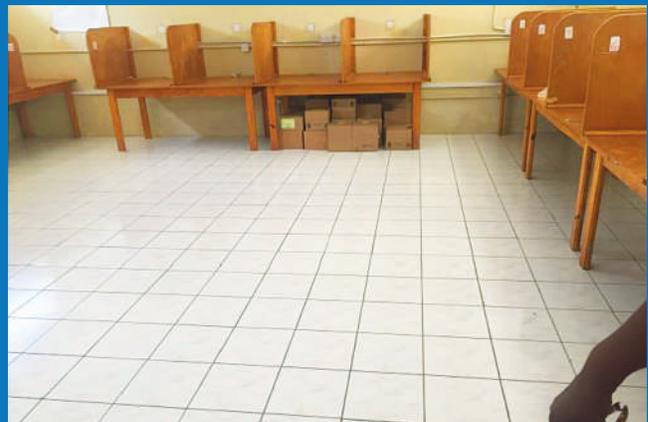
■ TERMITE INFESTED COMPUTER LAB

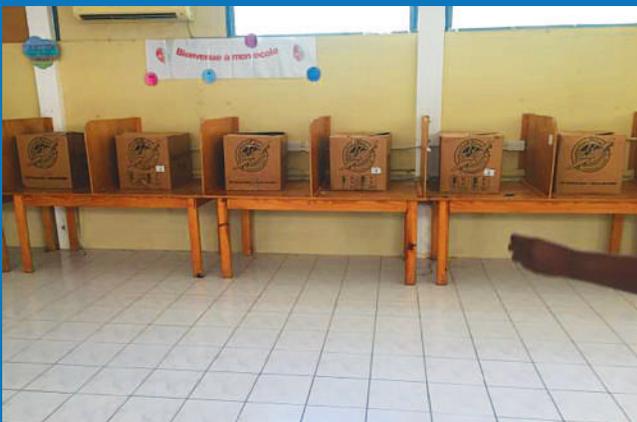
■ TERMITE INFESTED COMPUTER LAB

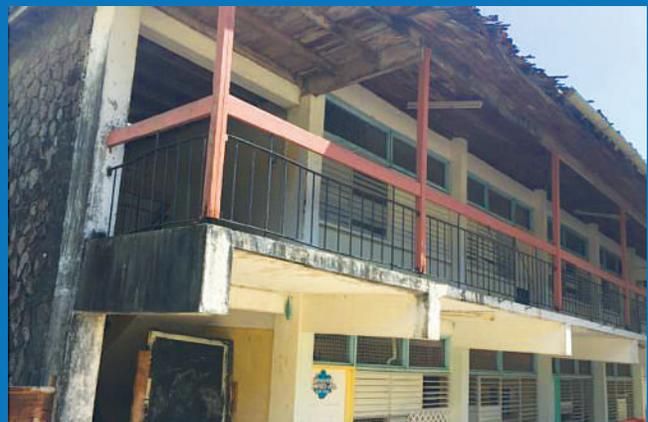
Maintenance and repair challenges also perpetuate several human-caused hazards around the school. The physical plant is over 40 years old and has only experienced minor repairs. Some blocks of the school have been abandoned on account of the roof being severely damaged or eaves in poor condition. There is also an annex which was damaged during the floods of Hurricane Tomas which has remained abandoned since that time.

■ ABANDONED UPPER LEVEL-BUILDING BLOCK

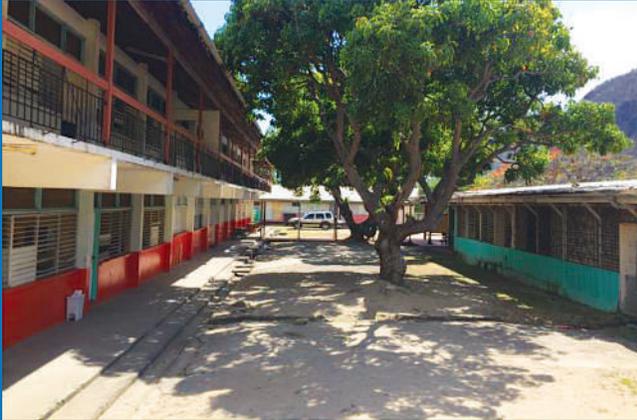
■ ABANDONED UPPER LEVEL-BUILDING BLOCK

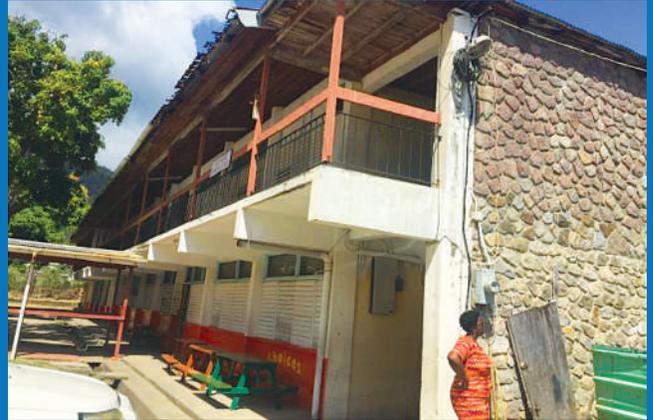
■ ABANDONED UPPER LEVEL-BUILDING BLOCK

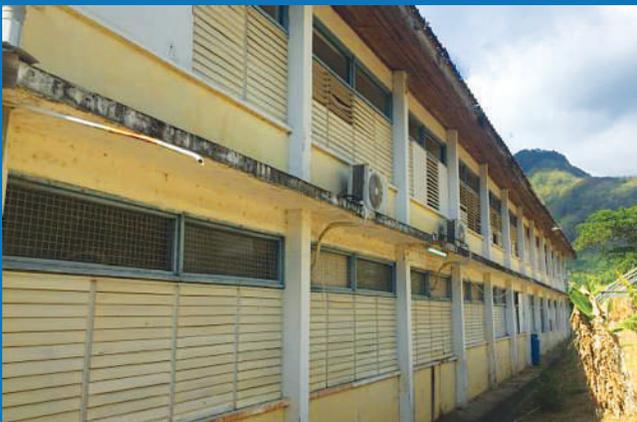
■ ABANDONED UPPER LEVEL-BUILDING BLOCK

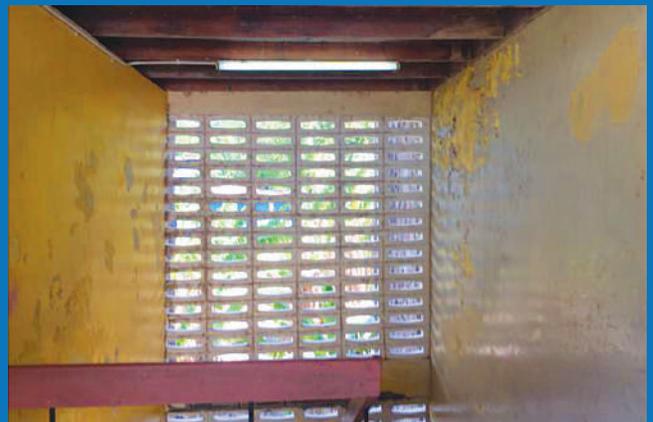
■ STAIRWELL OF ABANDONED UPPER LEVEL

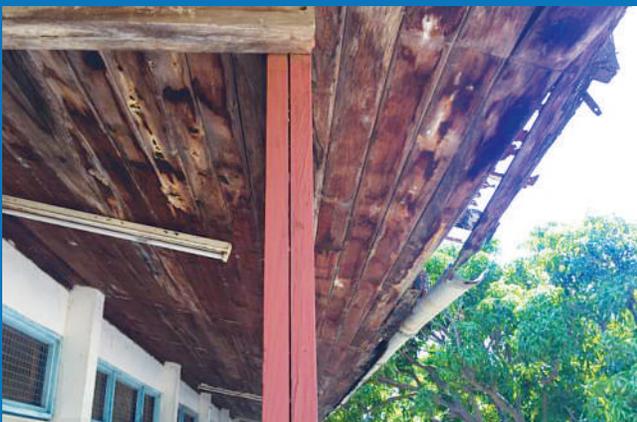
■ ROOF OF ABANDONED UPPER LEVEL

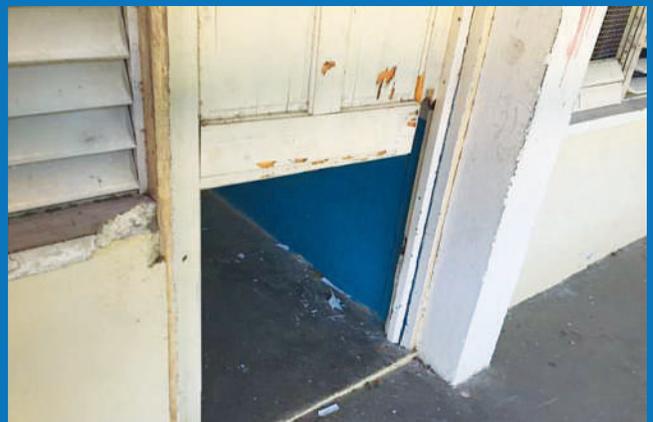
■ DOORS BROKEN

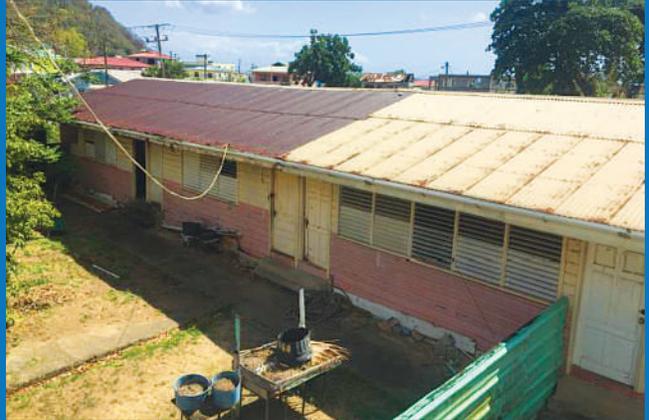
■ ABANDONED WOODEN BUILDING

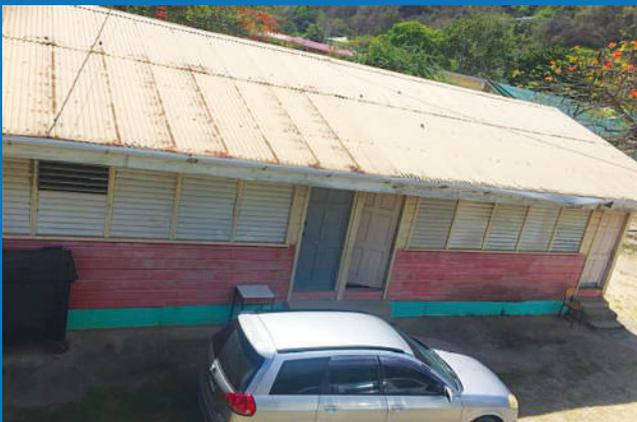
■ ABANDONED WOODEN BUILDING

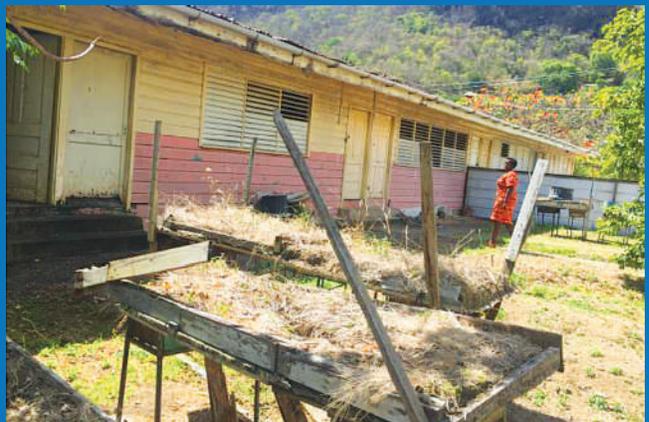
■ ABANDONED WOODEN BUILDING
