IMPLEMENTATION OF THE MODEL SAFE SCHOOL PROGRAMME IN THE CARIBBEAN

HAZARD RISK ASSESSMENT REPORT AND COSTED ACTION PLAN

ELIZABETH PEMBERTON
PRIMARY SCHOOL

ST. KITTS AND NEVIS

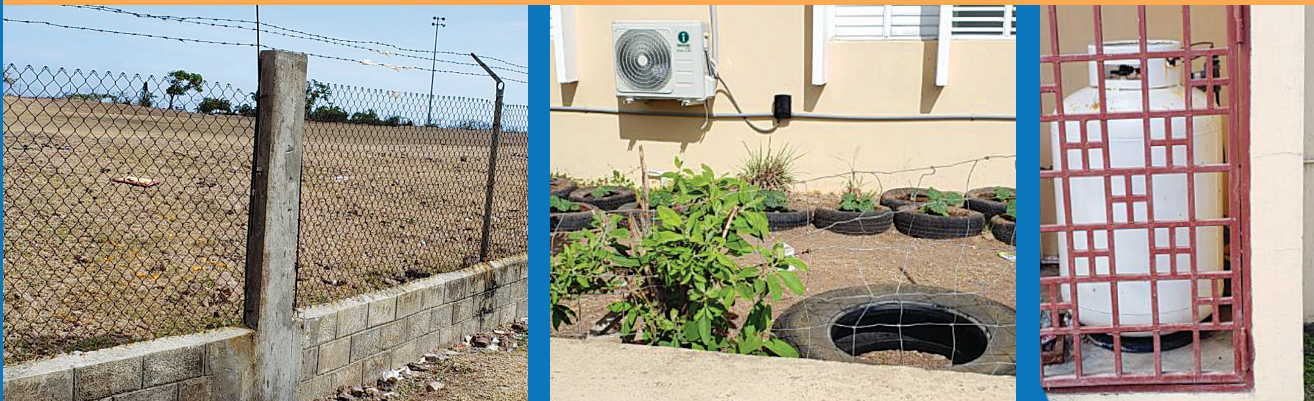
FIGURE 7.1: IMAGES HIGHLIGHTING KEY STRENGTHS AT ELIZABETH PEMBERTON PRIMARY SCHOOL

- LPG storage tanks were properly secured.
- The school has a gardening project which utilizes used tyres as flower beds.

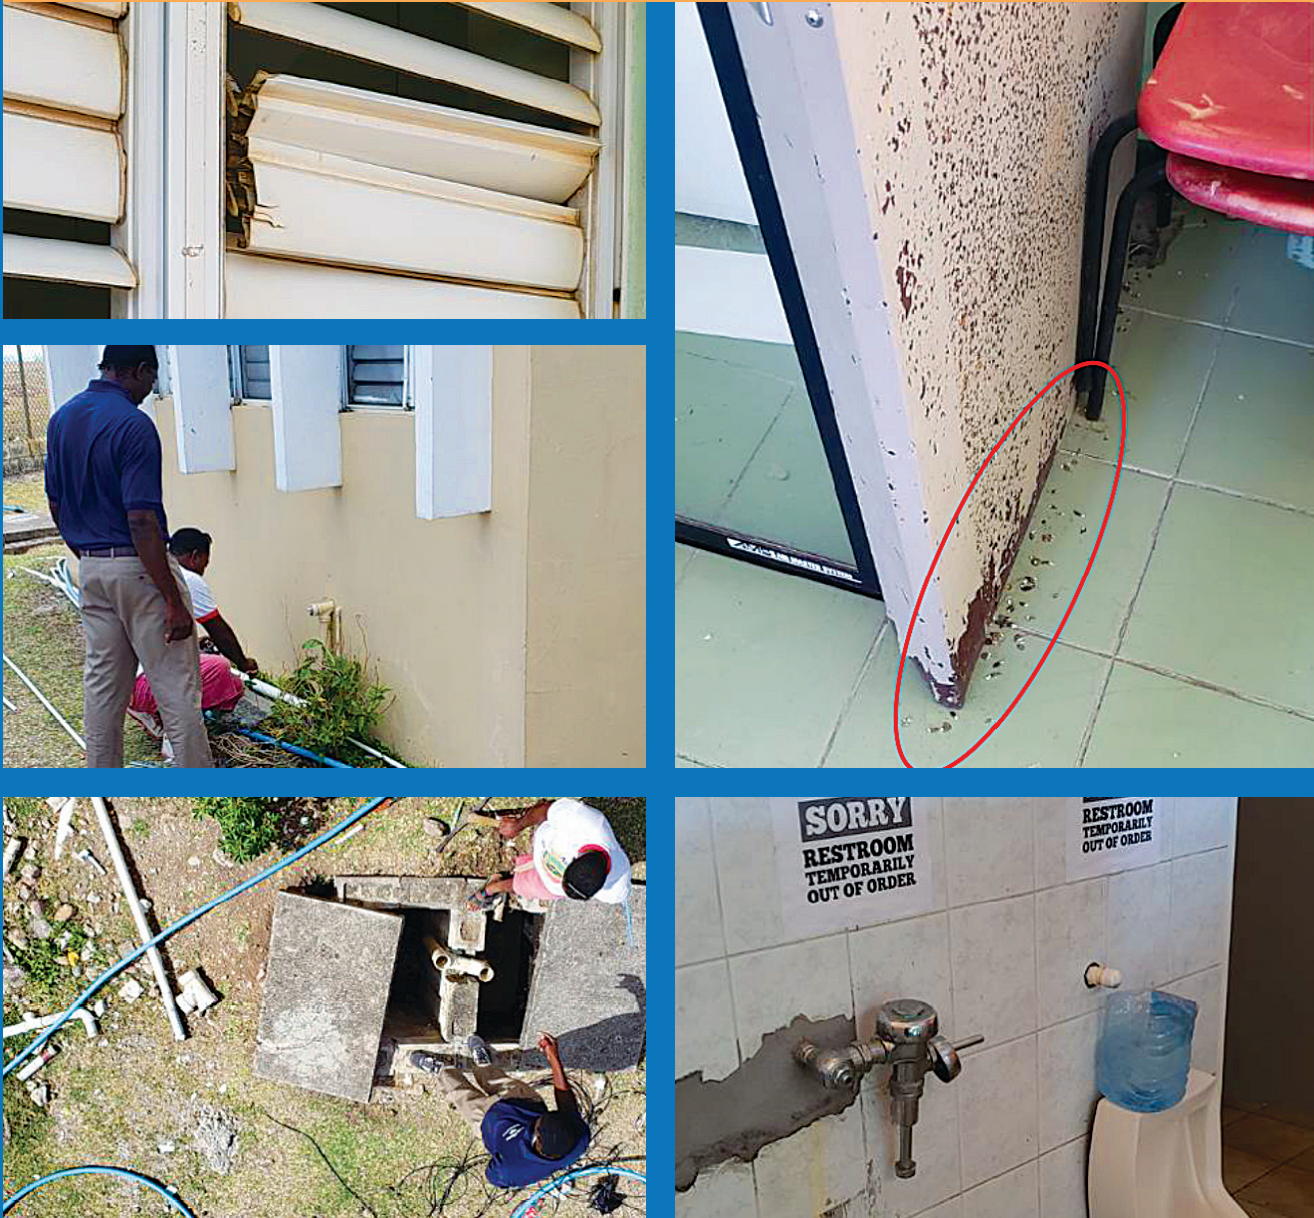
FIGURE 7.2: AREAS FOR IMPROVEMENT IDENTIFIED

- Exposed wires and pipes were observed and there was also evidence of construction/ongoing repairs during the site assessment.

- It is recommended that a point person be assigned the role as Health and Safety Officer. This Officer would attend training sessions, be responsible for ensuring that health and safety issues are documented and addressed, be responsible for managing safety supplies, ensure that drills are regularly carried out, and that staff and students are sensitized to their roles during an emergency.
