IMPLEMENTATION OF THE MODEL SAFE SCHOOL PROGRAMME IN THE CARIBBEAN

HAZARD RISK ASSESSMENT REPORT AND COSTED ACTION PLAN

SANDY POINT PRIMARY SCHOOL

ST. KITTS AND NEVIS

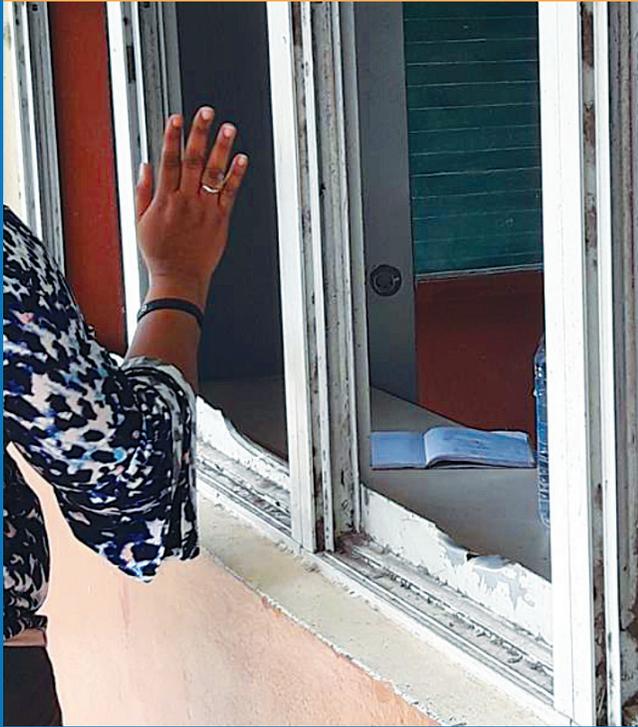
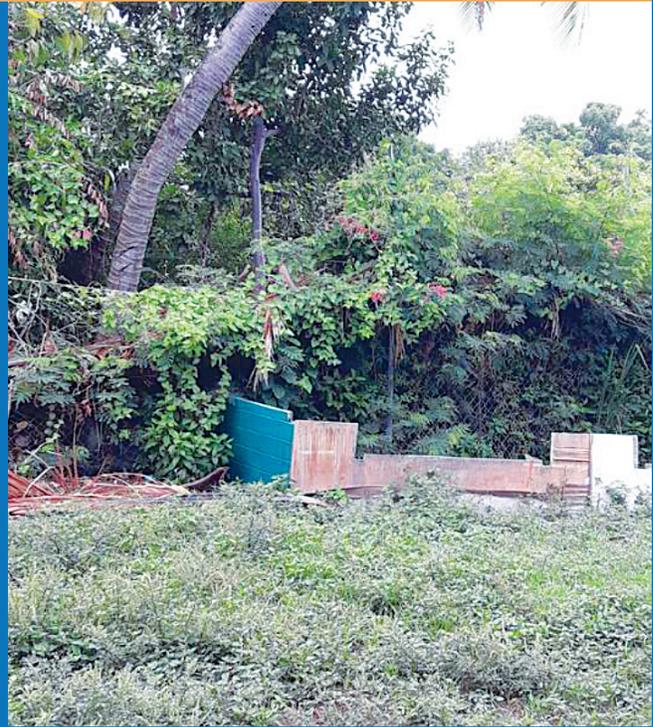
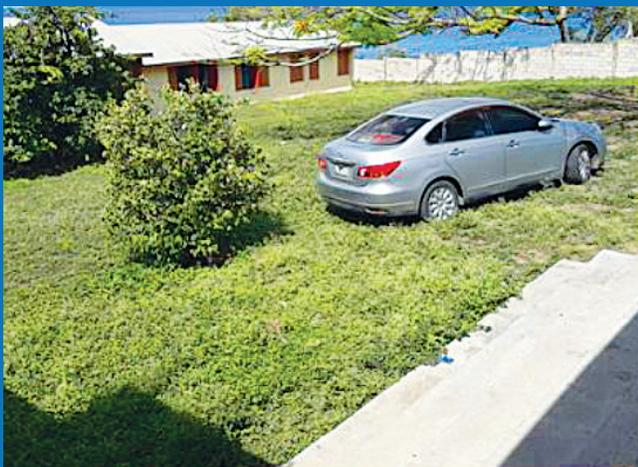
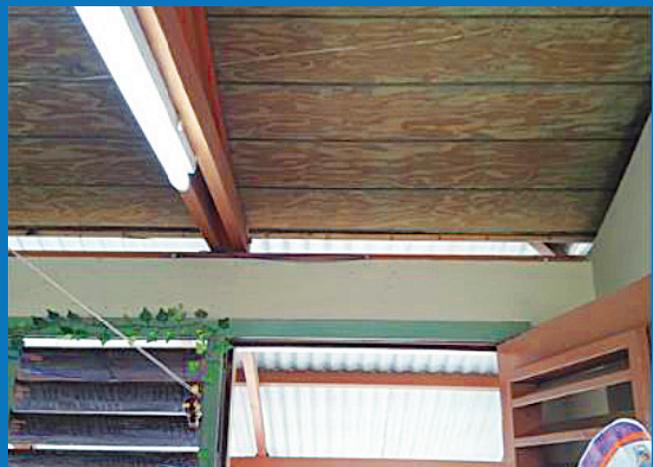
FIGURE 7.2: AREAS FOR IMPROVEMENT IDENTIFIED

- Though some repair work has been done (did roof repairs in some classrooms, sealed some openings around some classrooms), additional repairs and retrofits are needed.

- The school has had some issues of vandalism. The Principal indicated that more than one security guard is needed.
- It is recommended that a point person be assigned the role as Health and Safety Officer. This Officer would attend training sessions, be responsible for ensuring that health and safety issues are documented and addressed, be responsible for managing safety supplies, ensure that drills are regularly carried out, and that staff and students are sensitized to their roles during an emergency.

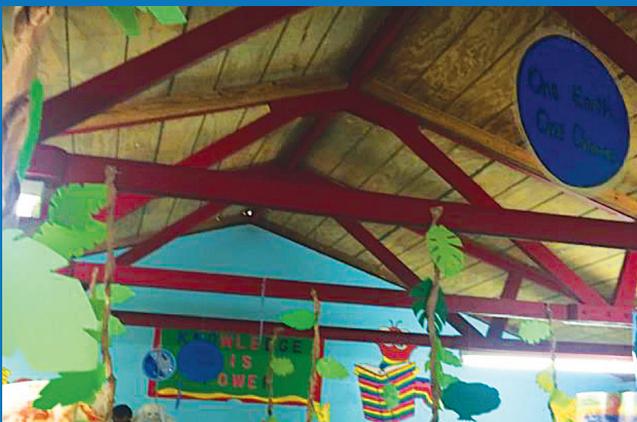
■ TYPICAL ROOF STRUCTURE

The school was assessed against the National Building Code which is common for the Organisation of Eastern Caribbean States (OECS) territory. The most serious area of deficiency was the Aluzinc roof covering on some of the buildings which appeared to lack the required hurricane straps. There were also cases of missing or broken windows which will put the entire building at risk in an extreme wind event. The main roof structures were found to be in generally good condition.
