IMPLEMENTATION OF THE MODEL SAFE SCHOOL PROGRAMME IN THE CARIBBEAN

HAZARD RISK ASSESSMENT REPORT AND COSTED ACTION PLAN

KINGSTOWN PREPARATORY SCHOOL

ST. VINCENT AND THE GRENADINES

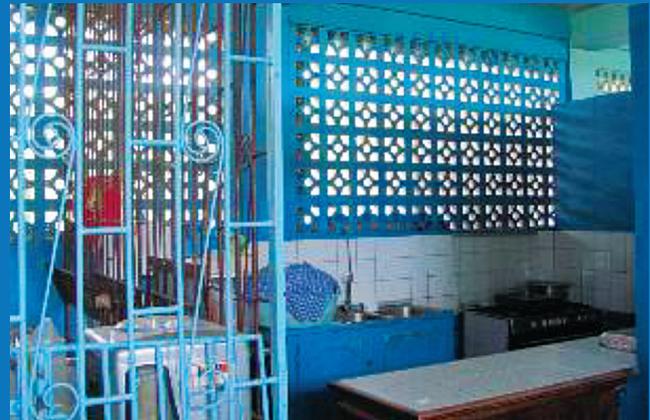
■ KITCHEN - BROKEN TILES

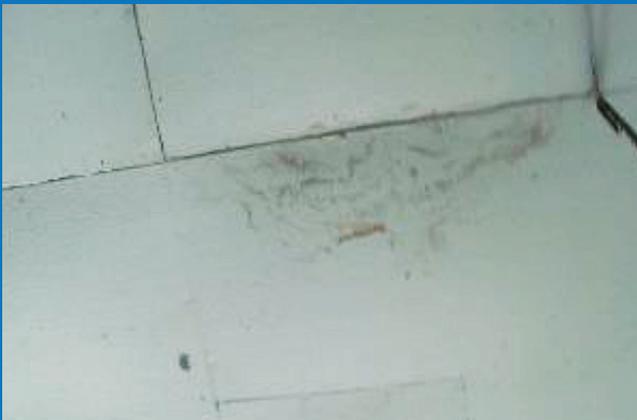
■ LEAKING ROOF

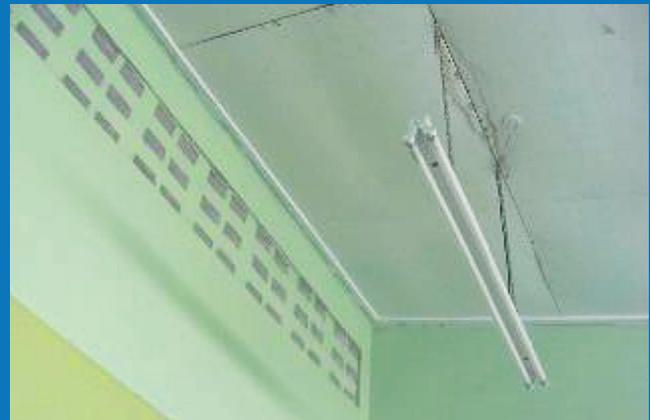
■ LEAKING ROOF

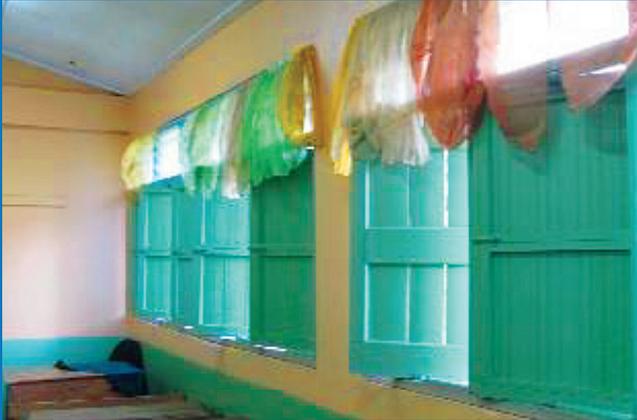
■ LEAKING ROOF

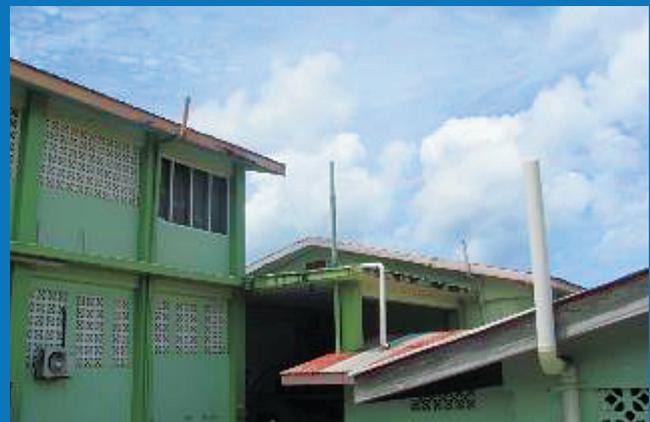
■ BROKEN WINDOW

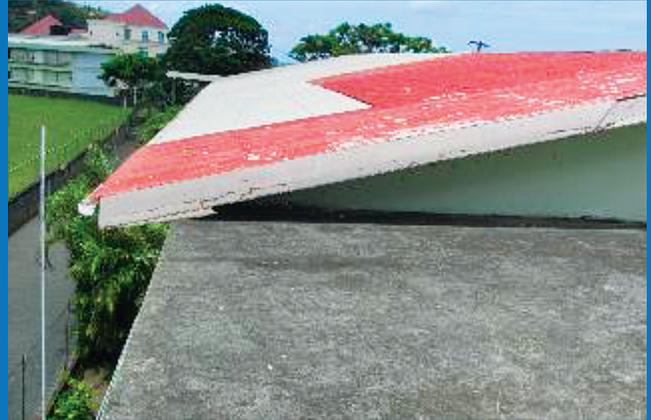
■ ROTTED ROOF SHEET

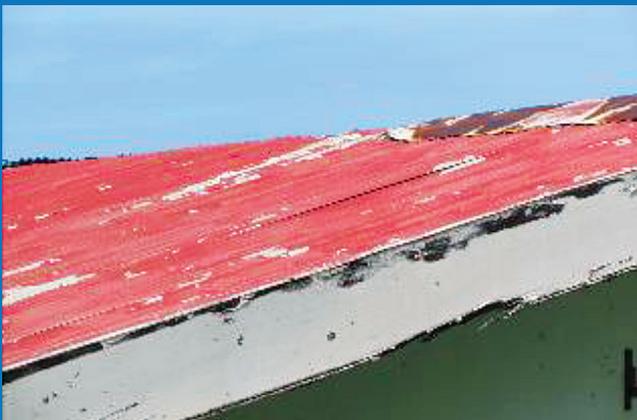
■ ROOF WITH LEAKS

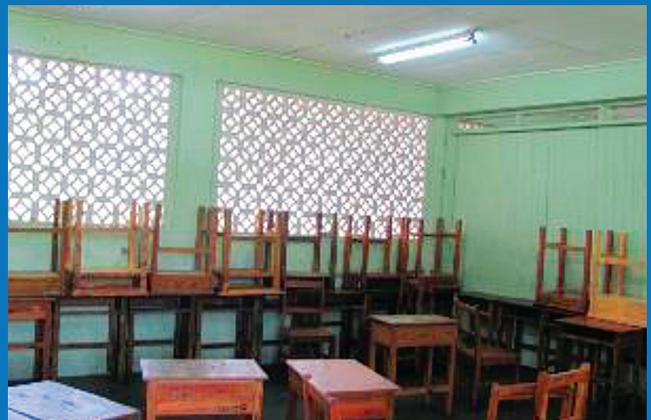
■ ROOF WITH LEAKS

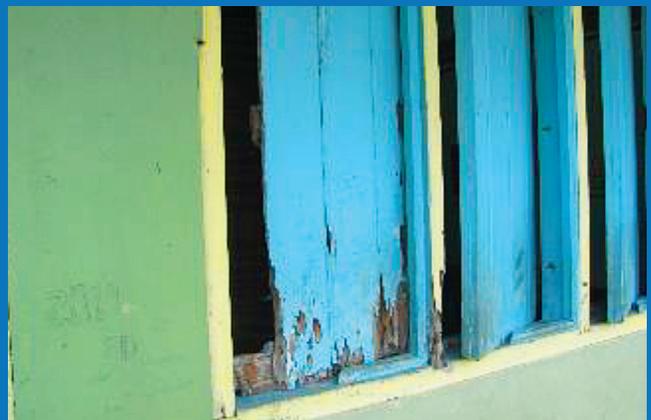
■ TERMITE INFESTATION

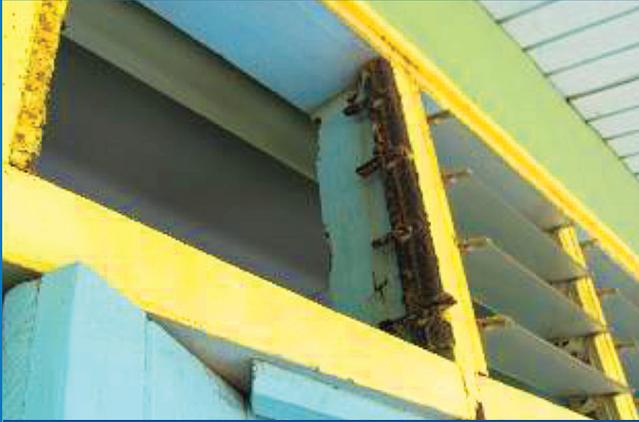
■ TERMITE INFESTATION
