NATIONAL SCALE LANDSLIDE HAZARD ASSESSMENT ALONG THE ROAD CORRIDORS OF DOMINICA AND SAINT LUCIA

Enschede, The Netherlands, March, 2015

Thesis submitted to the Faculty of Geo-Information Science and Earth Observation of the University of Twente in partial fulfilment of the requirements for the degree of Master of Science in Geo-information Science and Earth Observation.

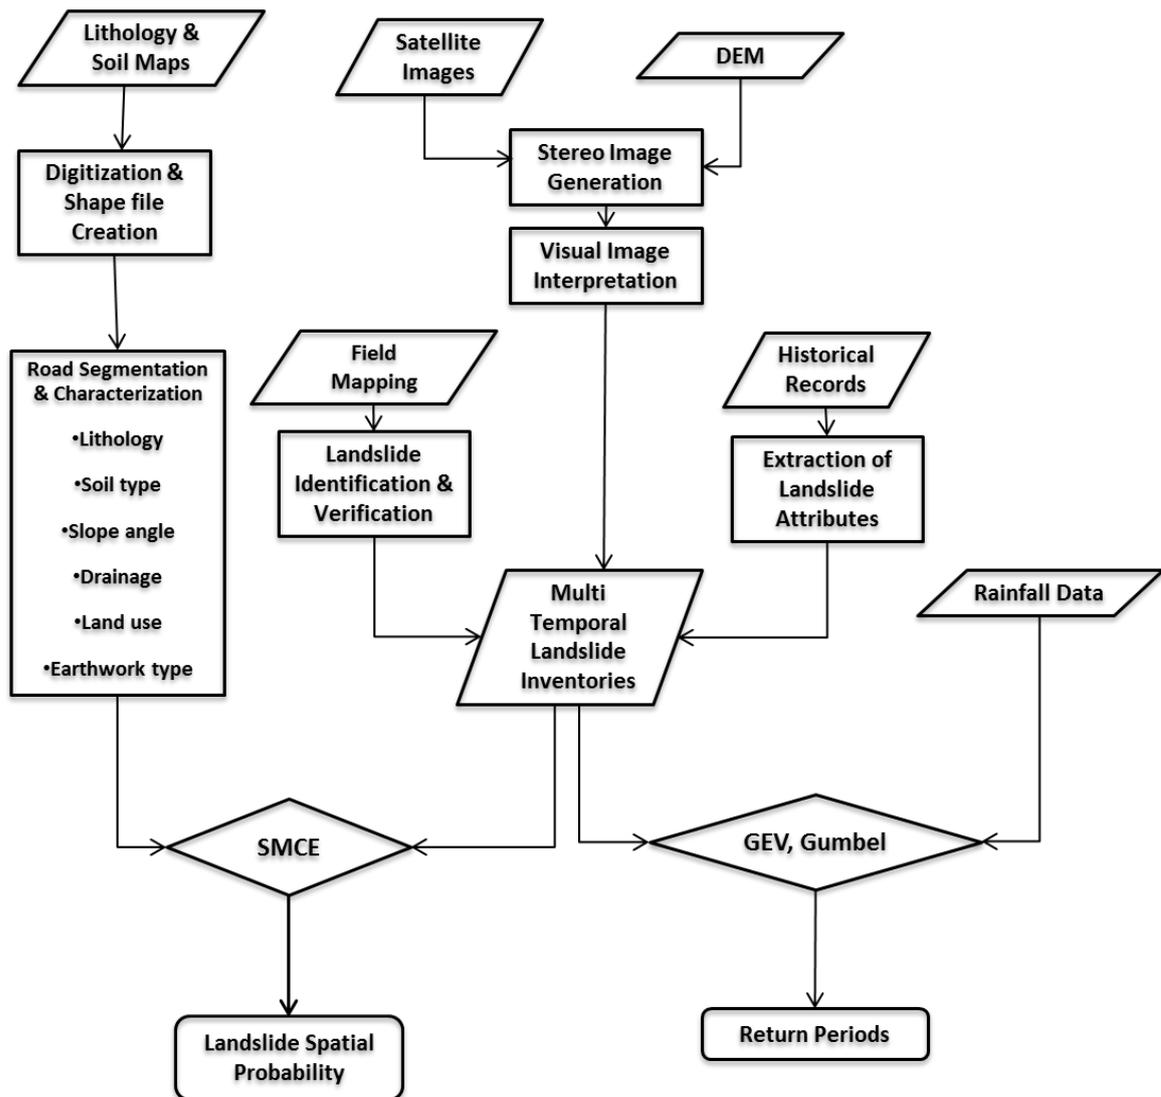
Figure 1.1. Flowchart of the methodology used in this research

This assessment of the landslides along the road network was mainly based on historical records collected from road maintenance and clearance reports of after landslide events. To support and verify the information obtained through historical records, visual image interpretation was also performed. The image interpretation was done using stereo image obtained by combining high resolution imagery with digital elevation model. Accordingly, multi temporal landslide inventory maps along the major roads were prepared. Based on the inventories, landslide density per kilometre length in each major road sections were calculated for different storm events. To analyse the temporal probability, the return periods of the rainfall amounts of the storm events that caused landslides were modelled using generalized extreme value distribution method and Gumbel method. Finally, the landslide susceptibility analysis was made using spatial multi criteria evaluation. All the methods used in this study are discussed in detail in Chapter 4. Figure 1.1 below shows the flowchart of the methodology used.

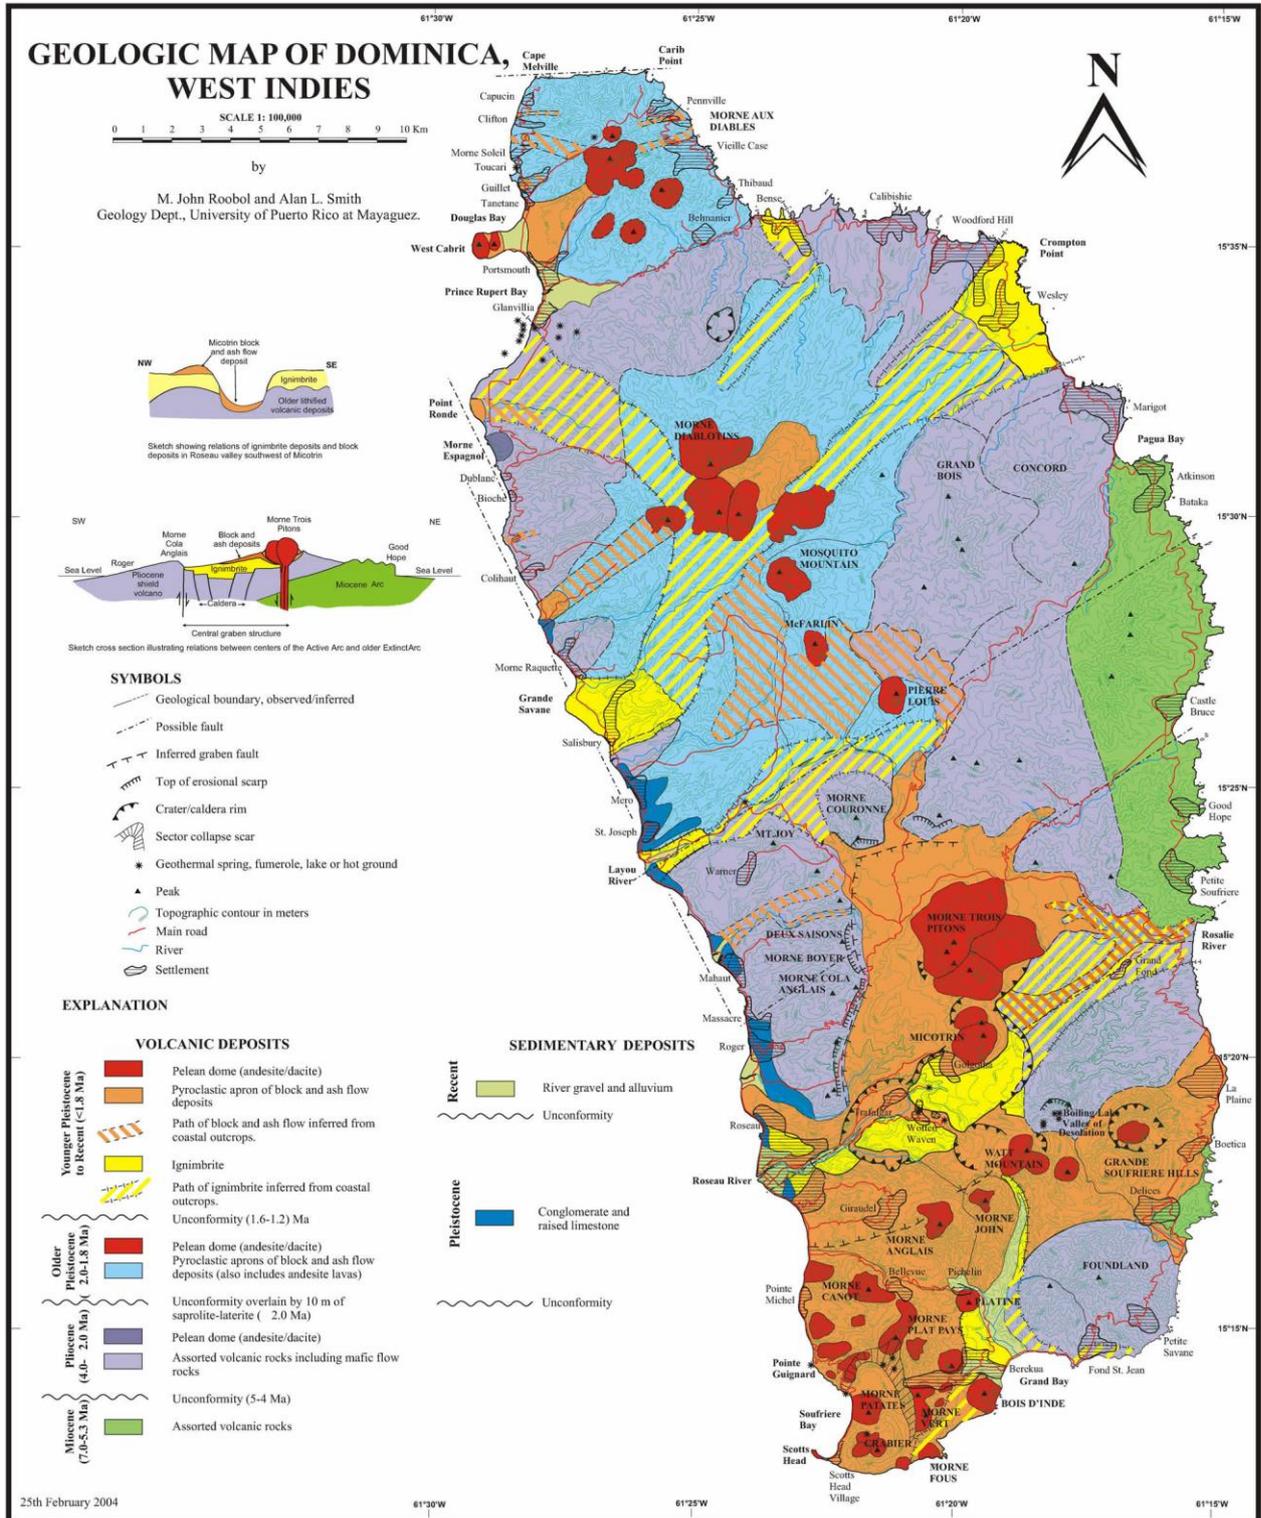
Figure 3.2. Geologic map of Dominica

The geology of Dominica is predominantly volcanic bedrock composed mainly of andesitic to dacitic material erupted from at least ten volcanic centres, mainly during the Pleistocene (Reading, 1991). The bedrock is a mixture mainly of the minerals plagioclase and biotite with some hornblende, quartz, and pyroxene. On a north-south trend through the central part of the island, young lava domes of morne diabltn, trois pitons, micrtin, and patates are aligned. Ignimbrite rocks deposited by hot ash fall and nuee ardantes are found at the outside surface of the plugged vents. Nearly vertical cliffs of fine grained and hard rock, resulted from these deposits, can be seen in some parts of the island. Two sedimentary bedrock units, consolidated limestone consisting of coral, shells and limey mud and unconsolidated alluvium, are the only

significantly different bedrocks found on the island (Degraff, 1987). Figure 3.2 shows the geologic map of Dominica.

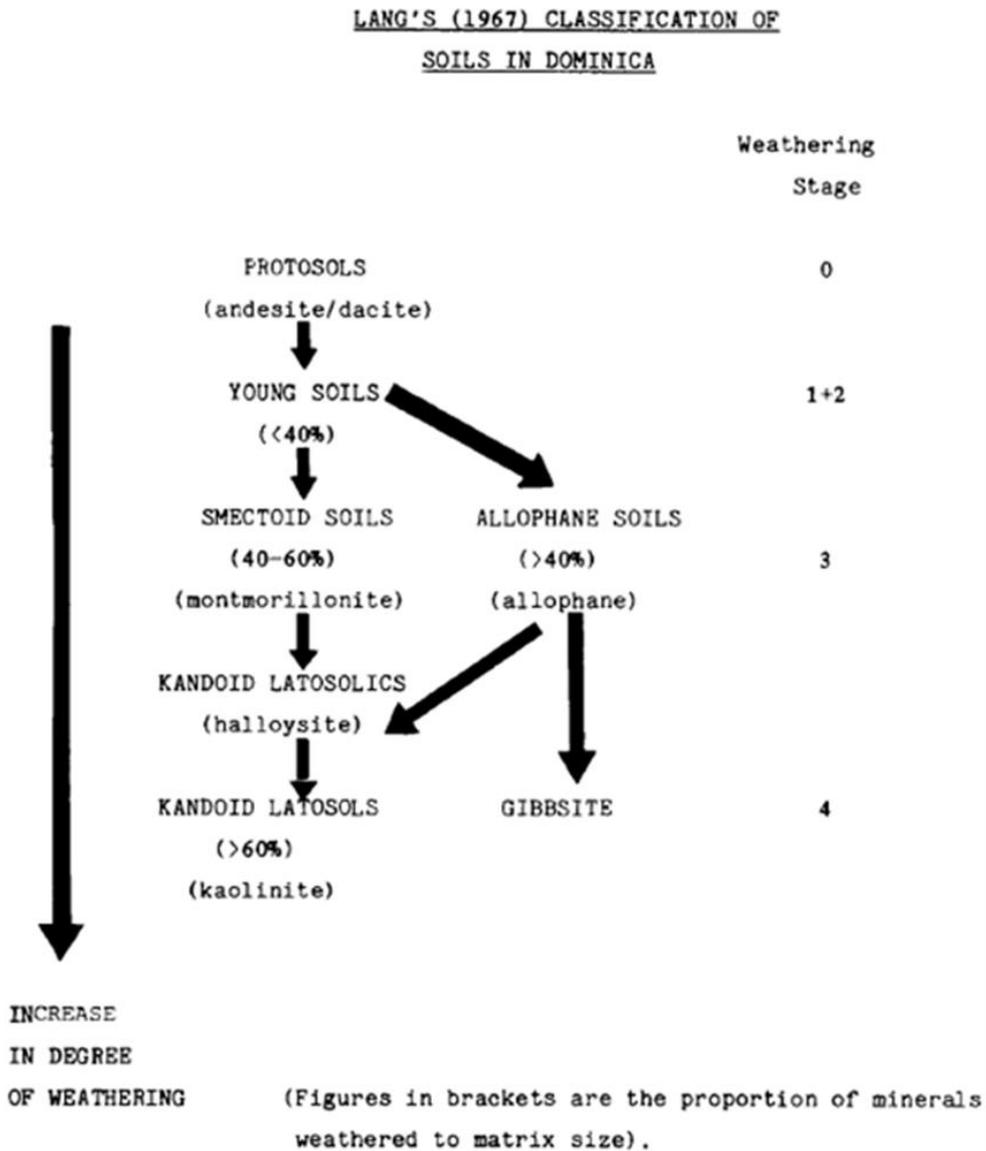
Figure 3.3. Lang’s (1967) classification of Soils in Dominica. Source: (Rouse et al., 1986)

Mr. David Lang completed the major work on the classification of Dominica’s soils over 40 years ago. He studied the basic soil characteristics and capabilities crucial for land use planning and agricultural development. Soils in Dominica are mostly residual soils, formed by the process of chemical weathering of rock. The climatic conditions of the island, especially warm temperatures and abundant rainfall, enhance the weathering process. Weathering of volcanic rocks changes their mineral composition and physical character. The andesitic bedrock on Dominica weathers to form clay and other secondary minerals (Degraff, 1987). The engineering property of these soils is often very different from that of transported and re-deposited soils. Their unique properties are a response to the combination of environmental conditions found in the tropics; climate (especially rainfall and temperature regimes), parent material, water movement (drainage conditions), topography (e.g. slope length and gradient), vegetation and age (i.e., degree of weathering) are generally considered the most relevant factors (Reading, 1991; Rouse, 1990). Figure 3.3 shows the Lang’s (1967) soil classification of Dominica based on degree of weathering.

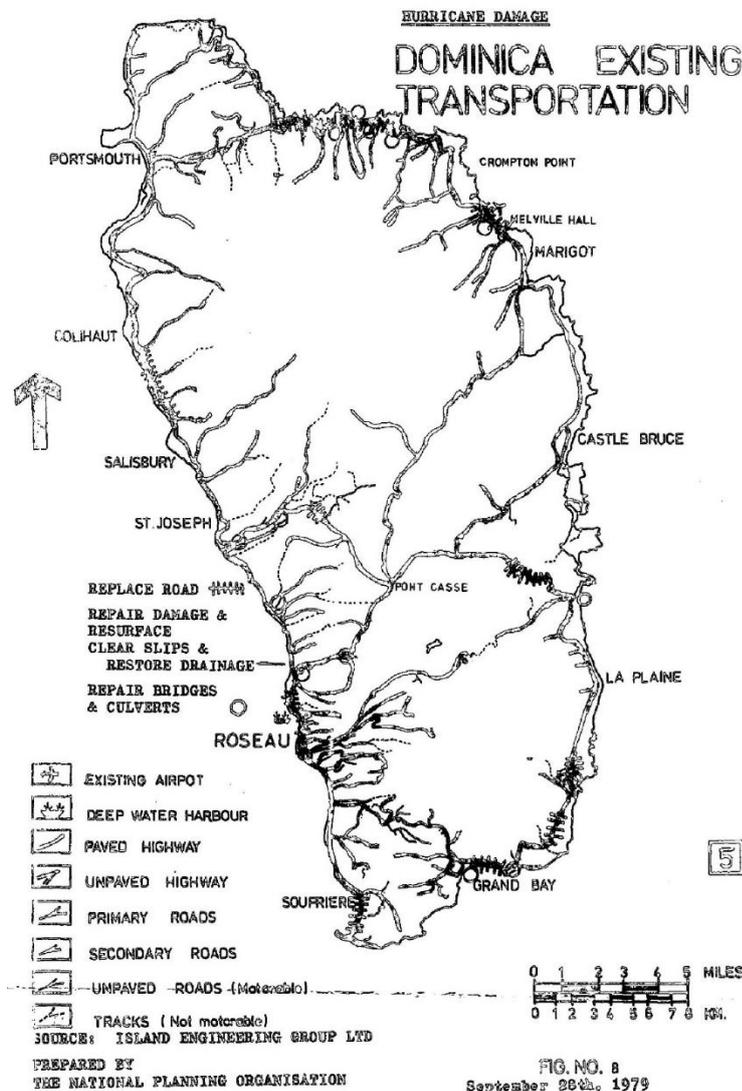
Figure 3.5. The road damage caused by hurricane David, Dominica. Source: (ECFLA, 1979)

The geology of Dominica coupled with its topography make the country very susceptible for landslides. In the past the country has encountered a lot of landslide events and almost all of them are related to high rainfall events. Between the period May and December, the country experiences its highest precipitation of the year and most of the disaster events occurred during this period. The disaster events occurred in Dominica since 1806 are provided in Appendix I. Hurricane David, which occurred on August 29/1979, can be considered as the biggest disaster event occurred in the last 40 years. The whole island was hit by the hurricane and suffered a considerable damage. Due to this event 42 persons were reported dead, around 2000 people were injured and 78% of the population was rendered homeless by housing destruction. Almost all the roads and most of the bridges were also damaged by this event. Many roads were blocked by landslides and road communication between the different parts of the country was greatly altered. The preliminary cost estimate for rehabilitation and reconstruction of the roads was estimated to be 82 million east Caribbean dollar, which is about 30 million us dollar with today's exchange rate. The map below (figure 3.5) shows the roads which were totally damaged and needed replacement and roads blocked by landslides and needed clearance (ECFLA, 1979).

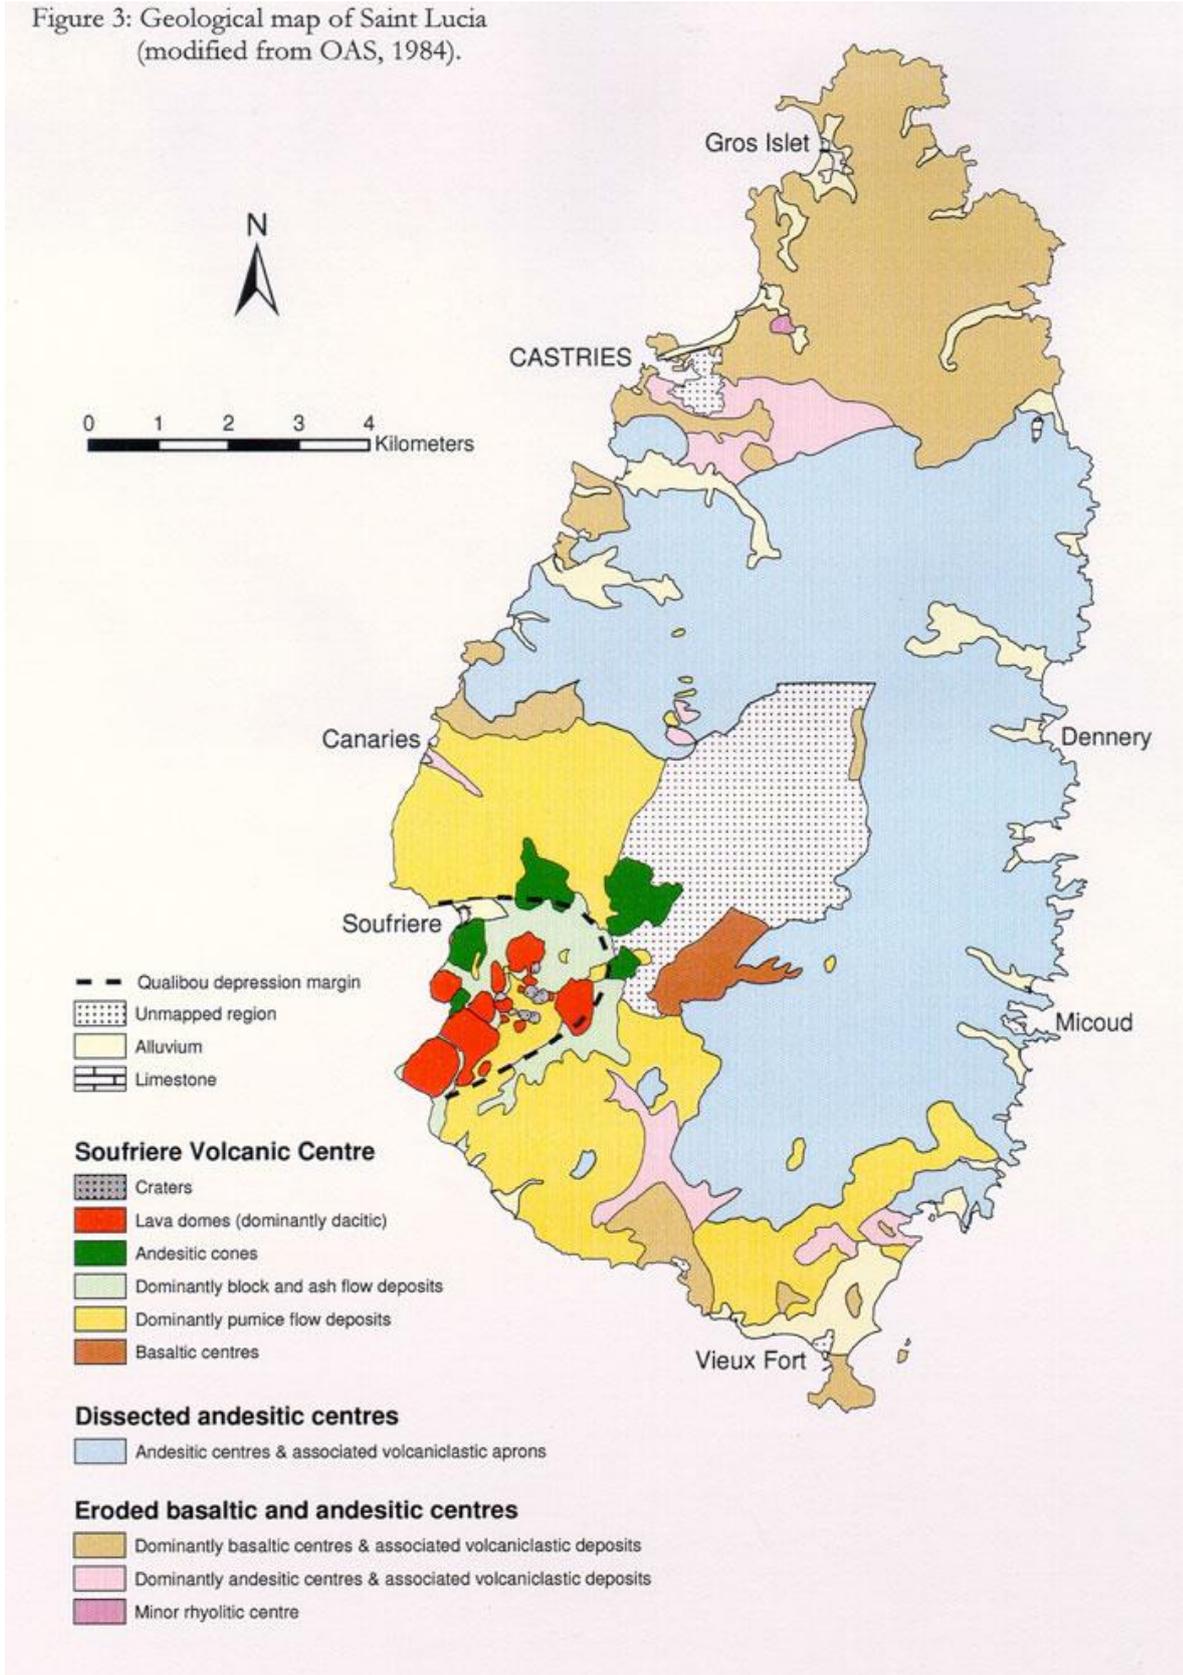
Figure 3.6. Geological map of Saint Lucia

Figure 3.6 below shows the geological map of Saint Lucia.

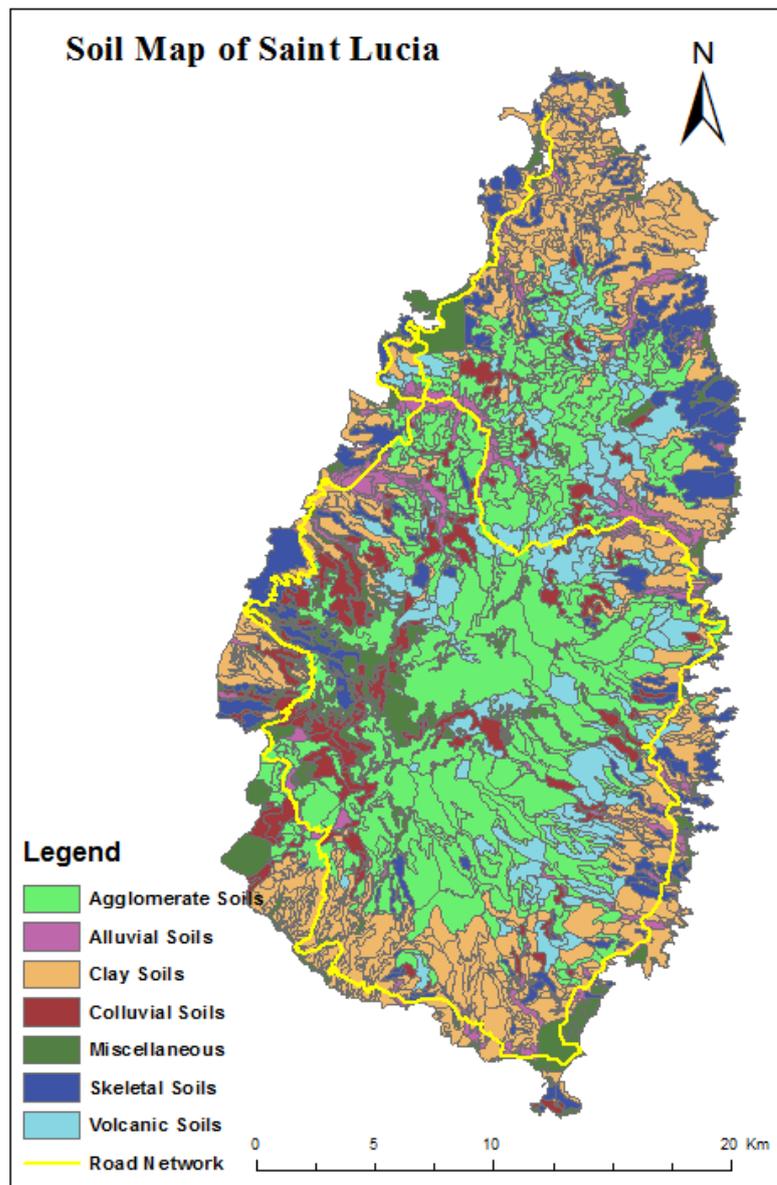
Figure 3.7. Soil map of Saint Lucia

The mineralogy of and weathering characteristics of the volcanic bedrock generally produces fine grained soils often containing high proportions of clay. Due to the widely varying rainfall pattern on the island, the parent materials are subject to different amount of leaching. This together with steep topography of the island and dacitic ash showers, contribute to the differentiation of the soil types. In areas with heavy rainfall and little or no dry season, the soils are of latosols or latosolic. The clay of these soils is usually kaolinitic but in special conditions allophane and illite may also exist. In areas with several months of dry season, the soils are of expanding clays of the montmorillonitic type (OAS, 1986). Under the unified soil classification used by engineers and geologists, the soils of Saint Lucia would be fine grained soils such as silty clays, clayey silts, silty clays-inorganic and sandy clays, or inorganic clays of medium plasticity (DeGraff, 1985). In the available soil map of Saint Lucia the classification is made based on parent material and the classes are: agglomerate soils, alluvial soils, clay soils, colluvial soils, miscellaneous soils and volcanic soils. The soil map of Saint Lucia is shown in the figure 3.7 below.

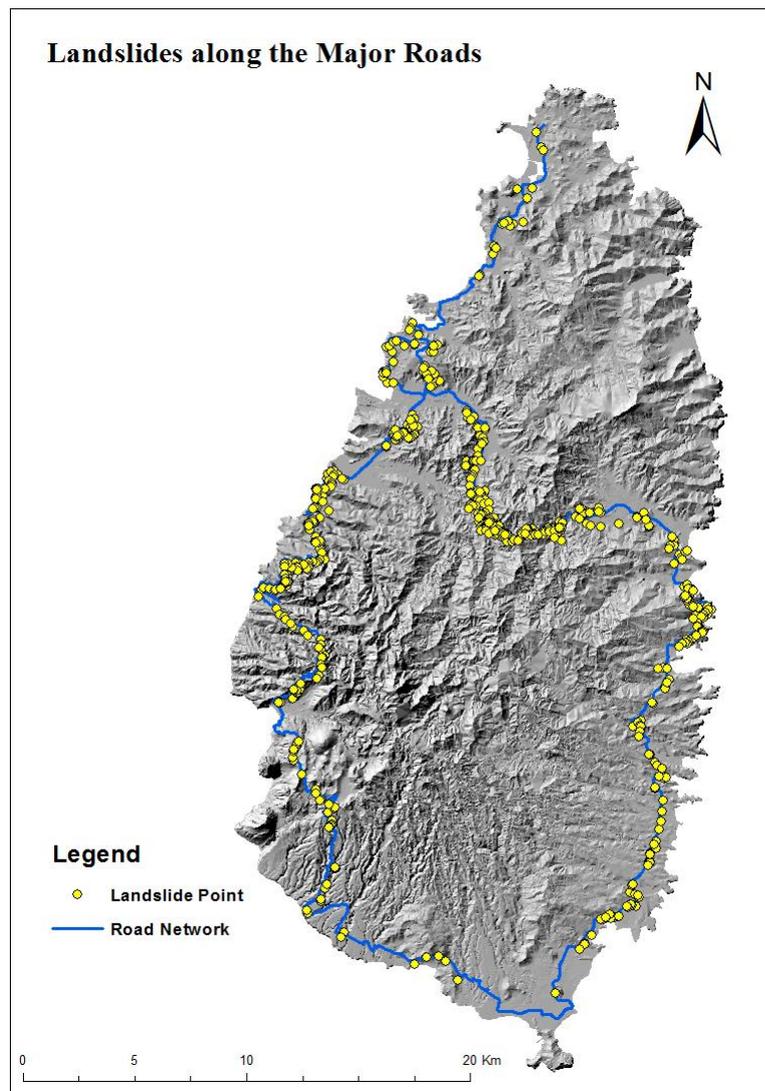
Figure 3.8. Landslides along the Major roads of Saint Lucia. Source: (Mott MacDonald, 2013)

Owing to the country's mountainous topography, volcanic geological formation and heavy rainfall St. Lucia is affected by frequent flooding and landslides. Like Dominica, Saint Lucia exhibits the highest precipitation of the year from May to December, as a result most of the disaster events occurred in the past are concentrated in this period. Just in the last five years the country was hit by two big disaster events, Hurricane Tomas and the 2013 Christmas eve trough. The Christmas eve trough in 2013, occurred on December 24/2013. This disaster event caused the death of 6 persons and displaced 550. A total of 99.88 million us dollar damage was reported from different sectors of the country due to the disaster. 72% of this damage was sustained by transportation infrastructure sector (GSL & WB, 2014). Figure 3.8 shows the landslide inventory map along the major roads of Saint Lucia, which was prepared by Mott MacDonald (2013). The inventory mainly contain landslides occurred during hurricane Allen (August, 1980) and hurricane Tomas (October, 2010). The Disaster events of Saint Lucia since 1870's are provided in Appendix II.

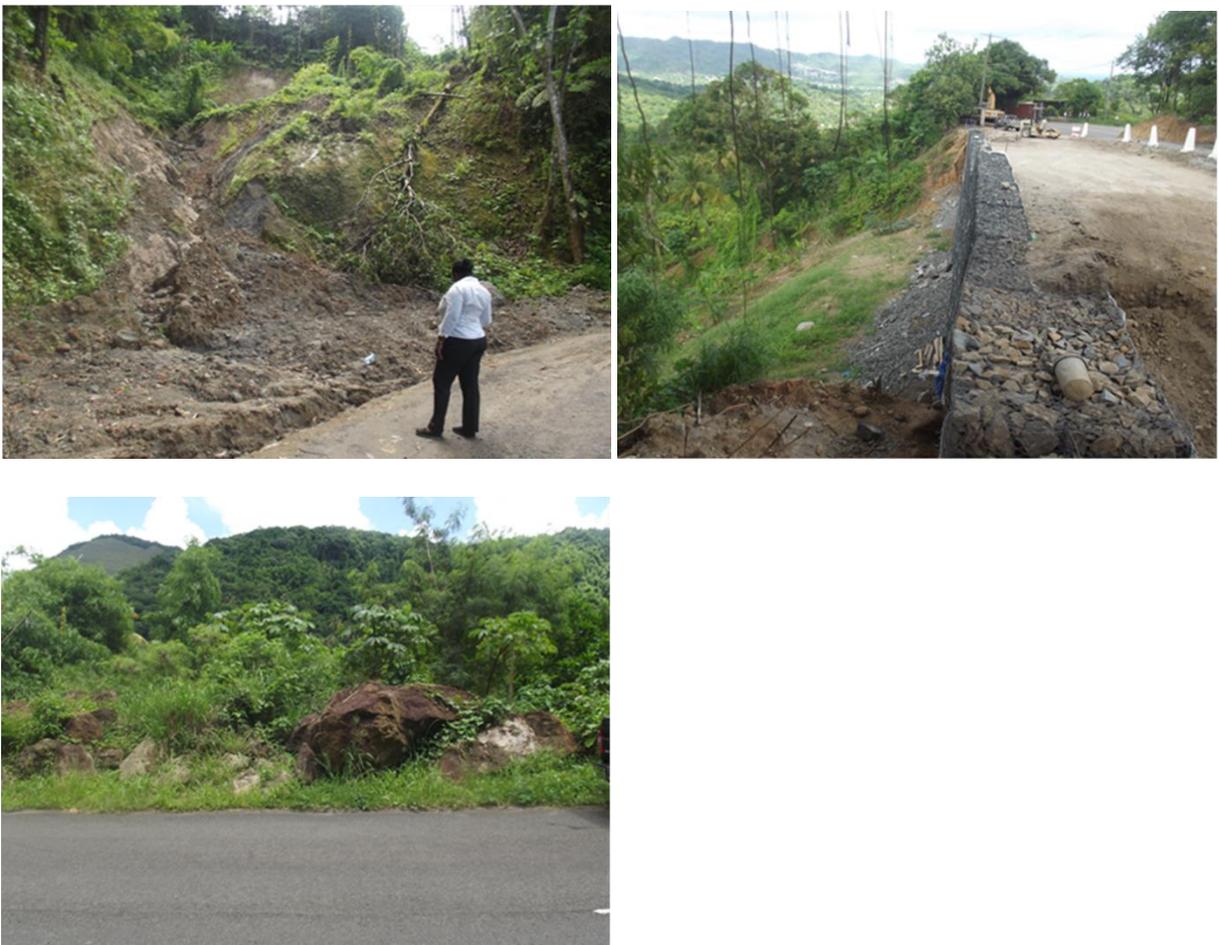
Figure 3.9. Pictures showing landslides along the major roads of Saint Lucia, Hurricane Tomas

During fieldwork, some of the road sections affected by hurricane Tomas was visited. Road sections around Canneries, Soufriere and Dennery regions were mostly affected by this event. The extent of the landslides and their effect was still visible. For instance, four embankment failures were occurred in Dennery region that washed away almost half lane of the road in each failure spots. The failures occurred with 500 meter intervals on average and now the road is being reconstructed (figure 3.8. top right). In addition, the rock falls occurred in Soufriere region during this event were quite considerable. The falling rocks were on average 1 to 1.5 m³ in size. Even though, there was no property damage, the road was closed for some time until it was cleared of the rocks. Figure 3.8 bottom left, shows some of the cleared rocks along this section of the road. The landslides occurred in Canneries were relatively fewer, but they were big in size. This road section was also closed for some time due to this slides. Figure 3.9 top left shows one of the big slides occurred in this region, this slide was also reactivated during the charismas eve event (2013).

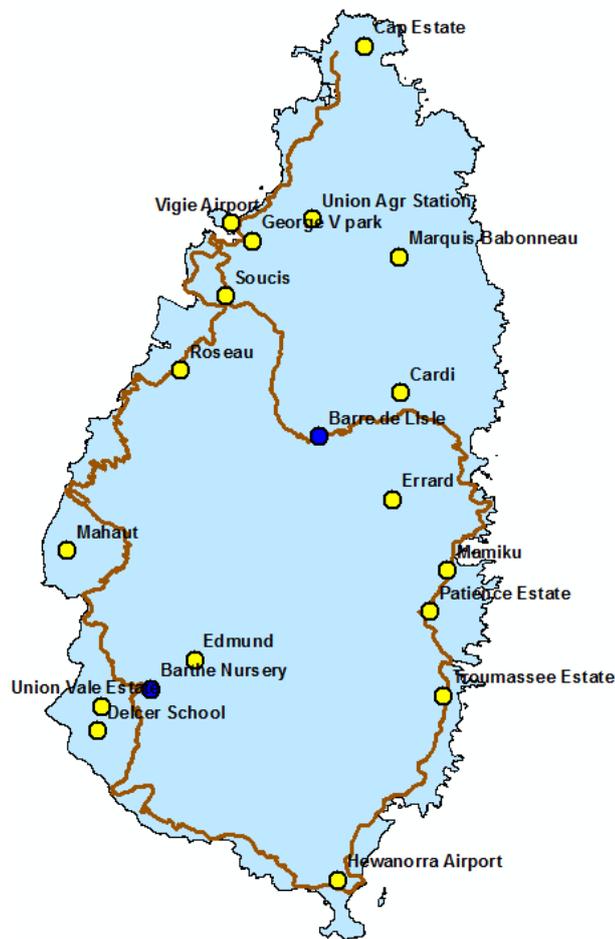
Figure 4.1. Rainfall Stations of Saint Lucia. The stations with blue dots are used for the analysis.

Rainfall records from 19 stations were obtained for Saint Lucia. All the stations have records on daily and hourly basis. Since the daily rainfall data contain longer period records than the hourly, the hourly records were not taken into consideration. The daily rainfall records are available for a period ranging from 26 to 51 years on different stations. For the purpose of this study, the stations with the longest record period (51 years) were considered. Nine stations have 51 years record (1955 - 2005), these stations are: Barre De L'Isle, Barthe, George V. park, Mahaut, Mamiku, Patience, Soucis, Troumasse and Union Agr satation. Nevertheless, all of these stations have missing data in the middle, five of them even 25 % and more missing data. For instance, Mahaut station has 9512 missing data i.e. more than 50 % of the expected 18628 records for 51 years. It was, therefore; decided to consider only stations with fewer missing data for the analysis. The stations with fewer missing data are: Union, Barre De L'Isle, Barthe and Union. Out of these stations, Barthe and Barre De L'Isle were chosen for the final analysis, considering there spatial representation. Barthe is located in the south west of the island and it is in proximity to Soufriere region, road section affected by frequent landslide occurrences. Barre De L'Isle is located in the middle of the island, which is also in proximity to the other landslide susceptible road section i.e. Barre De L'Isle section of the east coast road. Figure 4.1 below shows the geographical location of the stations on the island.

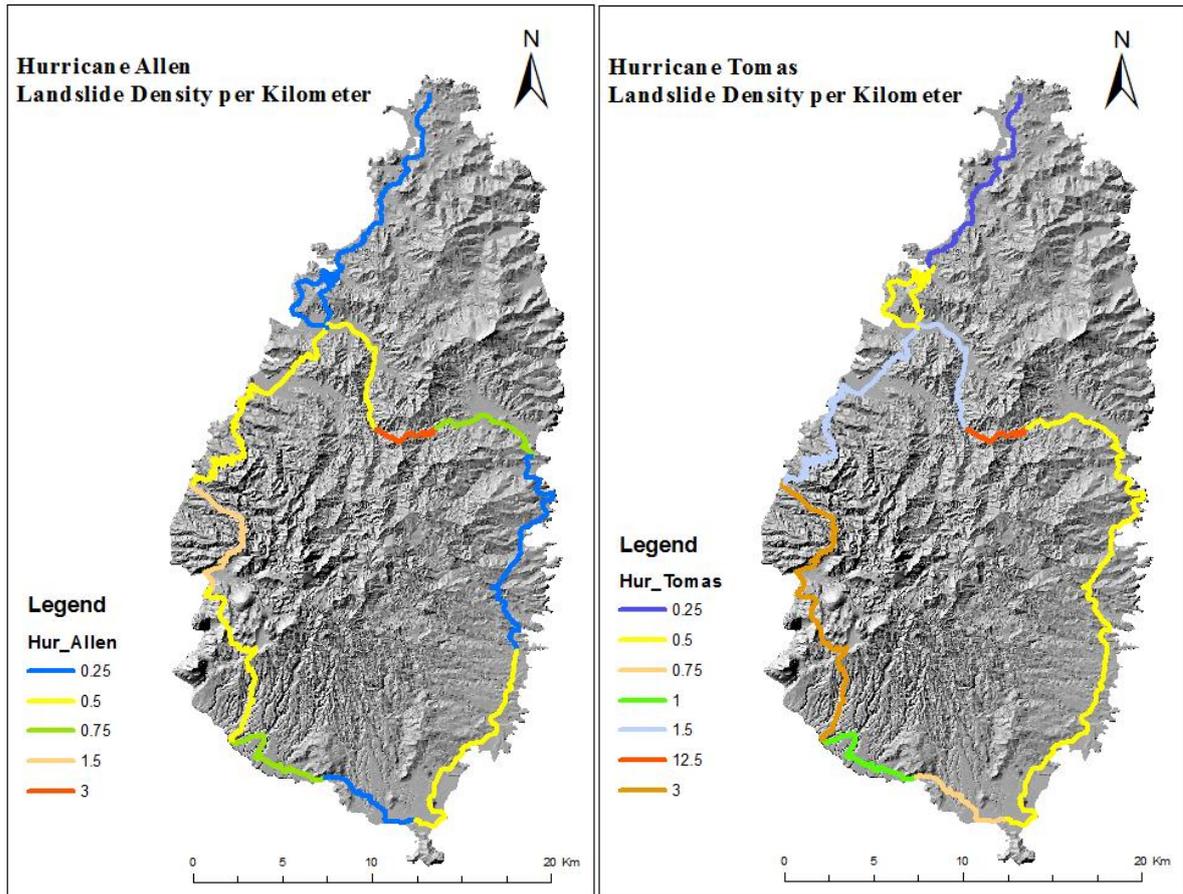
Figure 4.2. Mott MacDonald (2013) Landslide density per kilometre road. Post hurricane Allen (left) and post hurricane Tomas (right).

To assess the landslide hazard they used density analysis taking two storm events namely hurricane Allen and Tomas that occurred August 3, 1980 and October 31, 2010 respectively. The landslide inventories they used for these storm events were the works of Degraff after hurricane Allen (1980) and Rogers after Tomas (2010). During their analysis stage, they selected the landslides which they considered that directly affect the primary roads and made a different landslide datasets for both events. Then they totalled the number of landslide occurrences along a defined road section for each of the datasets and calculated a density per km of road section as shown in the figure 4.2 below. Road sections were defined based on the land morphology and locations of main towns. They supported the landslide inventories by field visit and verifying the landslide location and characteristics.

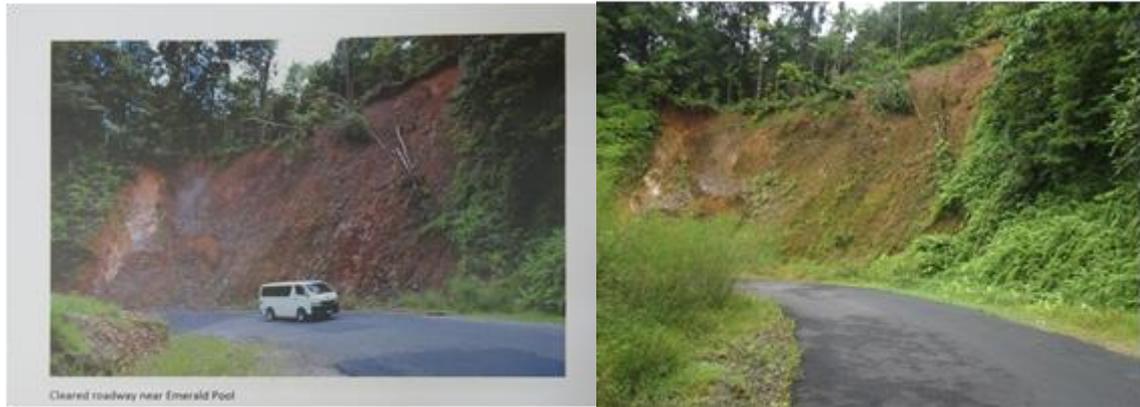
Figure 4.4 Relating the Landslide pictures, left from the report and right taken during field work. Which are very similar and easy to relate.

The reports from April 2013 and September 2011 have accompanying pictures of the landslides at the time of their occurrence. An attempt was made to relate these pictures with the pictures taken during fieldwork and locate them by their GPS point. Some of them were easy to relate because their scars were still visible during the fieldwork (figure 4.4). But for the others, which were vegetated during the field work period, personal judgment had to be taken in looking for some signatures to relate the pictures as shown in figure 4.5.

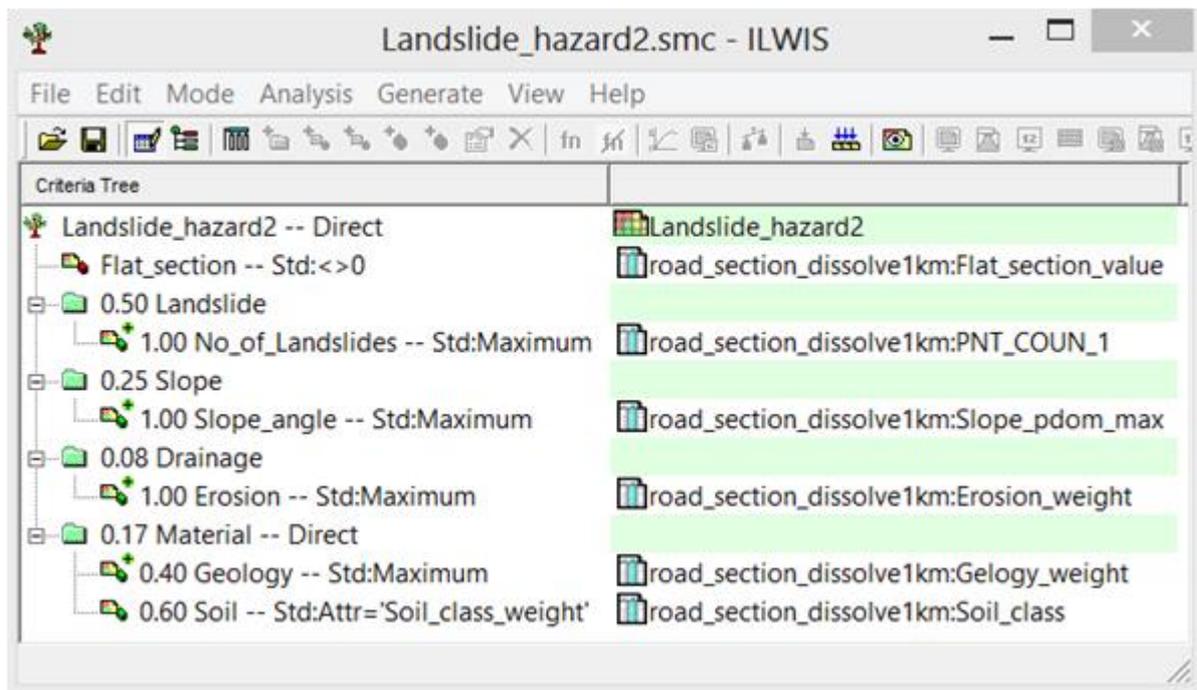
Figure 4.6. Spatial multi criteria tree for Saint Lucia

Other than the spatial factors mentioned above, flat section attribute was used as spatial constraint. This spatial constraint discard the flat section from the analysis by giving a value 0 in the final output. The weighing of the spatial factors was given using direct method. The highest weight is given to the landslide factor (0.5), followed by slope factor which is 0.25. Geology and soil together as material, are given 0.17 weight. Out of this, 60% of the weight is for soil and 40% is for geology. Finally the remaining 0.08 weight was given to erosion. Figure 4.6 below shows the SMCE criteria tree of Saint Lucia.

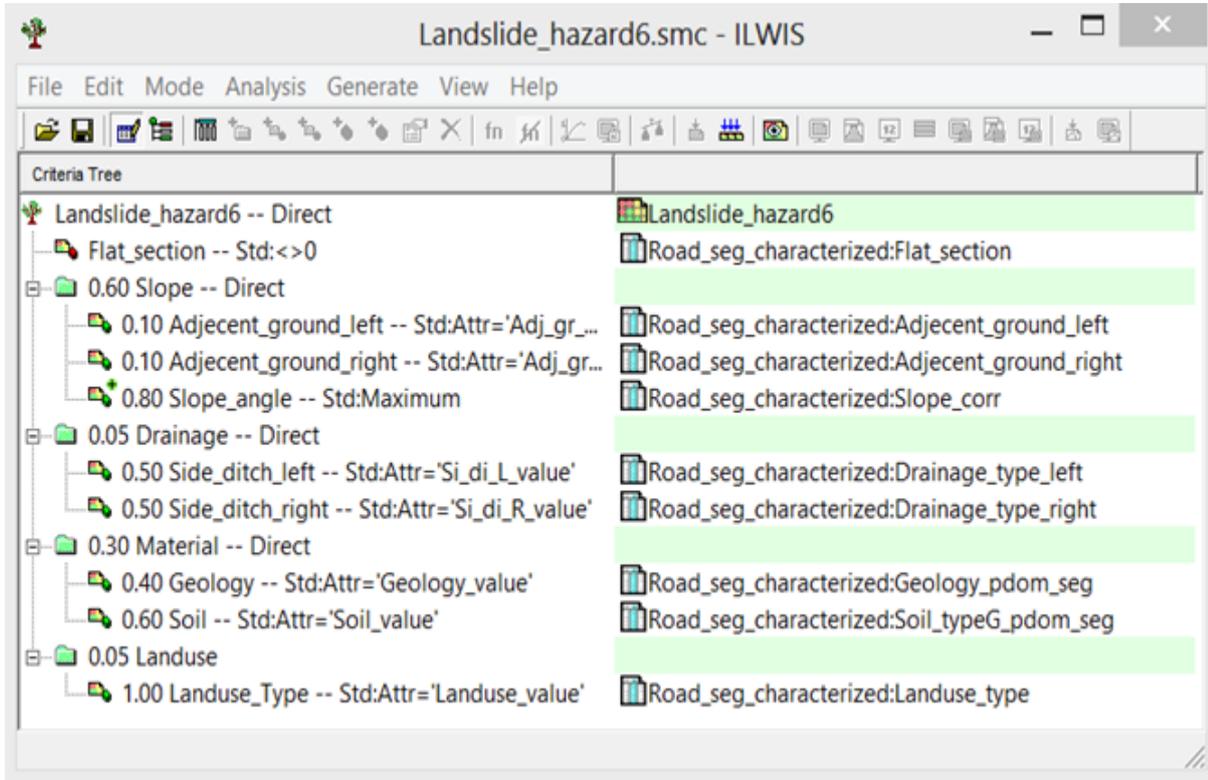
Figure 4.7. Spatial multi criteria tree for Dominica

Here also one attribute was used as constraint to exclude the flat sections from the analysis. In weighing of the spatial factors, which was done by direct method, the highest weight was given for slope which is 0.6. Material was given the next higher weight of 0.3. Drainage and land use took equal weight of 0.05. Figure 4.7 below shows the SMCE criteria tree of Dominica.

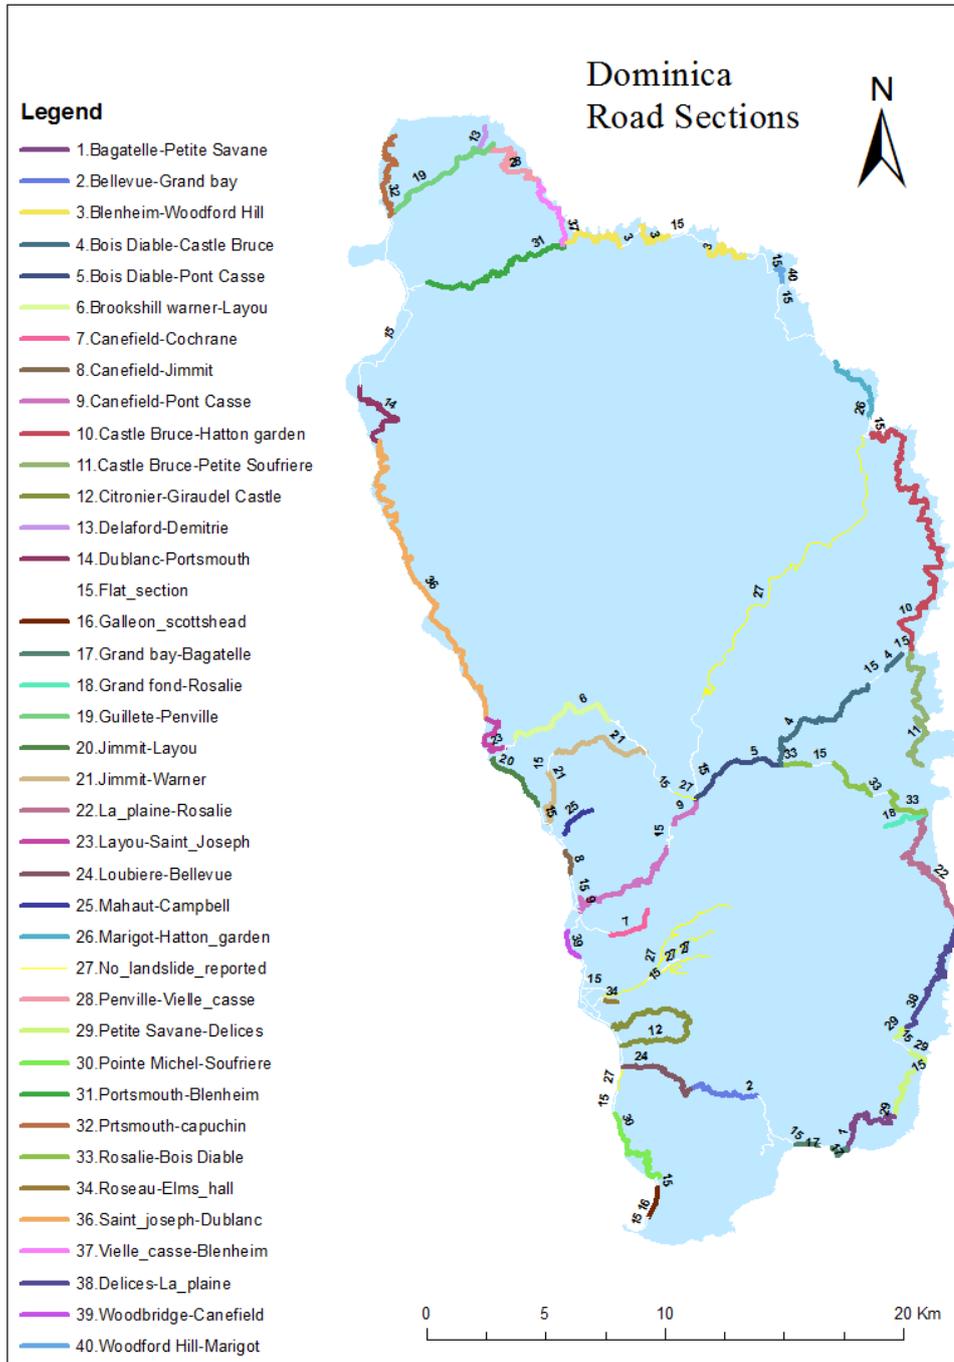
Figure 5.1. Map of the road sections of the major road network of Dominica

4.1.2. Here, landslide density analysis results of Dominica are presented. The analysis is made for five storm events: September 2009, October 2010, September 2011, November 2011 and April 2013. And the number of landslides reported on these events were 27, 20, 84, 74 and 44 respectively. The maps of these five events showing the number of landslides occurred in different major road sections of Dominica are provided in appendix A.3. In each of the events, the number of landslide occurrences reported in different road sections of Dominica were quite different, so are the results obtained from the landslide density analysis. The results are presented below (figure 5.1 and table 5.7) by providing the road sections map accompanied by table showing the landslide density in each of the road sections on the respective storm events.

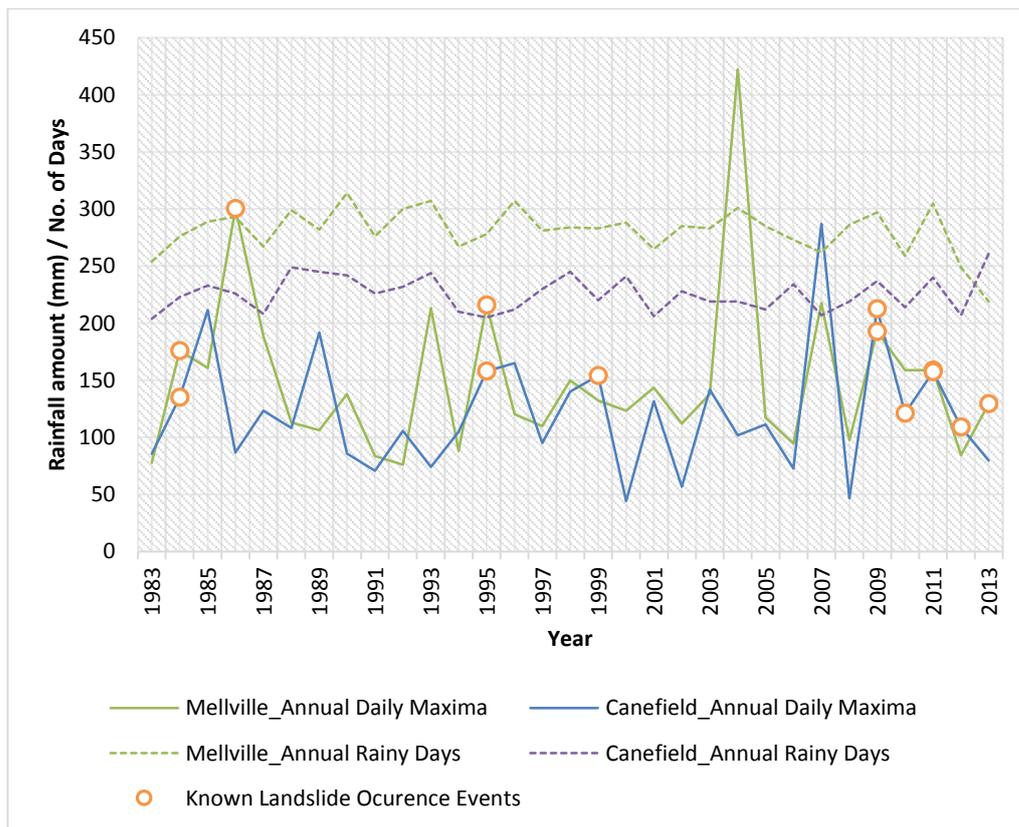
Figure 5.2. Annual daily maxima rainfall amount and annual rainy days for two rainfall stations of Dominica

The two rainfall stations of Dominica, Melville and Cane field, are analyzed separately. For Melville 40 years and for Cane field 32 years period rainfall records are considered. From the records it is observed that, Melville station encounter more rainfall than Cane field station both in rainfall amount and number of rainy days. Figure 5.2 shows the annual daily maximum rainfall and annual rainy days of each recording period in the two stations. The known landslide occurrence events are also indicated in the map. As can be seen from the figure, in all recording periods the annual rainy days are greater at Melville Station. In addition, with the exception of some years, the annual daily maximum rainfall amounts at Melville are more intense. Within the recording periods, Melville station has registered on average 157.1mm annual daily maxima rainfall amount, the maximum being 422.3mm. Whereas, at Cane field station these values become 120.2mm and 287.3mm respectively.

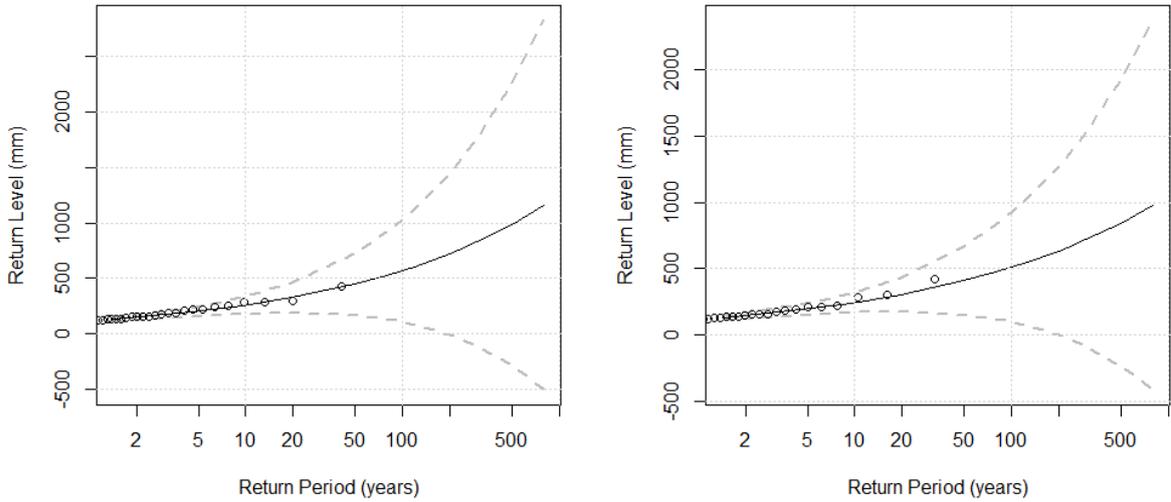
Figure 5.3. Rainfall return periods of the two stations of Dominica modeled using GEV distribution method. Mellville (left) and Cane field (right)

To calculate the rainfall return period, the annual daily maxima values from each recording period were taken, which resulted with 40 records for Melville station and 32 records for Cane field station. These records were tested to fit into Generalized Extreme Value (GEV) distribution model and Gumbel distribution model. The fitted models showed that GEV distribution model is a better fit for both stations. The GEV model has 5.11 and 4.17 likelihood ratio over the Gumbel model for Melville and Cane field stations respectively. Besides, three and more records fall out of the 95% confidence limit in the case of Gumbel model; while, the GEV model contained all the records. Figure 5.3 show the GEV fitted models of the two stations.

Accordingly, the rainfall amount for different return periods were computed using the GEV distribution model. Table 5.8 below shows the estimated rainfall amounts together with the 95% lower and upper confidence limit. Up to 20 years return period, the results obtained are somewhat similar. However, in return period 50 years and above the Melville estimation shows higher amounts than Cane field. The reason for this is that, the annual daily maxima values of Melville are relatively greater than Cane field. Moreover, Melville has 40 records which means that more extreme values to be considered. Generally, return period calculations give a good estimation for a period two times the rainfall recording period. Therefore, the results obtained here are as good up to 50 years return period. After that, the upper and lower confidence limits get considerably wide range. For instance, the 95% lower confidence limit of the 200 year return period even goes to negative value for Melville station.

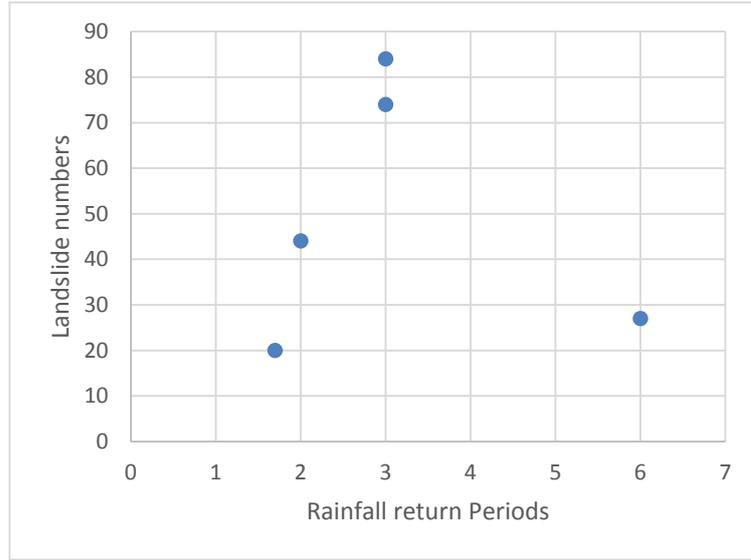
Figure 5.4. The number of landslides versus the return period of the five storm events, Dominica

The results obtained revealed that, almost all of the landslide events are relatively of short return periods. The longest return period found was from tropical storm Erica, which is 5 to 7 years considering both stations estimation. Hurricane Tomas, on the other hand, is the shortest with return period less than 2 years, but still the rainfall amount falls within the 95% lower confidence limit of the 2 years return period. The results also revealed that the number of landslides reported in each events are comparative with their rainfall return periods except for tropical storm Erica. Figure 5.4 below shows the landslides number versus the return period plot. Although, tropical storm Erica has the highest rainfall amount of all the five events, the reported landslides were relatively few (only 28 landslides). In contrast, on the 3 years return period events, hurricane Ophelia and November 2011, 84 and 74 landslides are reported respectively. The reason for this could probably be a problem of reporting, for some events all landslides are reported properly and for others only major slides are given emphasis. Unfortunately, there are no indications in the reports to confirm this assumption.
