NATIONAL SCALE LANDSLIDE HAZARD ASSESSMENT ALONG THE ROAD CORRIDORS OF DOMINICA AND SAINT LUCIA

Enschede, The Netherlands, March, 2015

Thesis submitted to the Faculty of Geo-Information Science and Earth Observation of the University of Twente in partial fulfilment of the requirements for the degree of Master of Science in Geo-information Science and Earth Observation.

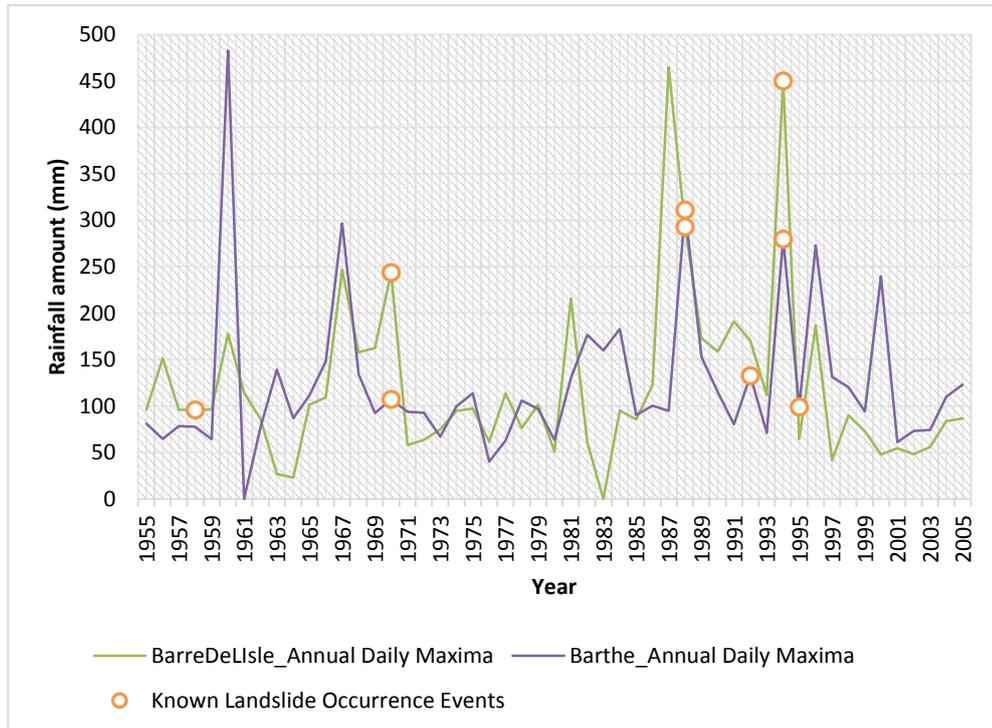
Figure 5.5. Annual daily maxima rainfall amount for two rainfall stations of Saint Lucia

As Explained in section 4.1.1, only two stations Barre De L'Isle and Barthe were considered in Saint Lucia for the analysis. The analysis was made taking the annual daily maxima for each record period, which resulted to 51 records for each station. Figure 5.5 shows the annual daily maximum rainfall of each recording period in the two stations together with the known landslide occurrence events. The records show that the rainfall in both Barre De L'Isle and Barthe stations are almost similar, with maximum annual daily maxima of 464.8 mm and 482.6mm and average annual daily maxima of 121.7 mm and 124.7 mm respectively.

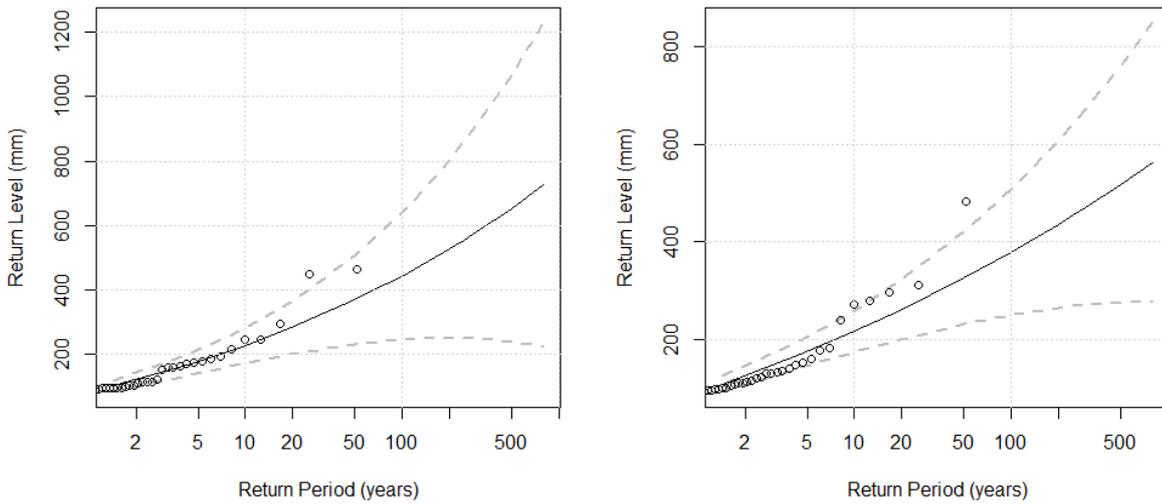
Figure 5.6. Rainfall return periods of the two stations of Saint Lucia modeled using GEV distribution method. BarreDeLIsle (left) and Barthe (right)

To analyze the frequency magnitude distribution of the records, generalized extreme value distribution (GEV) and Gumbel distribution models were tested. It was found that the GEV model gives a better fit than the Gumbel model. The GEV model has a 4.1989 likelihood ratio for Barre De L'Isle and 2.5367 likelihood ratio for Barthe over the Gumbel model. In addition, the Gumbel distribution shows four and more fitted values falling out of the 95 % confidence limit for both stations. On the other hand, the GEV model has only one fitted value for Barre De L'Isle and two for Barthe that fall out of the 95 % confidence limit. The fitted plot of the two stations using the GEV model are shown in figure 5.6 below.

Accordingly, the GEV model was used to calculate the rainfall amount for different return periods of the two stations. Table 5.10 shows the estimated rainfall amount of the return periods with 95% lower and upper confidence limit.

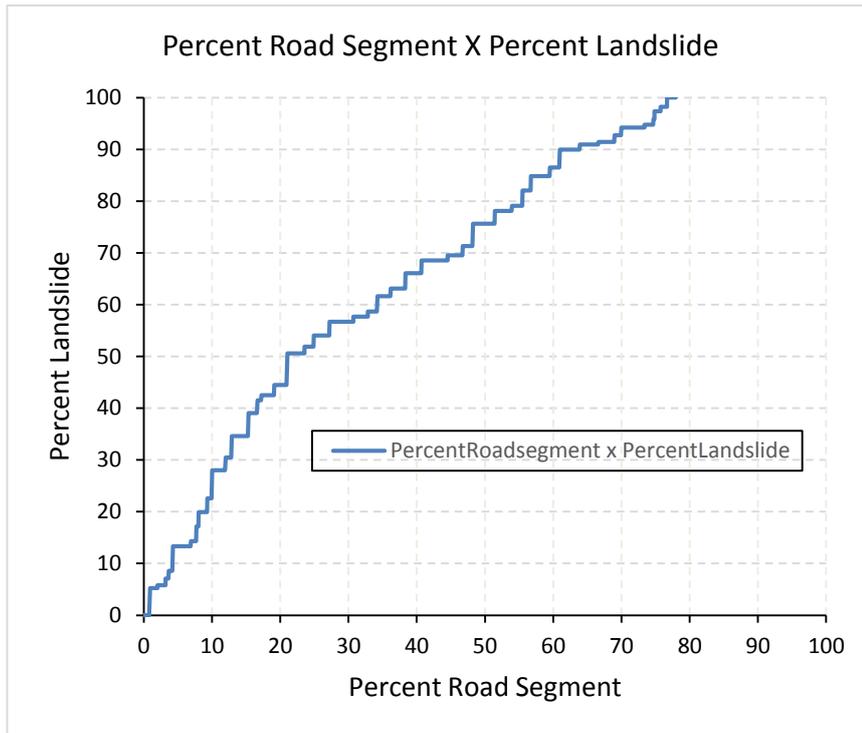
Figure 5.7. Prediction rate of the susceptibility analysis of Dominica

Figure 5.7 shows the prediction rate graph of the susceptibility analysis of Dominica. As the graph shows, about 60% of the landslides are located in 30% of the road segments with high susceptibility scores. Considering the quality and quantity of the data used for the analysis, it is believed that the prediction rate is satisfactory. Figure 5.8 shows the success rate graph of the susceptibility analysis of Saint Lucia. The graph shows that around 80% of the landslides are located in 30% of the road segments with high susceptibility scores.

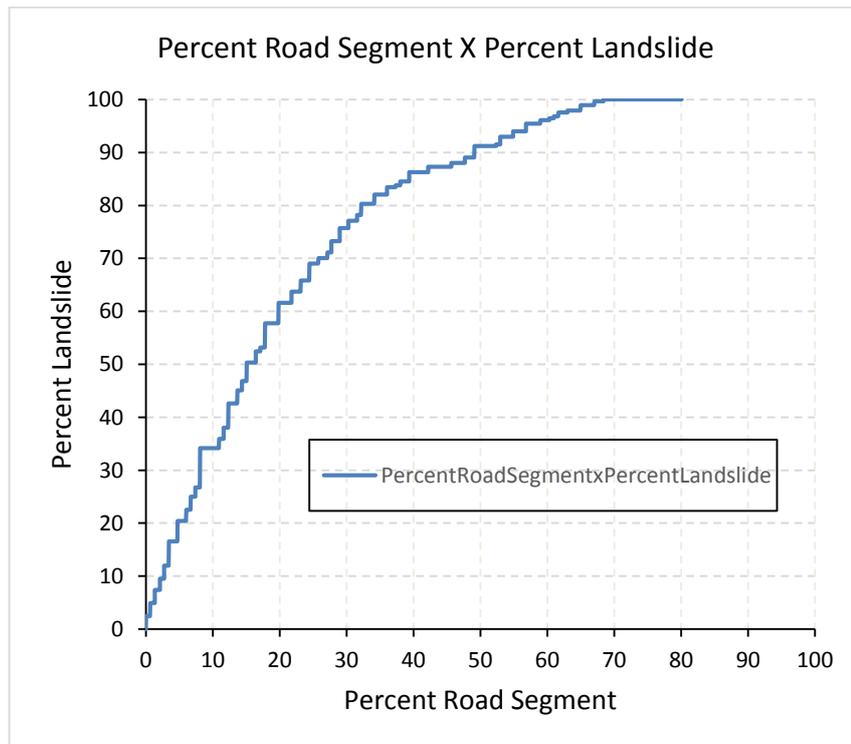
Figure 5.8. Success rate of the susceptibility analysis of Saint Lucia

Based on the prediction rate result for Dominica and success rate result for Saint Lucia, the susceptibility maps were then classified into three classes of susceptibility level i.e. high, moderate and low. The boundaries of these classes are determined by considering the percentage of the landslides. For Dominica, it was assumed that 60% of the landslides are located within high, the next 30% within moderate and the remaining 10% within low susceptibility class of the road segments. Whereas, for Saint Lucia, it was assumed that 80% of the landslides are located in the high, the next 15% in the moderate and the remaining 5% in the low susceptibility class of the road segments. The for using a different boundaries was that, in case of Saint Lucia the landslides were used as a spatial factor; therefore, the high susceptibility class should contain most of the landslides. With this classification, in both Islands, 40% of the major road segments fall in the low, 30% in the moderate and the remaining 30% in high susceptibility zones. The landslide susceptibility maps along the major roads are shown in the figure 5.9 (Dominica) and figure 5.10 (Saint Lucia). In the maps, known previous landslide locations of both Islands are also indicated with black dots.

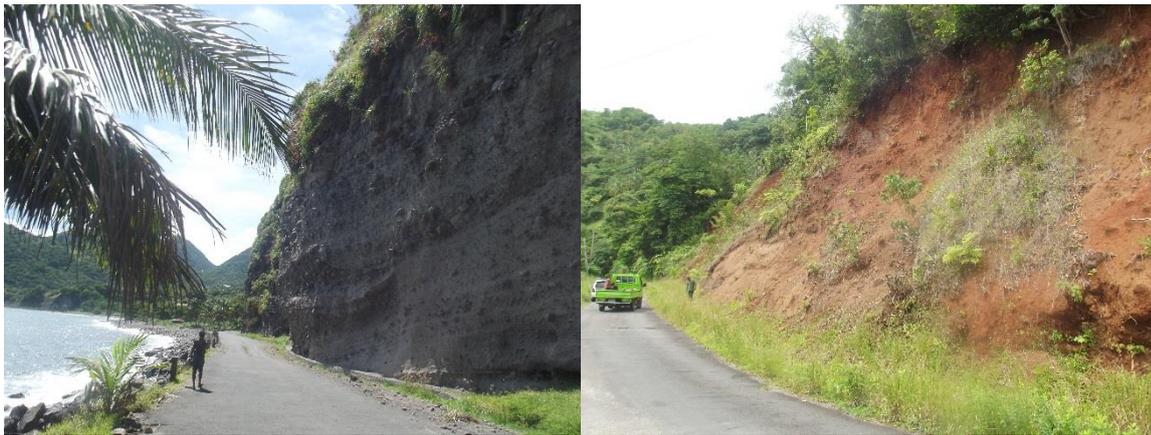
Figure 5.4.2. Road sections from Grand bay to Bagatelle (left) and from Castle Bruce to Petite Soufriere (right).

considerable high cut slope (between 45 and 60 degrees) with highly weathered clay material on most of their parts, which make them Landslide prone areas even with minor storm events (figure Below).
