# HAZARD RISK ASSESSMENT REPORT AND COSTED ACTION PLAN

## VIEUX FORT PRIMARY SCHOOL

SAINT LUCIA

Original Submission Date: January 17, 2020

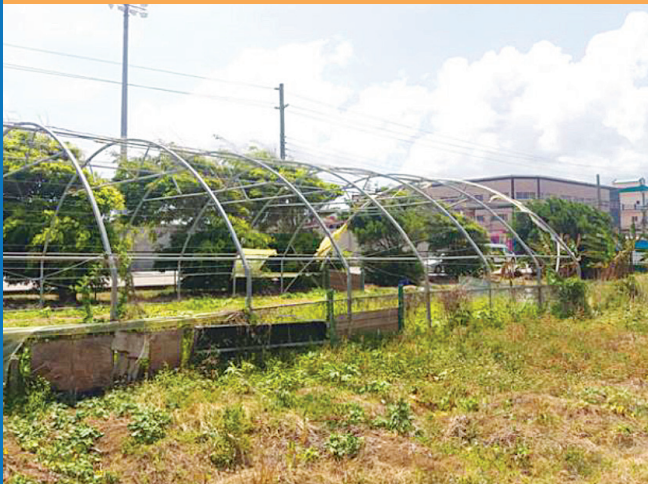
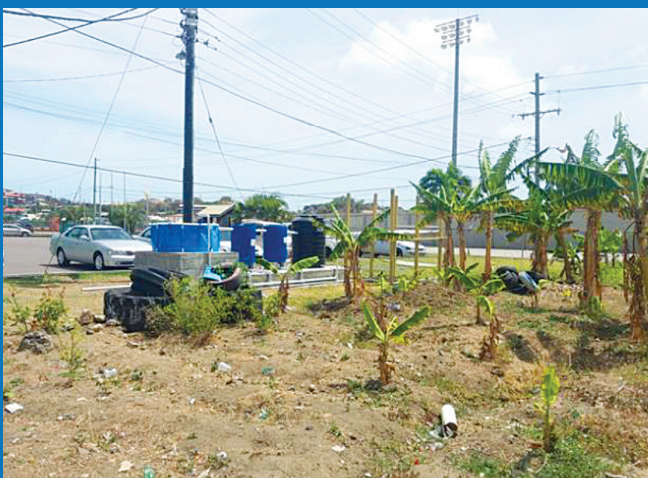
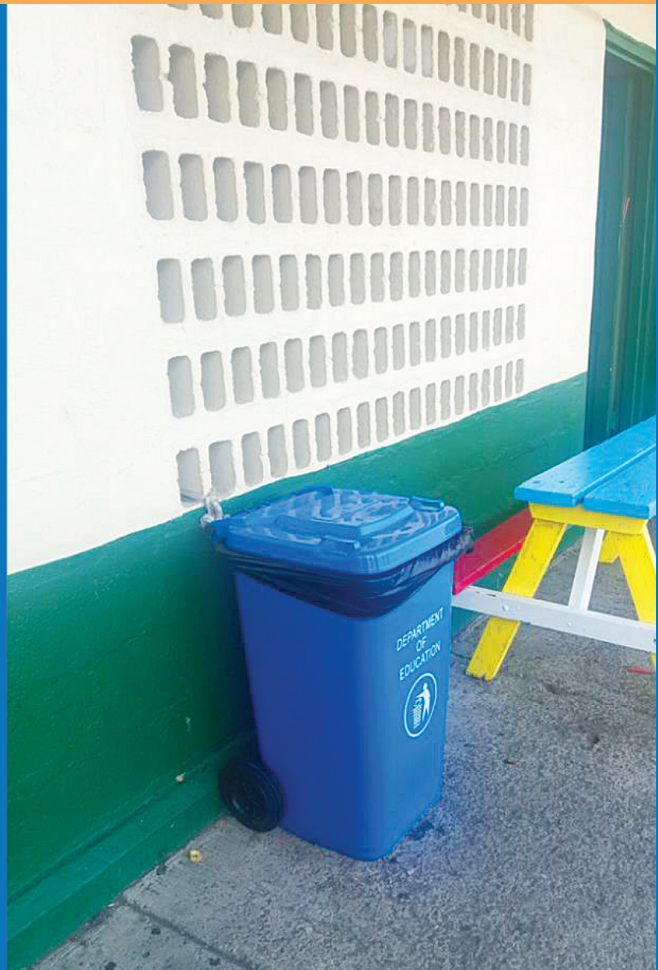
**FIGURE 7.1: EXAMPLES OF GREENING INITIATIVES AT VIEUX FORT PRIMARY (TOP: GREENHOUSE; BOTTOM: RAINWATER HARVESTING; RIGHT: RECYCLE BIN COLLECTING PLASTICS)**

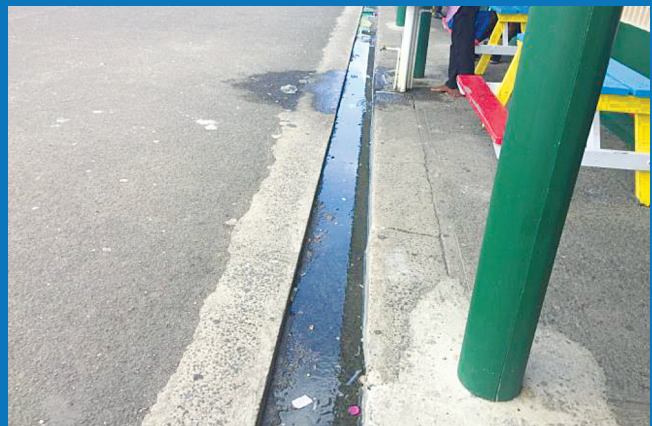
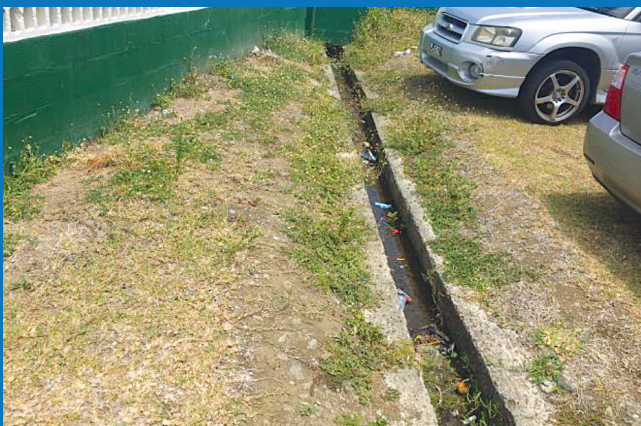
■ STORM DRAINS
