IMPLEMENTATION OF THE MODEL SAFE SCHOOL PROGRAMME IN THE CARIBBEAN

HAZARD RISK ASSESSMENT REPORT AND COSTED ACTION PLAN

CAYON HIGH SCHOOL ST. KITTS AND NEVIS

Environmental Solutions Limited

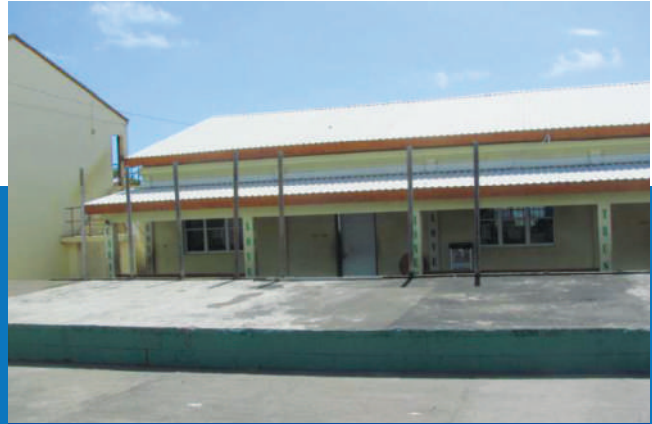
■ SINGLE STOREY ADMINISTRATIVE BUILDING

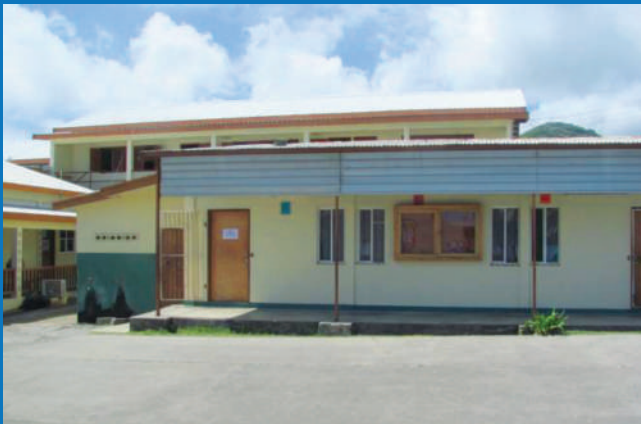
■ SINGLE STOREY ADMINISTRATIVE BUILDING

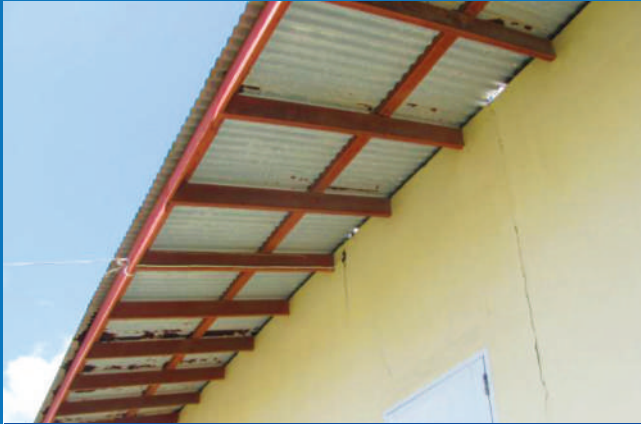
■ LIGHT WEIGHT ROOF
IN A STATE OF DESPAIR

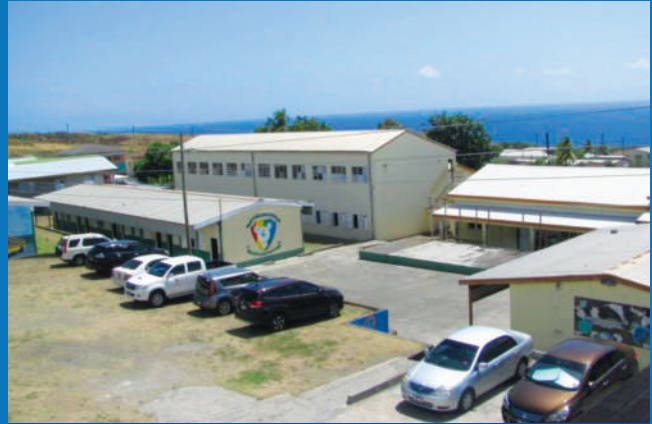
■ PANORAMIC VIEW
- SECTIONS OF COMPOUND

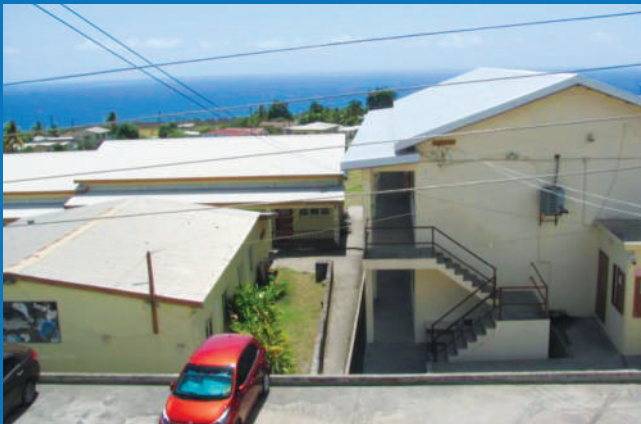
■ PANORAMIC VIEW
- SECTIONS OF COMPOUND

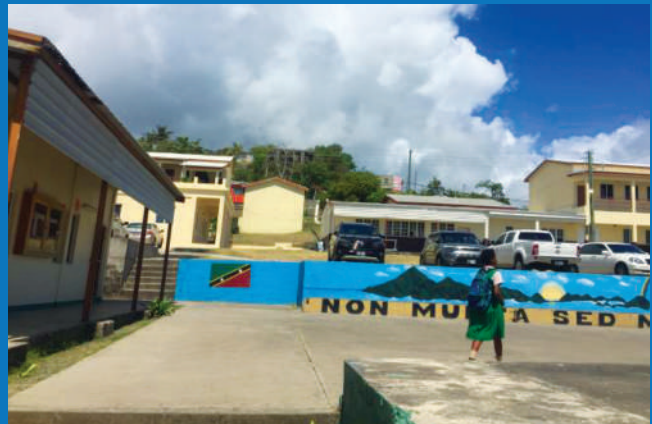
■ PANORAMIC VIEW
- SECTIONS OF COMPOUND

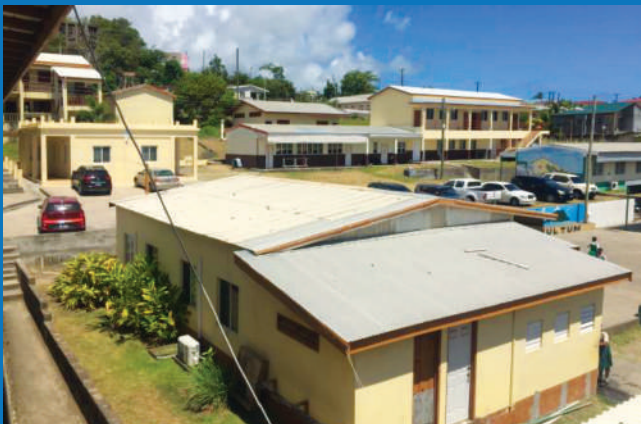
■ PANORAMIC VIEW
- SECTIONS OF COMPOUND

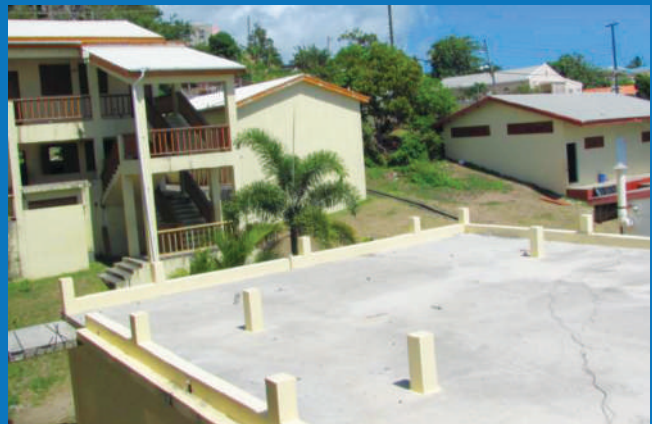
■ BUILDING WITH
CONCRETE ROOF

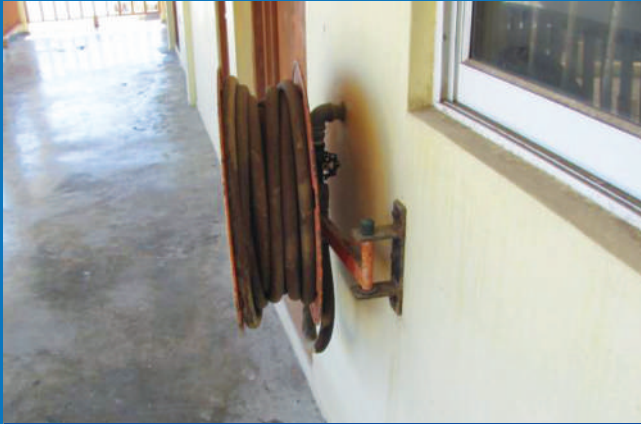
■ FIRE HOSE REEL

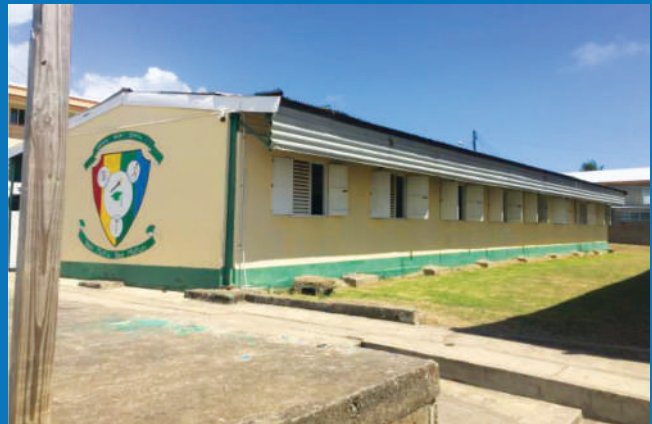
■ SINGLE STOREY CLASSROOM BLOCK

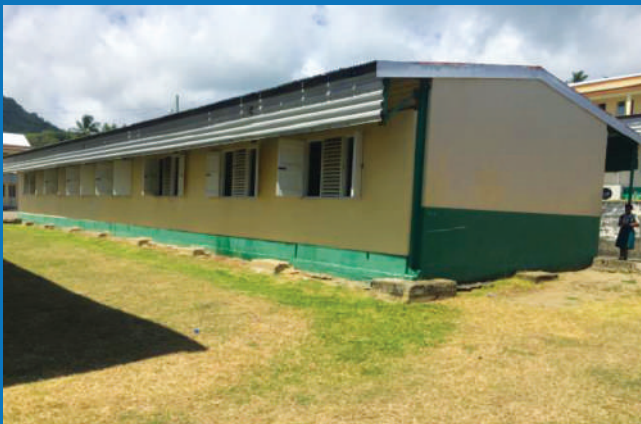
■ SINGLE STOREY CLASSROOM BLOCK

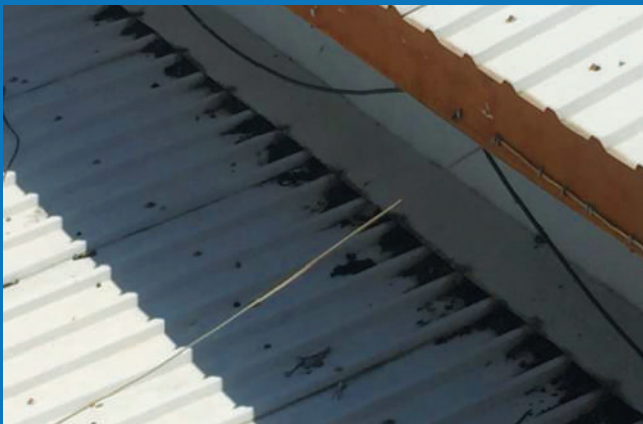
■ SIGNS OF BIRD INFESTATION
