IMPLEMENTATION OF THE MODEL SAFE SCHOOL PROGRAMME IN THE CARIBBEAN

HAZARD RISK ASSESSMENT REPORT AND COSTED ACTION PLAN

SANDY POINT PRIMARY SCHOOL

ST. KITTS AND NEVIS

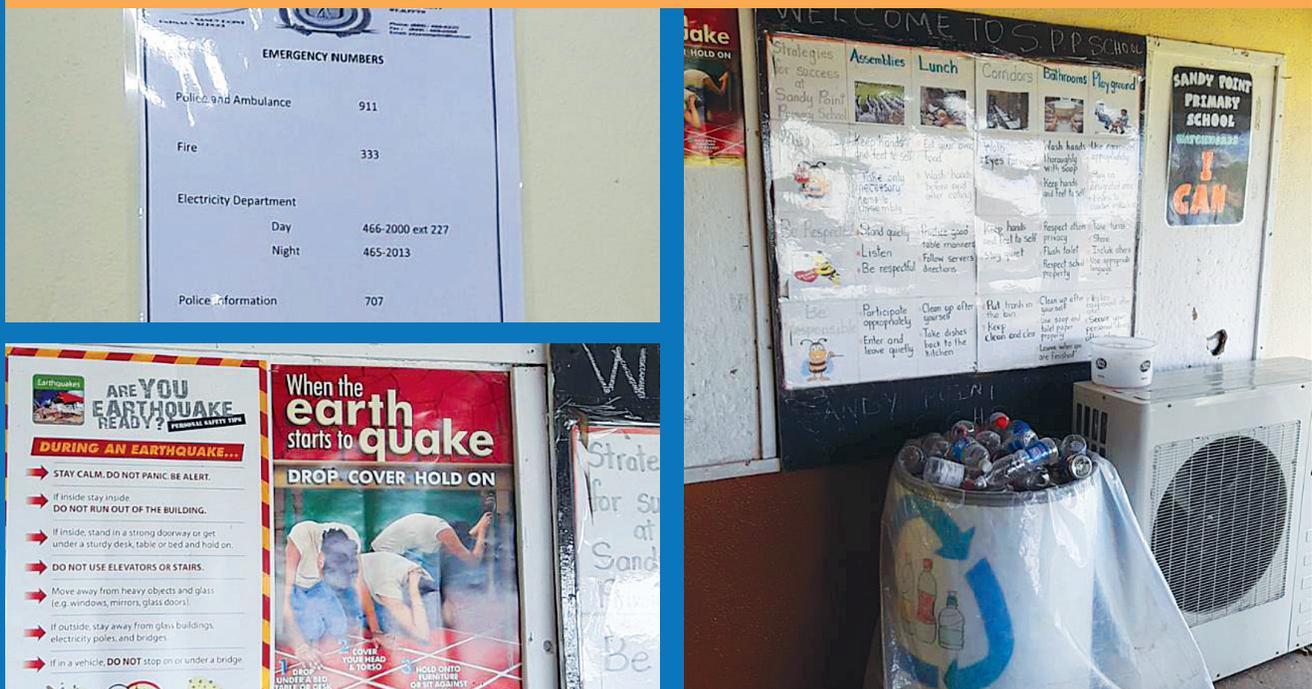
FIGURE 7.1: IMAGES HIGHLIGHTING KEY STRENGTHS AT SANDY POINT PRIMARY SCHOOL

- The school has raised funds in the past for special projects. On one occasion funds were raised to paint the entire school.

- Though some repair work has been done (did roof repairs in some classrooms, sealed some openings around some classrooms), additional repairs and retrofits are needed.
