IMPLEMENTATION OF THE MODEL SAFE SCHOOL PROGRAMME IN THE CARIBBEAN

HAZARD RISK ASSESSMENT REPORT AND COSTED ACTION PLAN

CAYON HIGH SCHOOL ST. KITTS AND NEVIS

Environmental Solutions Limited

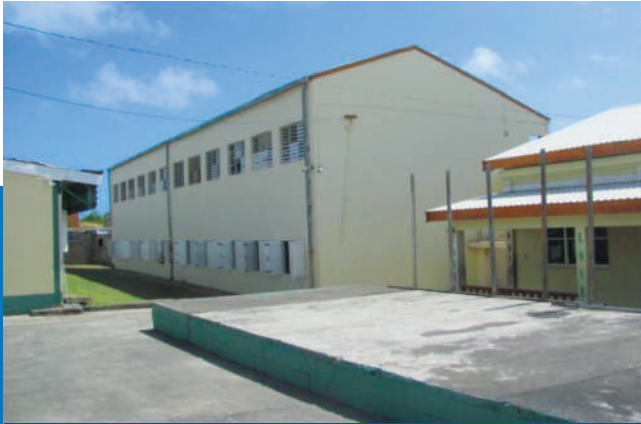
■ TWO STOREY RECTANGULAR BUILDING WITH GABLE TYPE ROOF

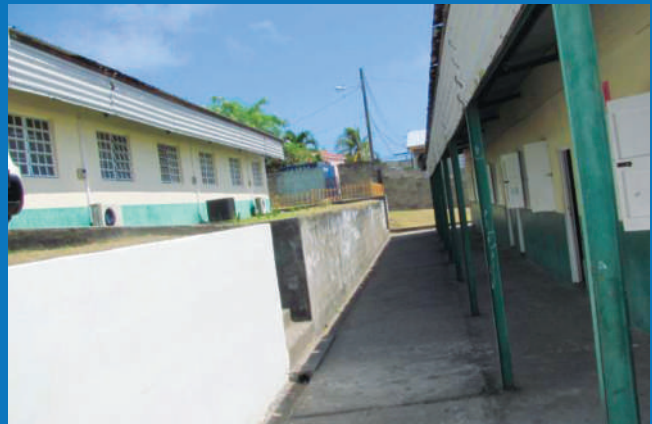
■ COVERED AND UNCOVERED CIRCULATION

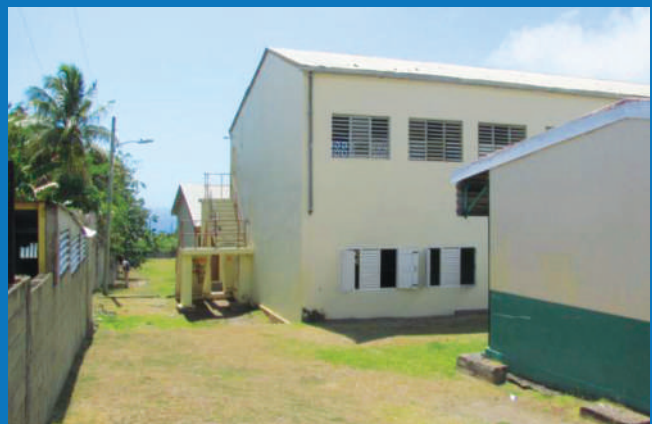
■ UNCOVERED CIRCULATION

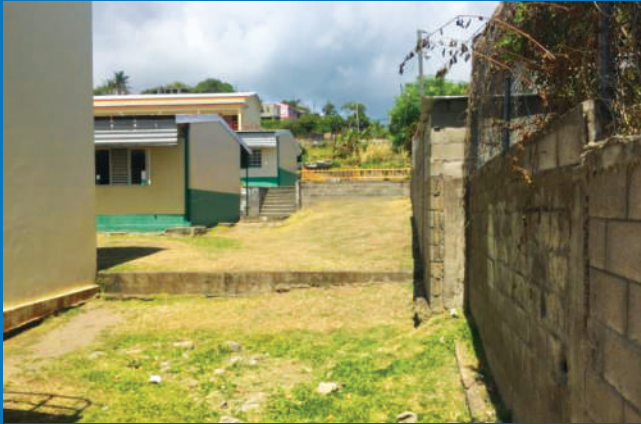
■ UNCOVERED CIRCULATION

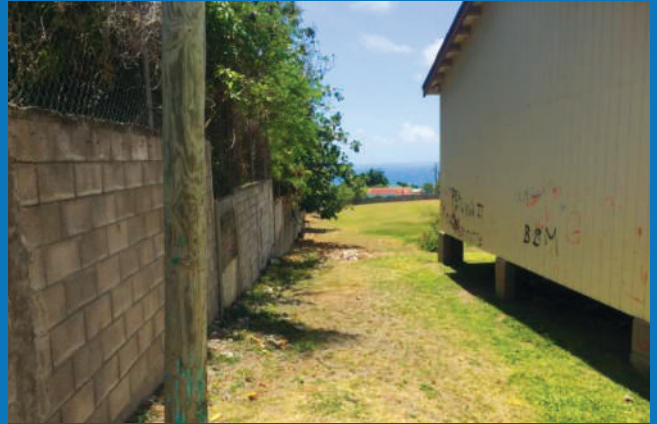
■ UNCOVERED CIRCULATION

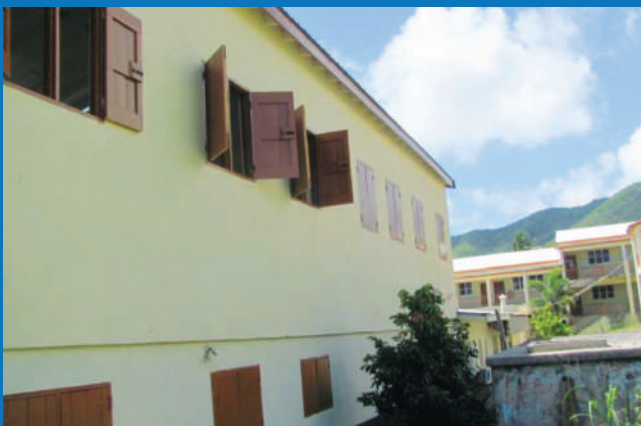
■ WOODEN WINDOWS

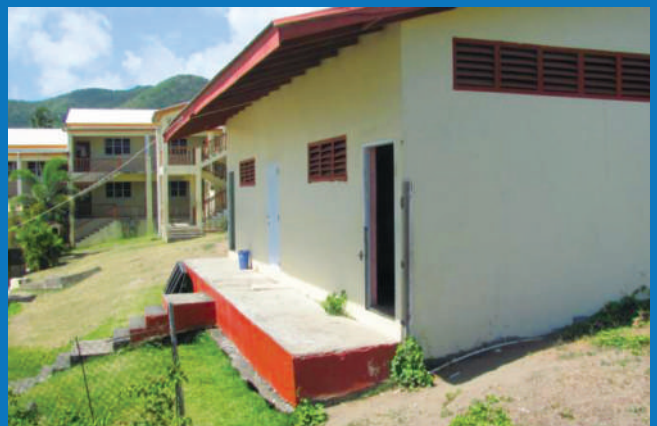
■ TOILET BLOCK

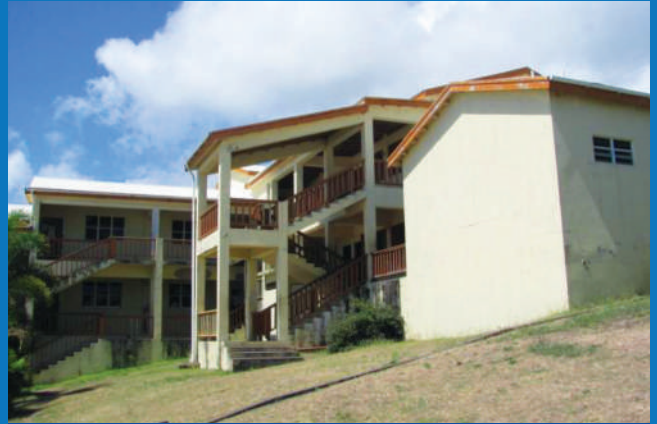
■ THE NEWER
BUILDINGS

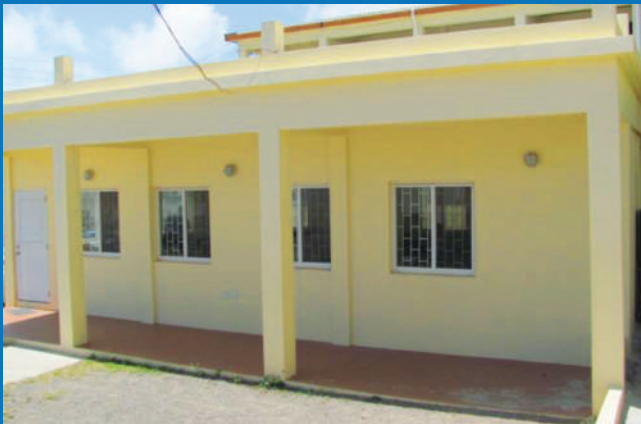
■ THE NEWER
BUILDINGS

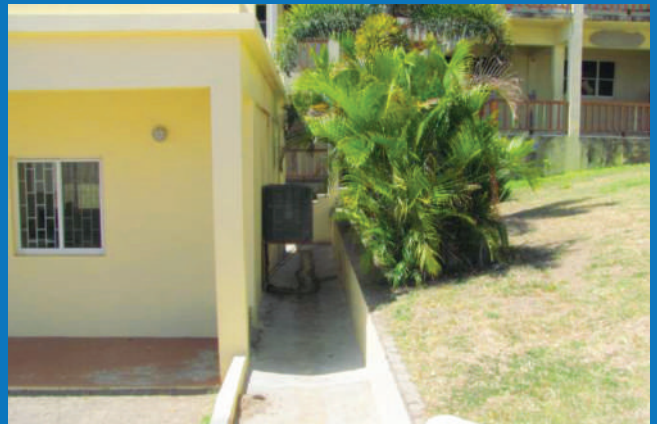
■ THE NEWER
BUILDINGS

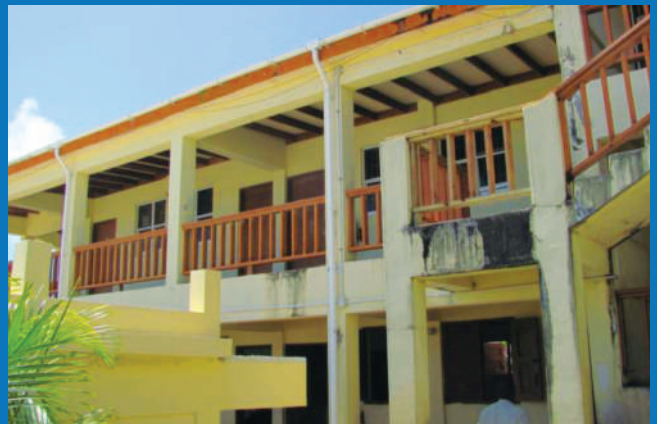
■ THE NEWER
BUILDINGS

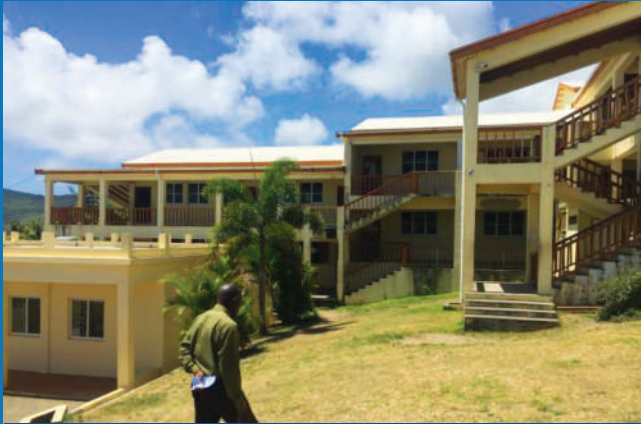
■ THE NEWER BUILDINGS

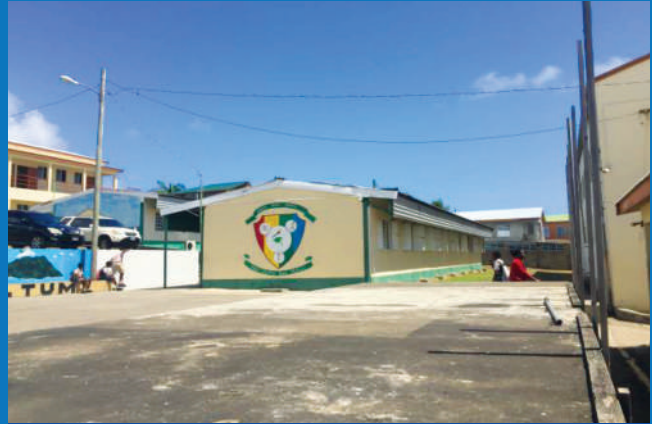
■ VIEW OF MAIN COURTYARD

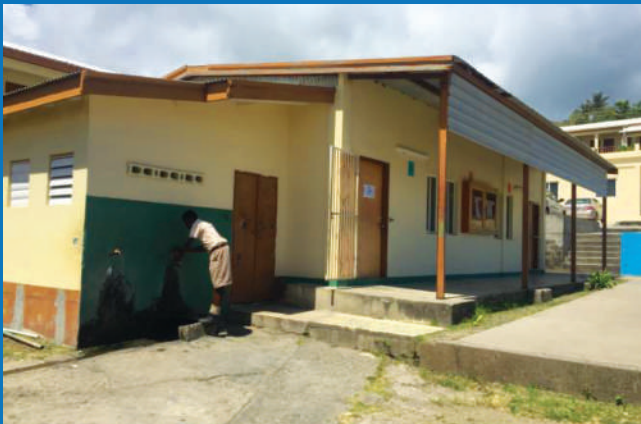
■ EXAMPLE OF INCREMENTAL CONSTRUCTION

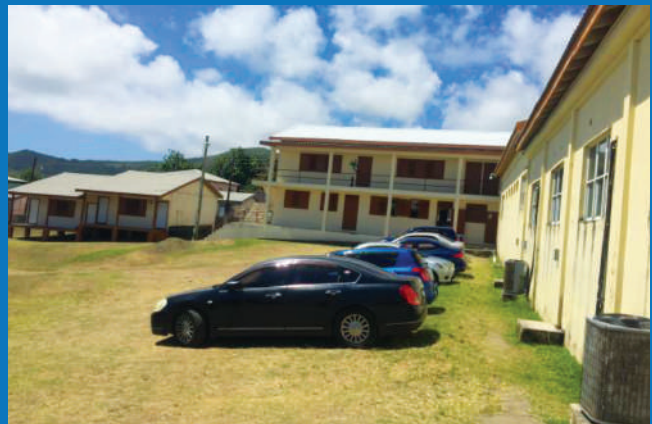
■ BUILDING WITH SHORT EAVES
